**AIRCRAFT SERIOUS INCIDENT
INVESTIGATION REPORT**

**PRIVATELY OWNED
JA 201M**

Company	Privately owned
Type, Registration Mark	Piper PA28RT-201T JA201M
Incident Class	Runway excursion (when an aircraft is disabled to perform taxiing) Article 166-4, item (iv) of the Ordinance for Enforcement of the Civil Aeronautics Act of Japan
Date and Time of the Occurrence	At about 11:26 Japan Standard Time (JST: UTC + 9 hours, unless otherwise noted, all times are indicated in JST in this report on a 24-hour clock), July 18, 2021
Site of the Serious Incident	Niigata Airport (37°57'23 N, 139°06'51 E)

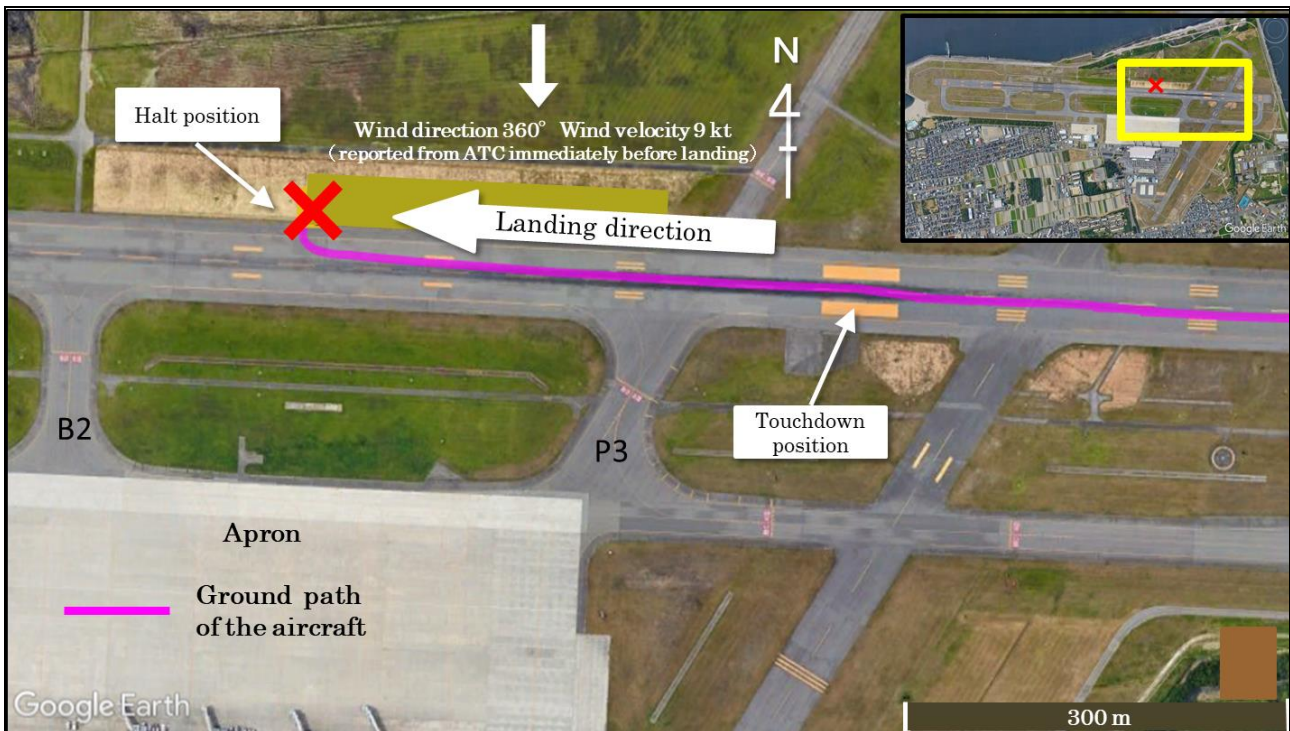
Figure 1 Estimated taxiing ground path of JA201M

There was no abnormality recognized in the aircraft at the beginning of landing roll. The aircraft slowed down by the engine thrust set at idle position without applying brakes. While decelerating, the captain applied the left rudder to enter the B2 on the left after passing the junction to the P3 taxiway, the captain felt that the response of the aircraft to the rudder steering was slow. As this situation was quite similar to the punctured tire during taxiing the captain had once experienced, the captain judged that the right tire punctured. Because the captain wanted to avoid highly possible damage to the right main landing gear wheel that might occur if taxiing in such condition continued up to the taxiway on the left side of the course. In addition, the captain thought that deviating the runway could avoid runway closure and thereby did not hinder operations of scheduled flights, the captain decided to deviate to the grassy area on the right side (the north side of the runway). The captain notified the decision to the air traffic controller at Niigata Aerodrome Control Facility, changed the course to the right after decelerating to approximately 5 kt, and ran off the runway proceeding at almost right angles to the longer side of the runway. After entering the grassy area, the aircraft continued taxiing changing the course further to the right and came to a halt near 41 m in the north of the runway centerline with the nose facing east-northeast, almost reverse direction to the landing direction. After the aircraft halted, the captain shut down the engine at that position since the aircraft was in condition of being disabled to perform taxiing.

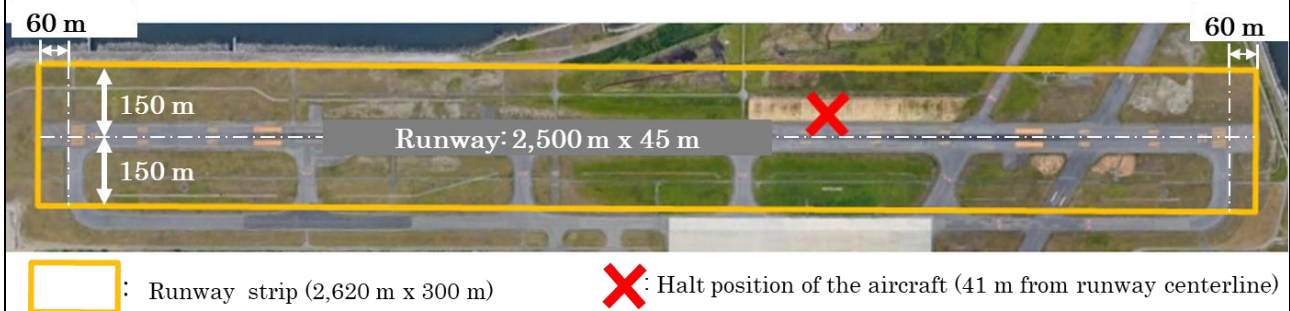
Figure 2 Runway strip of runway 10/28 at Niigata Airport (aerial photograph of Google Earth with some explanatory modifications added)

The position where the aircraft halted (the location 41 m away from the centerline of runway 28) was inside the area designated as a runway strip *¹ pertaining to runway 28 (see Figure 2).

Besides, when a disabled aircraft halts in a runway strip, a runway is forced to be closed by “Guidelines for runway operations when a disabled aircraft exists” (KOKU-KU-AN-HO No. 933 dated March 28, 2014), which forced the runway to be closed until the aircraft was cleared off.

However, the location where the aircraft halted and could not perform taxiing was inside the runway strip of runway 28 at the airport that forced the runway to be closed until a disabled aircraft was cleared off. It is highly probable that the recognition of the captain that, "Deviation from the runway could avoid the runway closure," was due to his or her insufficient understanding of the extent and operations of the runway strip.
