# AIRCRAFT ACCIDENT INVESTIGATION REPORT

AEROMOT INDUSTRIA MECANICO -METALURGICA AMT-200

(MOTOR GLIDER, TWO-SEAT), JA201X

TAJIMA AERODROME, TOYOOKA CITY, HYOGO PREFECTURE, JAPAN

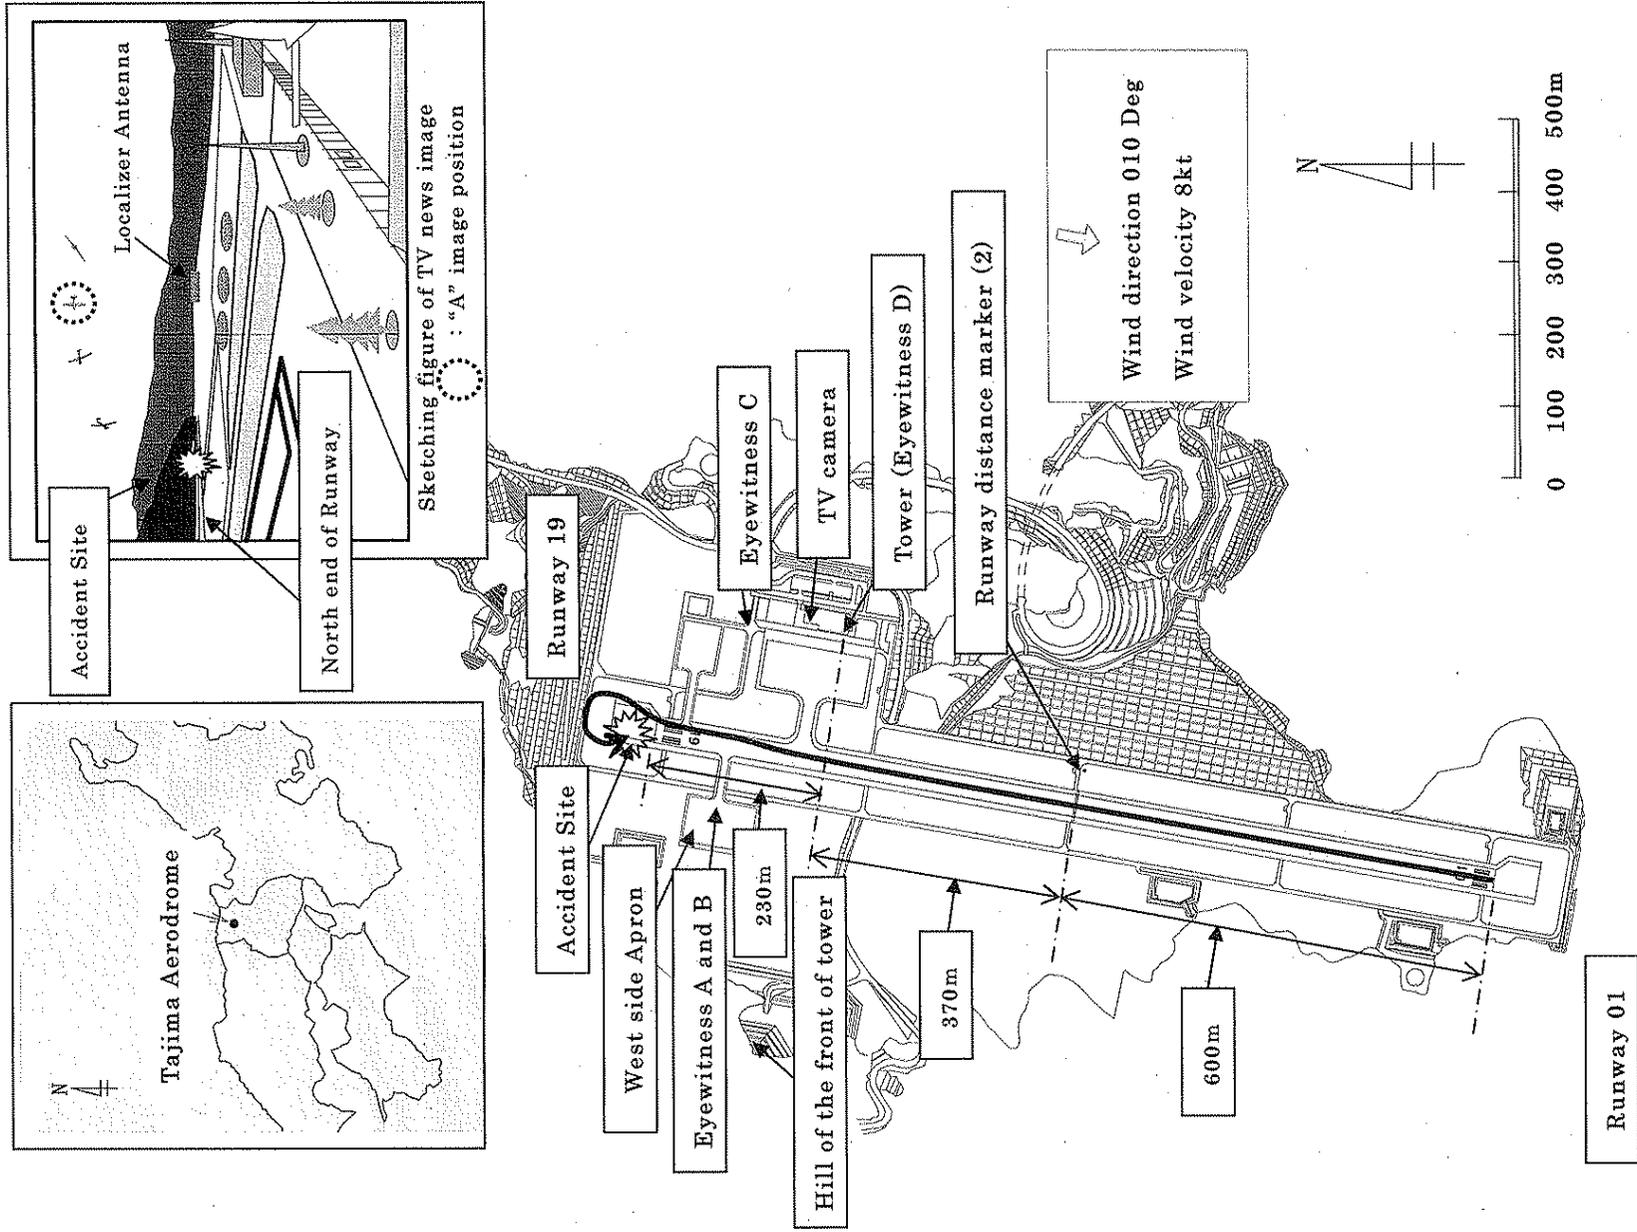
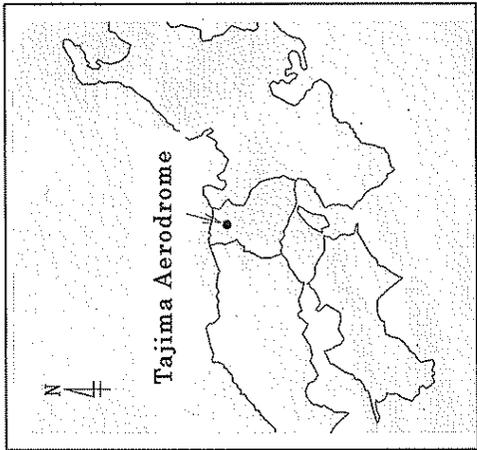
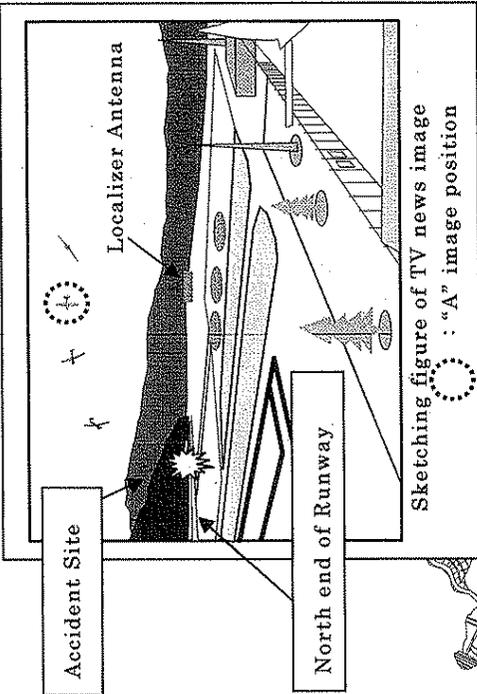
Figure 1 Estimated Flight Route

The aircraft’s height above the ground seemed approximately 40 ~ 50 m at the north end of Runway 01 (hereinafter referred to as “the runway end”), when I felt the aircraft deviated to the right a little.

Contrary to my first impression that the aircraft was going to make a right turn, the aircraft made a tight turn to the left immediately.

During the tight left turn, bank of the aircraft was so deep that I thought it was trying to turn and land on Runway 19. However, the aircraft immediately entered into a left spin, made a turn of heading and crashed with its nose facing north. I think that the propeller was rotating at that time.

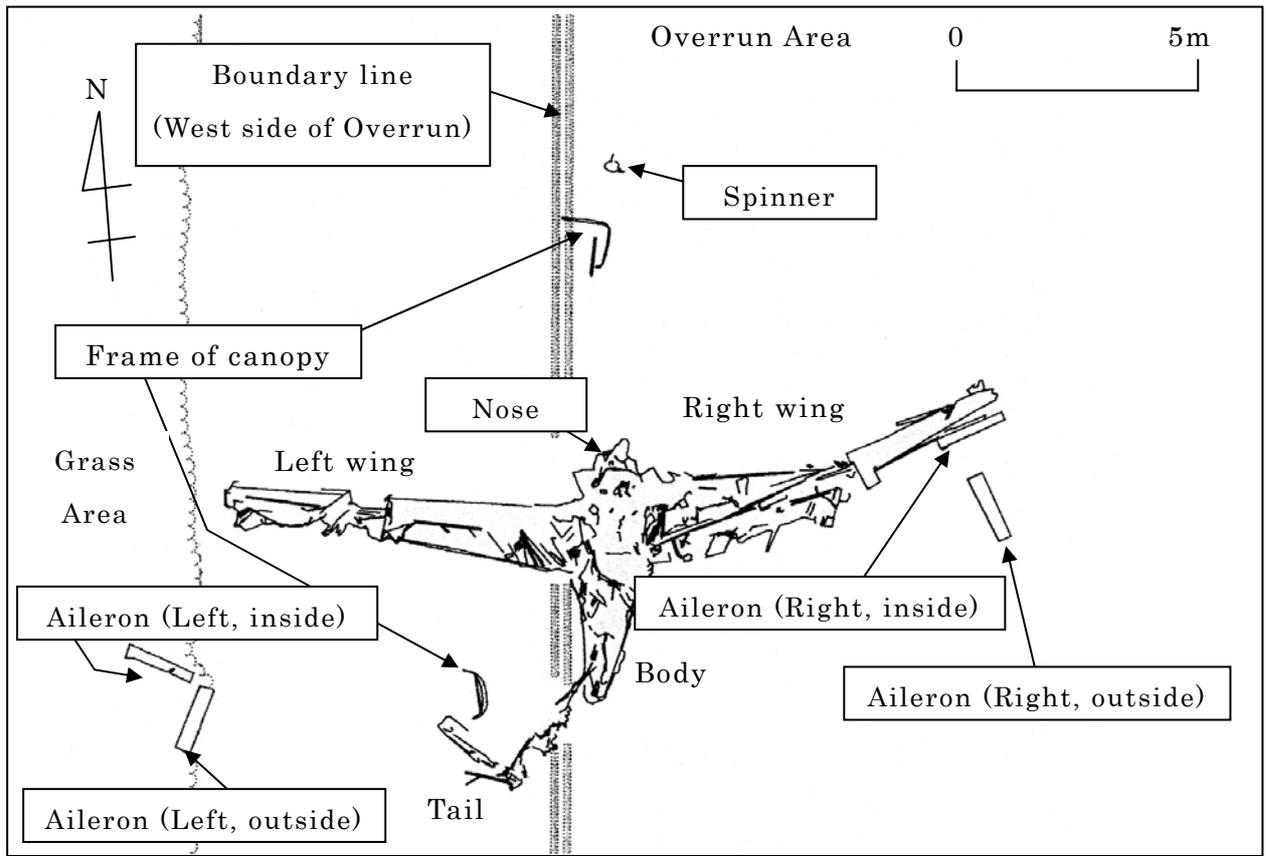
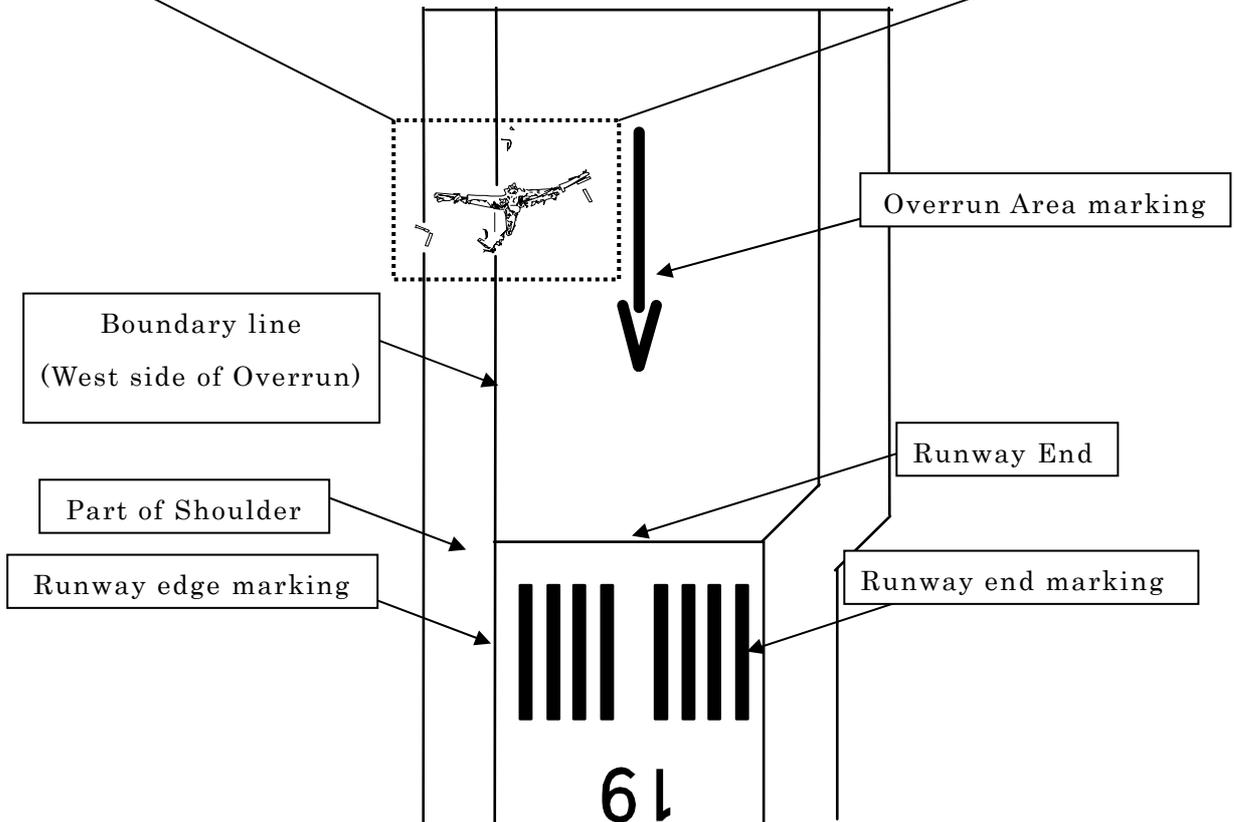
Figure 3 Around the Accident Site

Fragments of the aircraft were found scattered in a circle of an approximately 25 m radius surrounding the engine compartment.

The ground facilities near the crash site sustained no damage. No scratch marks made by the crash were found near the crash site, for example on the overrun areas. An inspection conducted by the aerodrome management organization after the crash found no abnormalities along the path on which the aircraft had moved on the day of the accident, and on the west apron. (See Figures 1 and 3.)

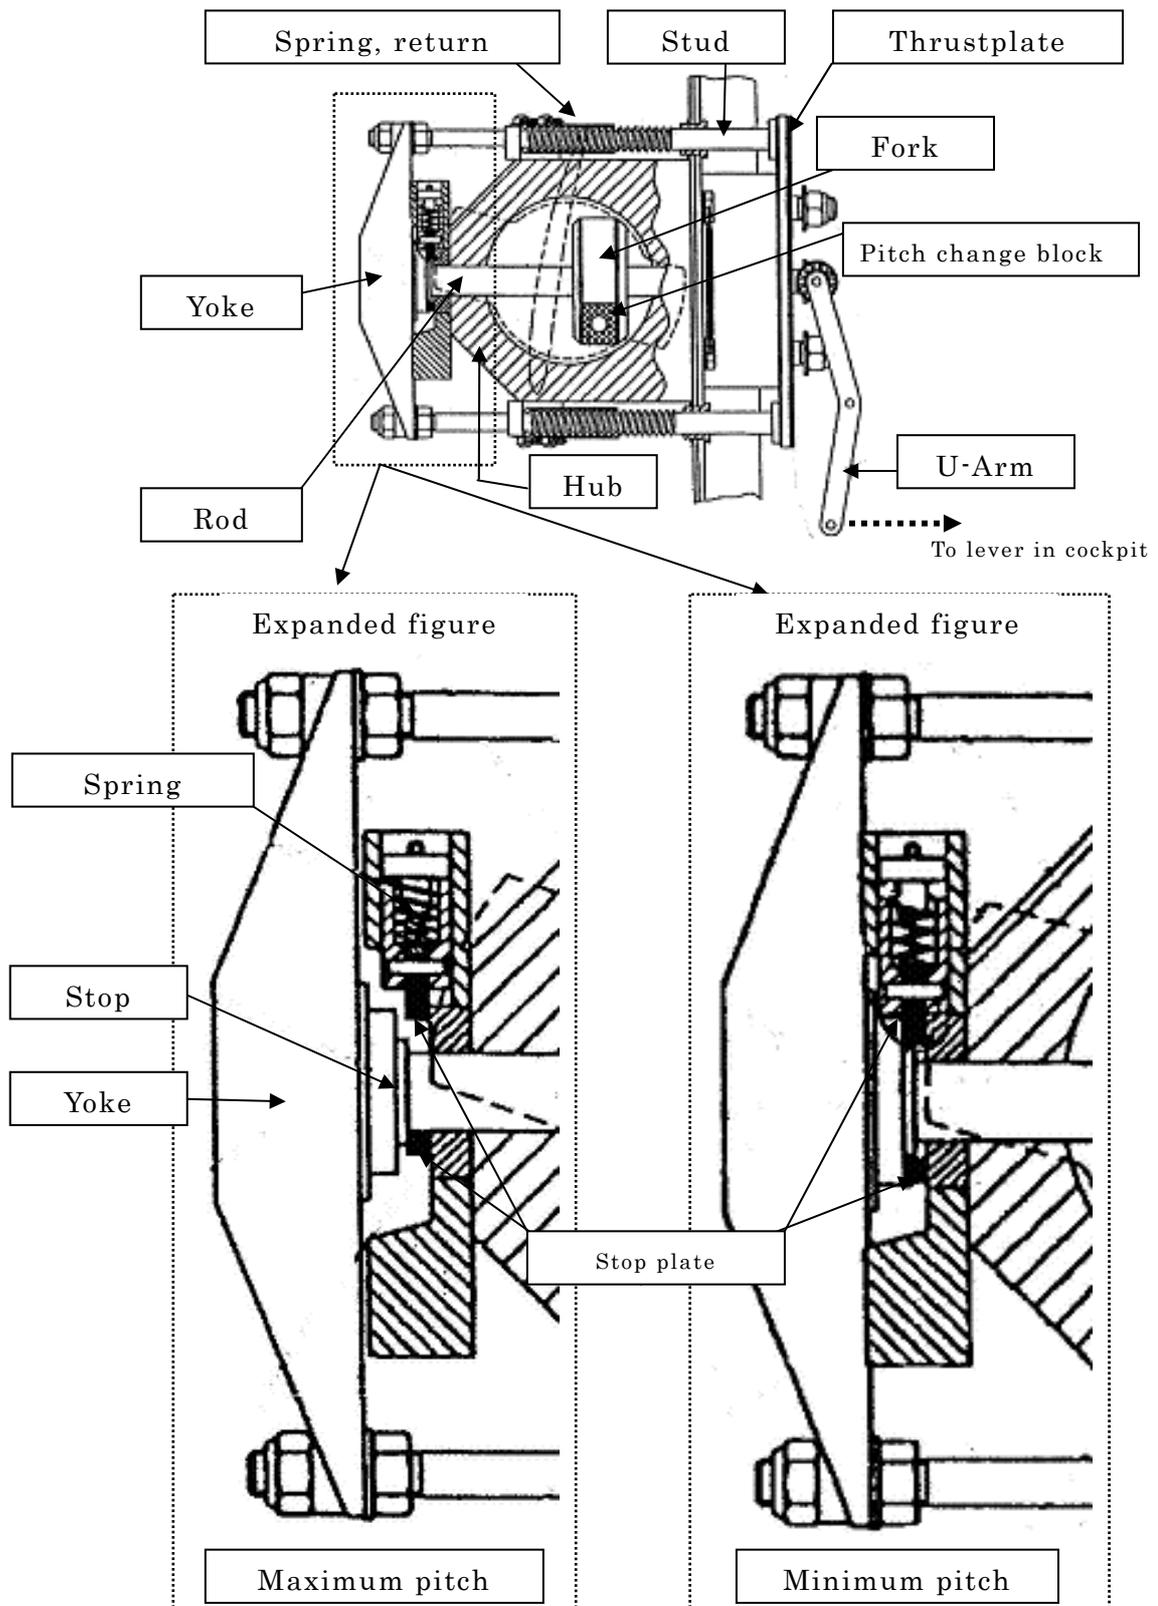
Figure 4 Propeller pitch change mechanism

- (3) As described in 2.8.2 (5), the root portion of the torn-off blade B could easily be turned by hand. This is because the pitch change block, the part that connected the root portion of the blade to the fork, was broken. The root portion of blade A, on the other hand, was found normally connected to the pitch change block.

- (4) The stop plate and its spring were in normal condition.
- (5) The stop plate was in the minimum pitch position.
- (6) The stop was found displaced by approximately 1 mm towards the maximum pitch position due to deformation of the yoke.

The stop plate is subject to both centrifugal and spring forces but it remains fixed by frictional force as long as it is pressed aft by the yoke.

Based on these things, it is considered possible that the low takeoff flight path of the aircraft might be caused by the PIC performing the takeoff with the propeller mistakenly in the maximum pitch position.

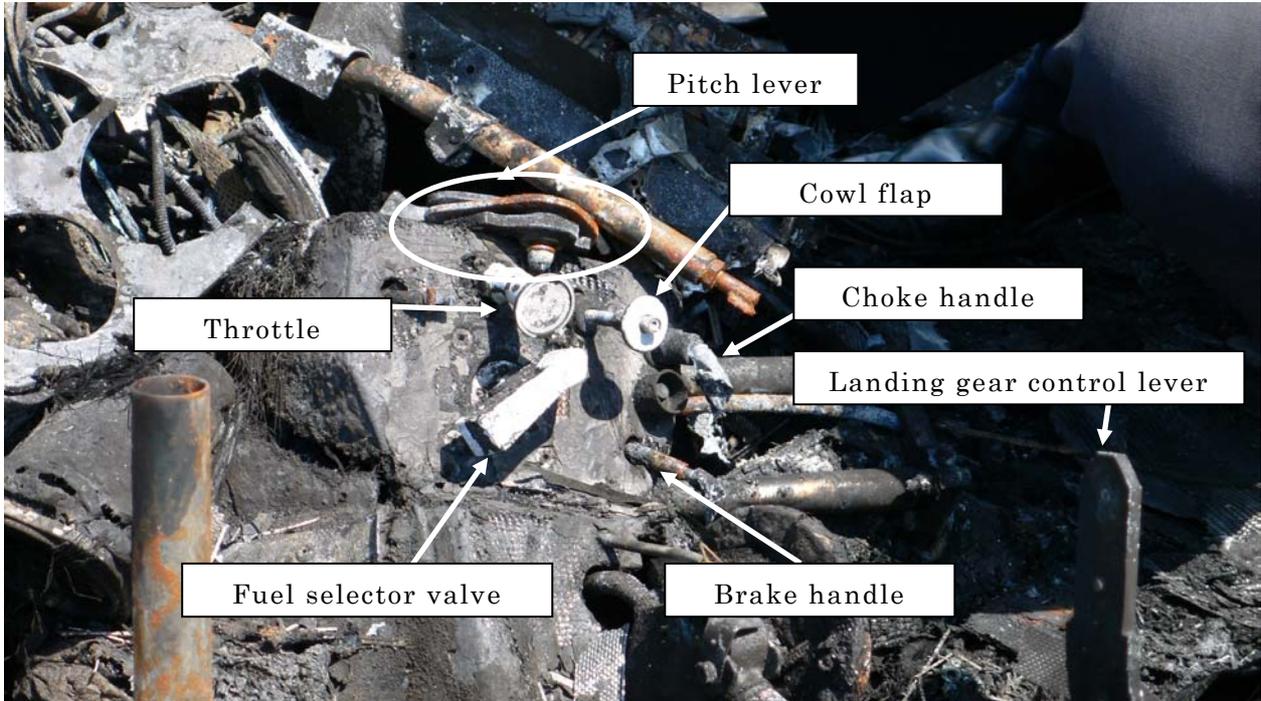
Photo Situation of the switches

As described in 2.8.3 (2), the on-site examination conducted just after the accident revealed that the choke handle was in the pushed-in position. In the subsequent teardown examination, the choke valves were found at nearly half-open position\*<sup>3</sup> as described in 2.11.1 (3).

It is considered possible that these conditions were attributable to the choke cables having been bent by the impact of the crash or by the crushing of the engine compartment.

As described in 2.8.3 (2), the fuel selector valve position was found to be midway between the "Right" and "Closed". In light of the following reasons, it is considered possible that the valve was in the normal position during flight but the impact forces of the crash then moved it.
