AA2007-2

AIRCRAFT ACCIDENT INVESTIGATION REPORT

PRIVATELY OPERATED,
AEROMOT-INDUSTRIA MECANICO METALURGICA
AMT-200 (MOTOR GLIDER, DUAL-SEAT) JA203X
MIHO AIRSTRIP, SHIMIZU-KU WARD, SHIZUOKA-CITY
JULY 15, 2006

March 30, 2007

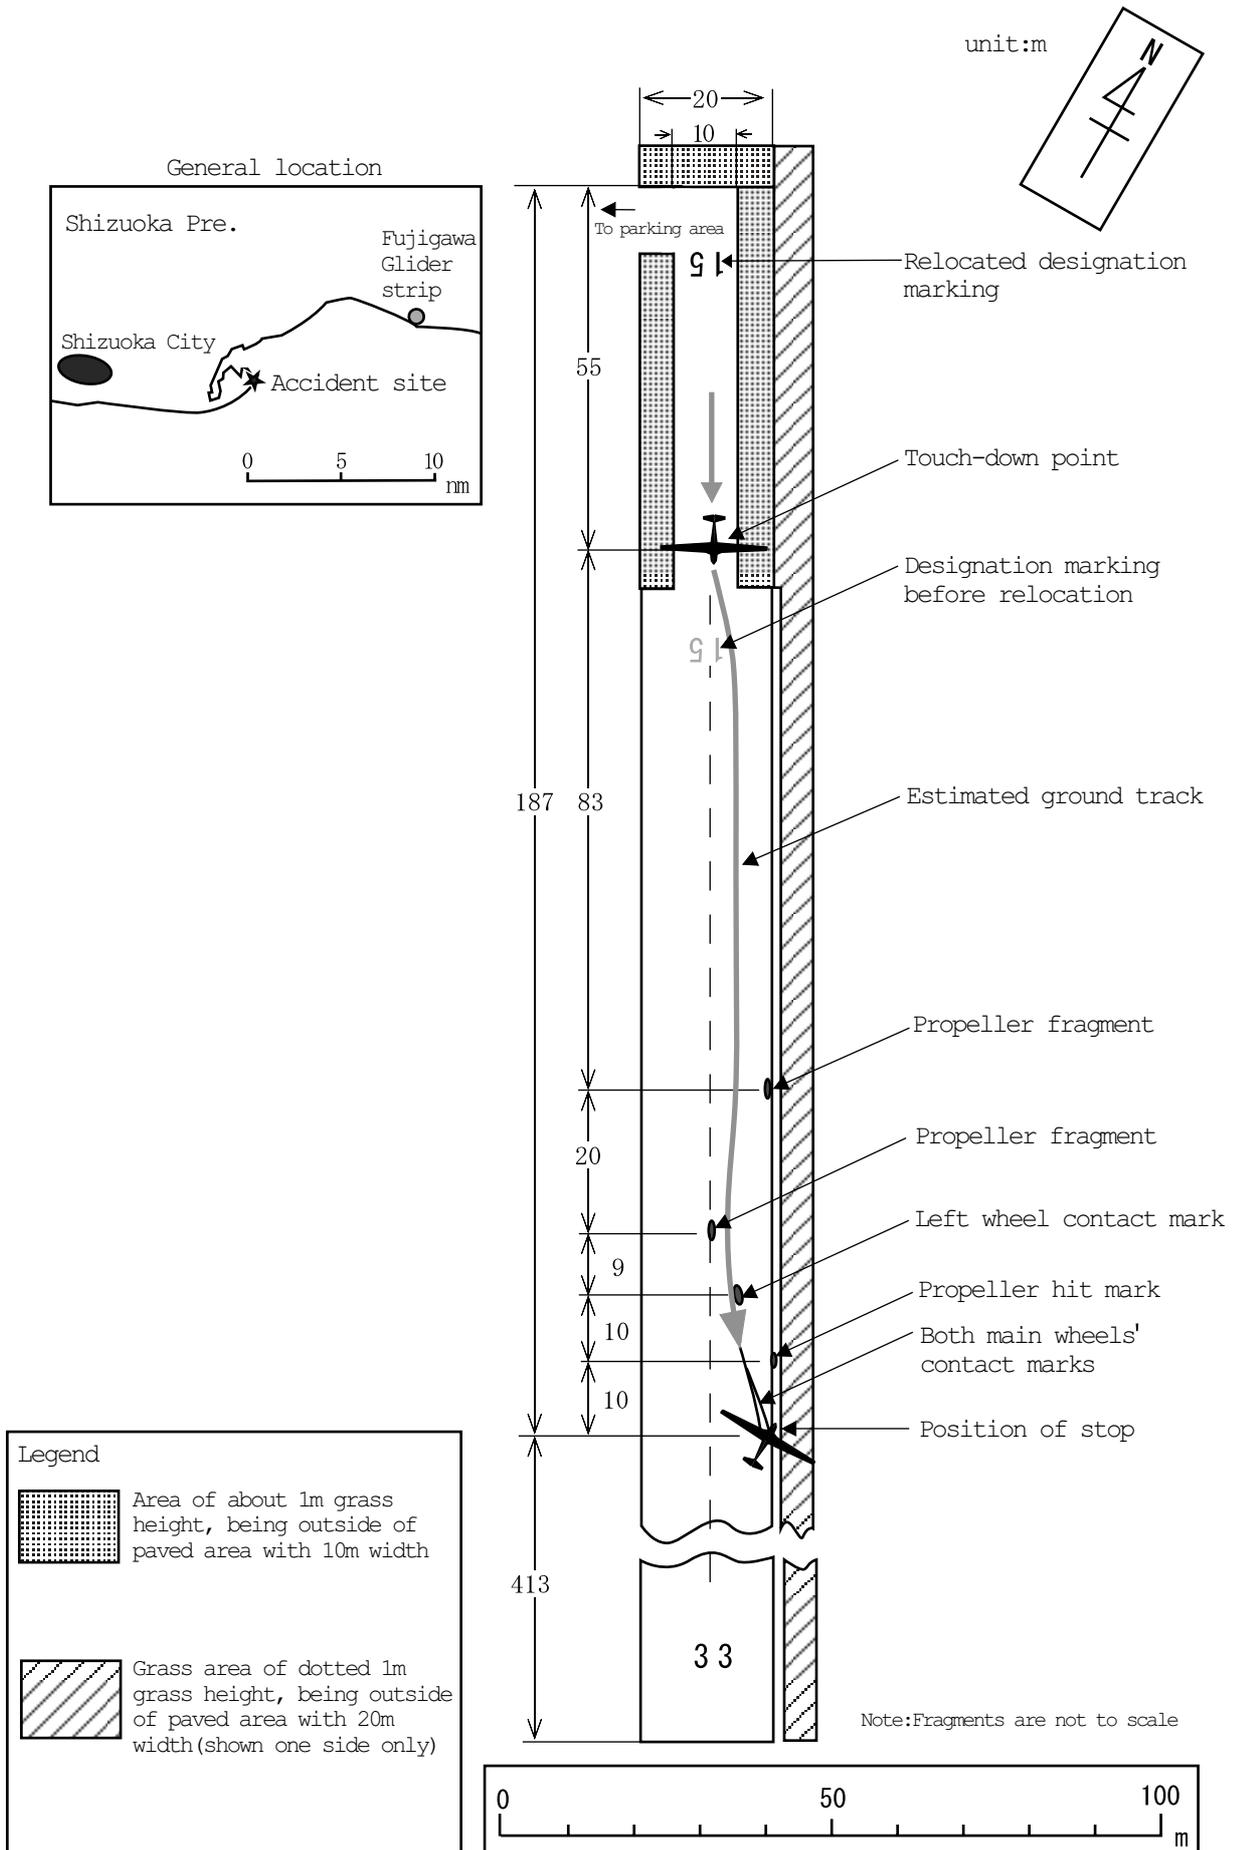
Figure 1 Accident Site Layout

Length and width of the airstrip, according to the airstrip layout which is attached to the temporary take-off/landing application submitted by an airplane operator to the Tokyo Airport Office, measure 600m long by 20m wide paved with asphalt, however, in reality northern end portion of the airstrip (62m in length) where the aircraft touched down is paved 10m wide. The area outside of the width is covered by grass, but perimeter of the airstrip including this area has not been mowed for a certain period of time, which resulted that the grass height measured about 80cm in the area where right wingtip passed whereas it measured about 1m in the area where left wingtip passed.

The aircraft was immobilized oriented to the north near the boundary between shoulder-like area and airstrip. Contact marks made by both main wheels stretched about 12m long to the point where the aircraft stopped. A contact mark made by left main wheel was found about 10m before the beginning of the aforementioned marks. A hit mark made by propeller was found on the shoulder-like area about 10m before the point where the aircraft stopped.

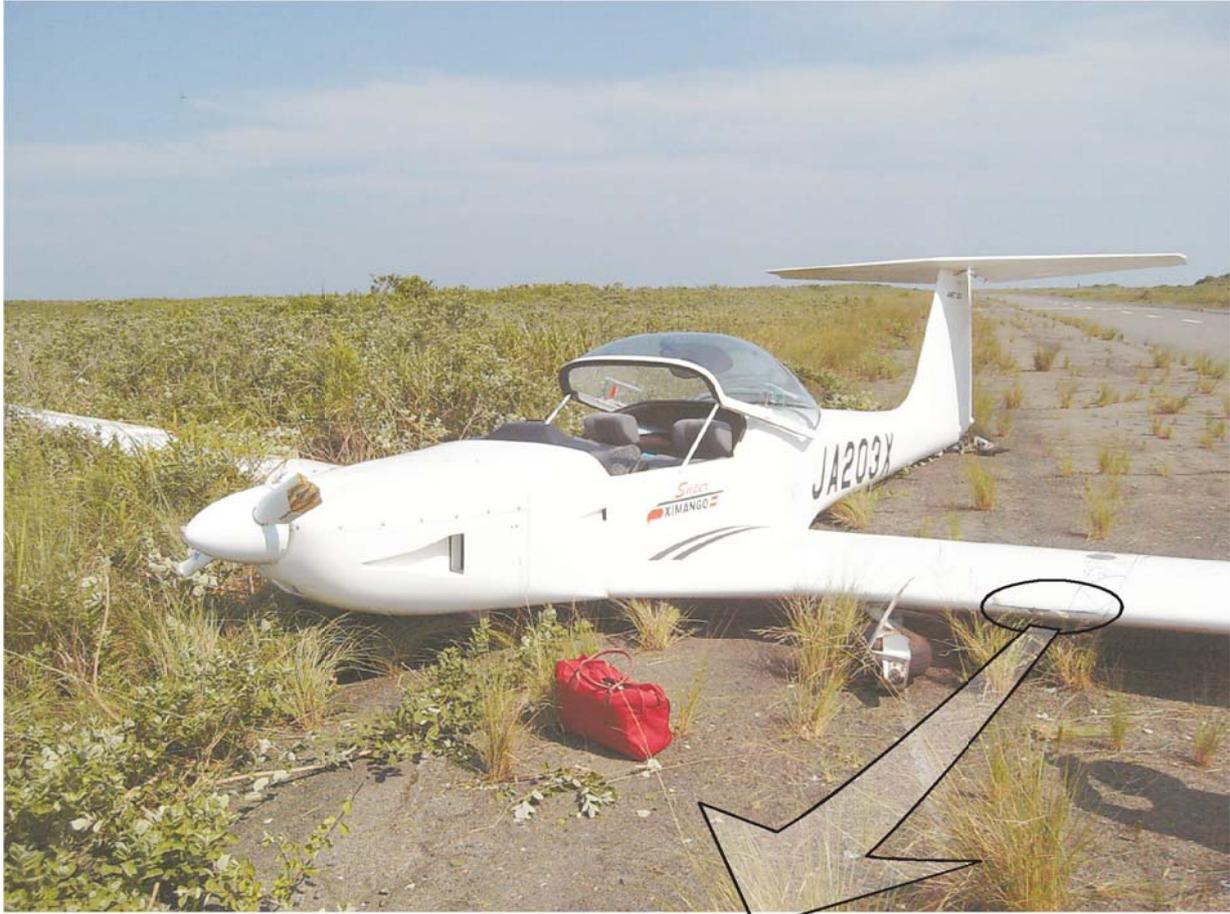
Picture Accident aircraft and damage

- (1) Main landing gears and tail wheel Fractured
- (2) Left wing Damaged
- (3) Propeller Fractured

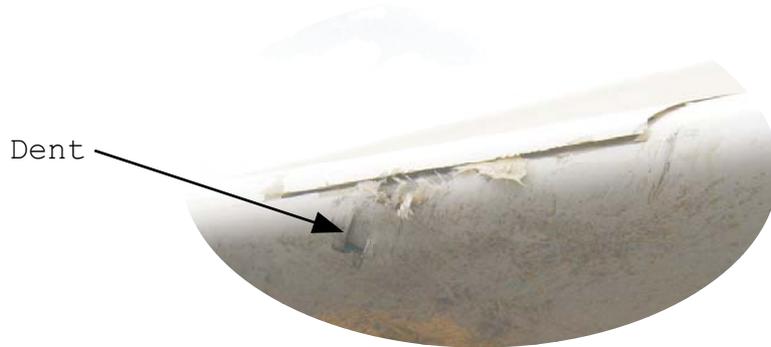
Leading edge, Left wing

(2) On the left wing leading edge about 2m away from the wing root, there was a about 40cm long span-wise crack and paint was scratched off there. On the lower part of the crack there was a dent which is considered to have been hit by a part of rectangular shaped object and red oil streaks were observed nearby. A part of left wingtip paint was thinly scratched off in the span-wise direction.

The reason for the 40cm long crack on the left wing leading edge is estimated as follows.

When the left main landing gear fractured, a spring contained in the oleo was extended when the main landing gear's fractured part detached from the airframe, then a part of the main wheel was pulled back by the spring and strongly hit the left wing leading edge.

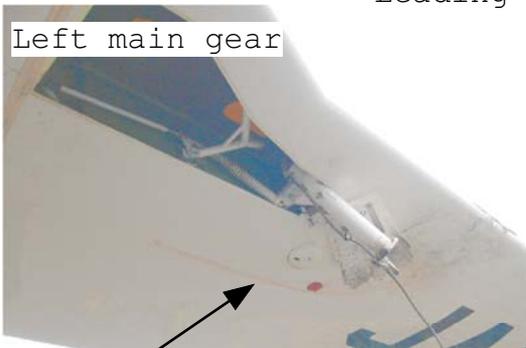
Left main gear

(1) Main landing gear shock struts and tail wheel shock strut were all fractured. The spring housed in the left main landing gear strut was fractured after a part of it was extended.

Streak of red oil
