**AIRCRAFT ACCIDENT
INVESTIGATION REPORT**

**NARA DISASTER PREVENTION AIR CORPS
J A 2 0 N A**

INJURY TO A RESCUEE DURING HOIST OPERATION NARA DISASTER PREVENTION AIR CORPS BELL 412EP (ROTORCRAFT), JA20NA NISHIYOSHINO TOWN, GOJO CITY, NARA PREFECTURE, JAPAN AROUND 13:48 JST, SEPTEMBER 16, 2013

March 27, 2015

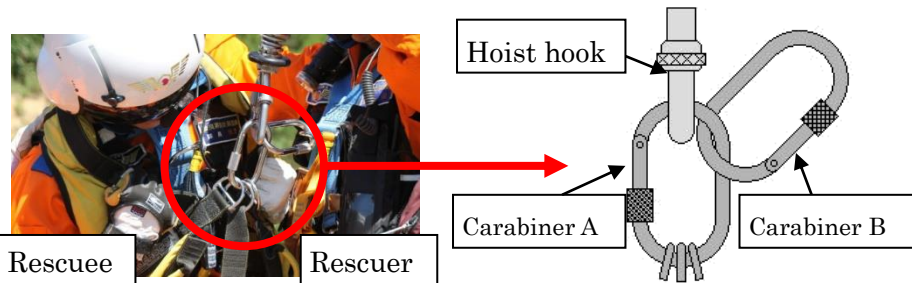
Although the rescuee A understood that the rescuer was explaining something to her before the rescue, due to the loud noise of the helicopter and her difficulty in hearing, she could not hear the content of the explanation. The rescuee A complained of pain because while she was being lifted, she felt pain so intense that it was as though her finger was being torn off.

Although she was still in considerable pain even after being lowered to the ground, she endured the pain since she was frightened of being lifted by the helicopter and wanted it to be completed quickly. She does not remember where or how she was holding on.

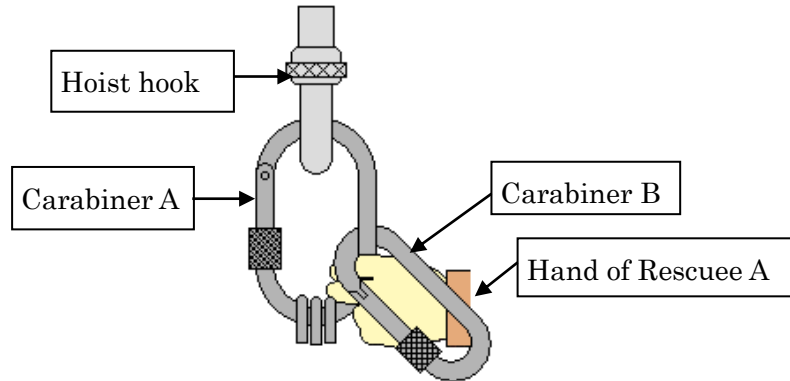
she attempted to do so, it would have been possible to prevent her finger from passing into carabiner A.

It is also somewhat likely that if the Disaster Prevention Air Corps had thoroughly implemented the above procedures, or had selected rescue equipment for which it would not have been physically possible to hold carabiner A, it would have been possible to prevent the rescuer A from being caught in carabiner B.

In this accident, it is highly probable that at the moment the aircraft lifted the rescuer and the rescuer at the same time, the rescuer held carabiner A, which was connecting herself to the rescuer, in order to support her body falling backward, causing her finger to be caught in the rescuer's carabiner B and injured.
