**AIRCRAFT ACCIDENT  
INVESTIGATION REPORT**

**J A 2 1 3 0**

**Japan Transport Safety Board**

PRIVATELY OWNED  
ALEXANDER SCHLEICHER ASK 13 (GLIDER, TWO-SEATER), JA2130  
YOMIURI OTONE GLIDING FIELD, OTONE-MACHI,  
KITASAITAMA-GUN, SAITAMA PREFECTURE, JAPAN  
AT ABOUT 10:23 JST, JULY 20, 2008

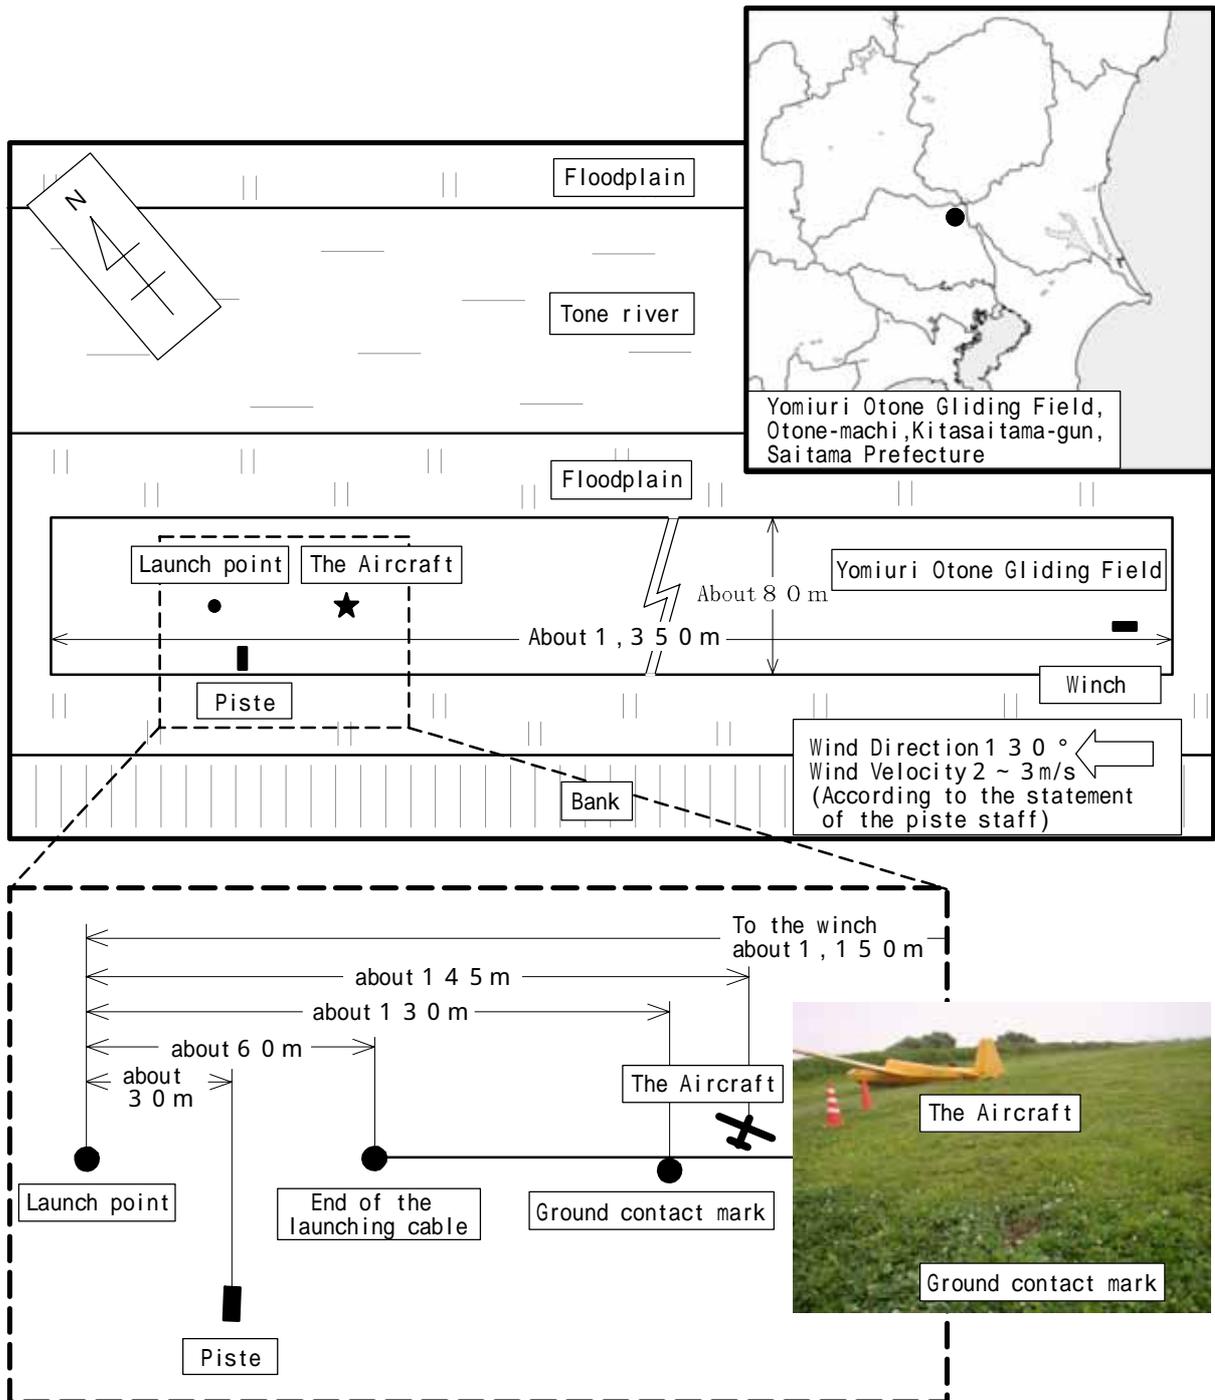
Figure 1 Accident Site Layout

The winch had been positioned about 1,150 m away from the launch point. The parachute attached to the end of the cable having been released from the Aircraft was at a point about 60 m from the launch point. The cable was found running straight from the winch without any intermediate bends in the reverse direction. Ground contact mark of the Aircraft was observed at about 130 m from the launch point, and the Aircraft was in a stop with the nose facing leftward at an angle of about 70° at about 145 m from the launch point.

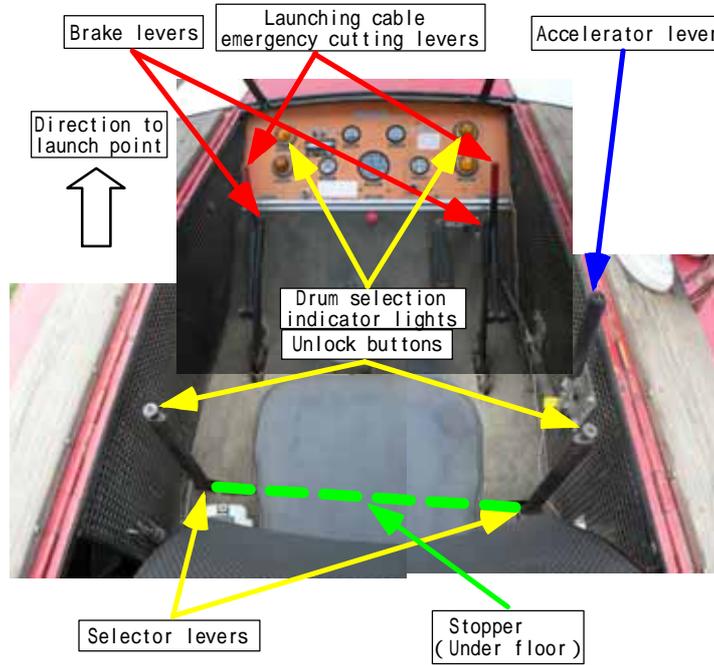
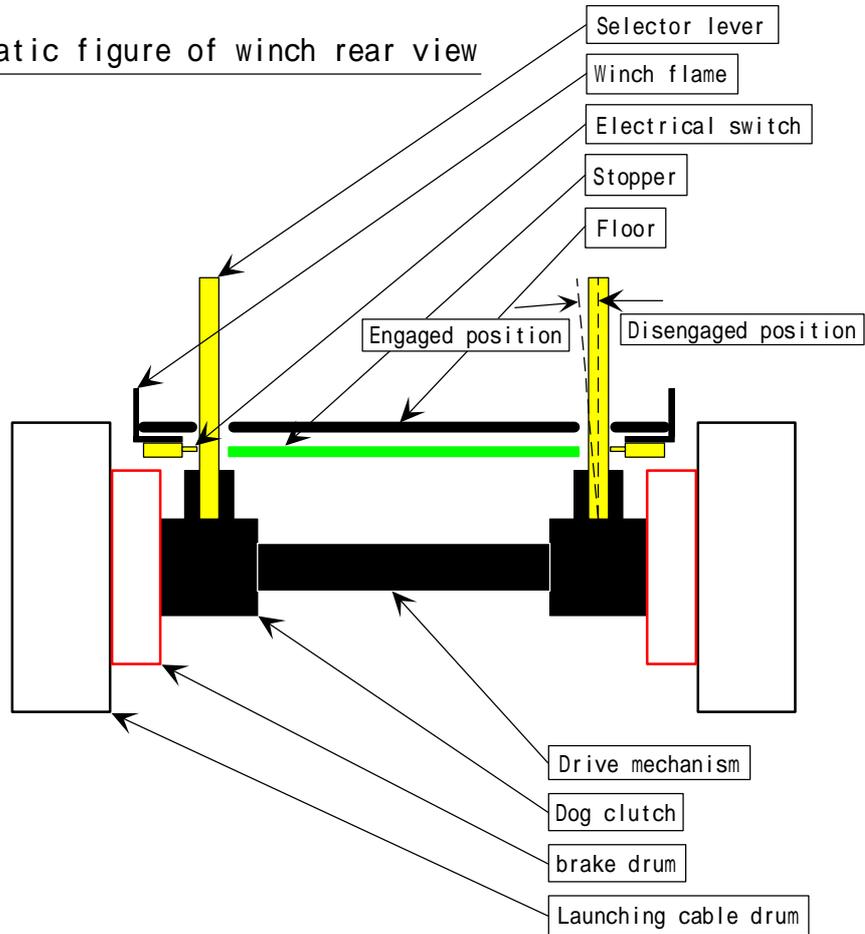
Figure 3 Winch

In order to make it mechanically impossible that the operation of pulling both the selector levers simultaneously to the operator seat and placing them in the engaged position, the stopper is installed like strut between the root sections of the both selector levers under the floor of the winch operator seat.

The stopper is not connected to the selector levers, but is supported by the floor of the winch operator seat by means of bolts in such a way that the stopper moves to the left or to the right as either of the selector levers is moved left or right.

An electrical switch is installed on the winch frame near the root of each of the left- and right-drum selector levers respectively. When the lever is moved from the disengaged position to the engaged position, the switch which had been kept pressed by the lever is released, and this causes the switch contacts to close and energizes the corresponding circuit, and thus illuminates the associated drum selection indicator light on the instrument panel of the operator seat respectively.

According to the winch owner, the right-drum selection indicator light was already inoperative due to a malfunction when the winch was imported, and as the troubleshooting conducted by the winch owner failed to identify the cause, the winch had since been used unrepaired.

In the situation with the right selector lever set to the disengaged position, the left selector lever was moved slowly toward the engaged position side from the disengaged position within the range at the intermediate lever position between the engaged and disengaged positions after pressing the unlock button and while leaving the button in the pressed position.

The amount of movement of the lever was measured at its top end using the disengaged position as a reference, and the left-drum dog clutch started to engage when the lever was moved about 3.5 mm, and the left-drum selection indicator light turned on when the lever was moved about 43 mm, and the unlock button popped out, locking the lever in the engaged position when the lever was moved about 45.5 mm.

The result of this examination showed that the lever has a travel range of 39.5 mm in which the drum is engaged without illumination of the indicator light.

- (1) Judging from the findings of the winch examination described in 2.10.1, it is considered highly probable that at the time of the accident the left-drum selector lever was positioned between the engaged and disengaged positions with the unlock button pushed in. Although the winch design does not assume any operation with a drum selector lever in an intermediate position between the engaged and the disengaged positions, it is considered highly probable that during the disengagement operation of the left selector lever, the winch operator failed to fully ensure that the lever was definitely in the disengaged position by checking that the unlock button was in the “out” position and thus the lever was locked, so the setting of the lever to the disengaged position was incomplete. It is considered probable that a factor contributing to the operator's failure to make sure of the lever setting is that the operator did not know about the existence of lever positions that allow both drums to become engaged simultaneously.

With regard to the reason why the left selector lever was able to stay between the engaged and the disengaged positions and thus allowing both drums to engage simultaneously, it is considered highly probable that this state is caused by the lack of stopper length.

- (1) The stopper on the winch was removed and replaced with a stopper supplied by the Company. As the length of the new stopper was adjustable, the owner adjusted it in such a way that there is no clearance between the stopper's ends and the levers' root sections when one lever is set to the engaged position and the other lever to the disengaged position, thereby eliminating any chance of the simultaneous engagement of both drums.
- (2) The light system for the left- and right-drum selection indicator lights was repaired to ensure that the lights work respectively.
- (3) A daily checklist has been established in order that the winch is inspected according to the daily checklist before every operation to check that there are no problems with the winch.

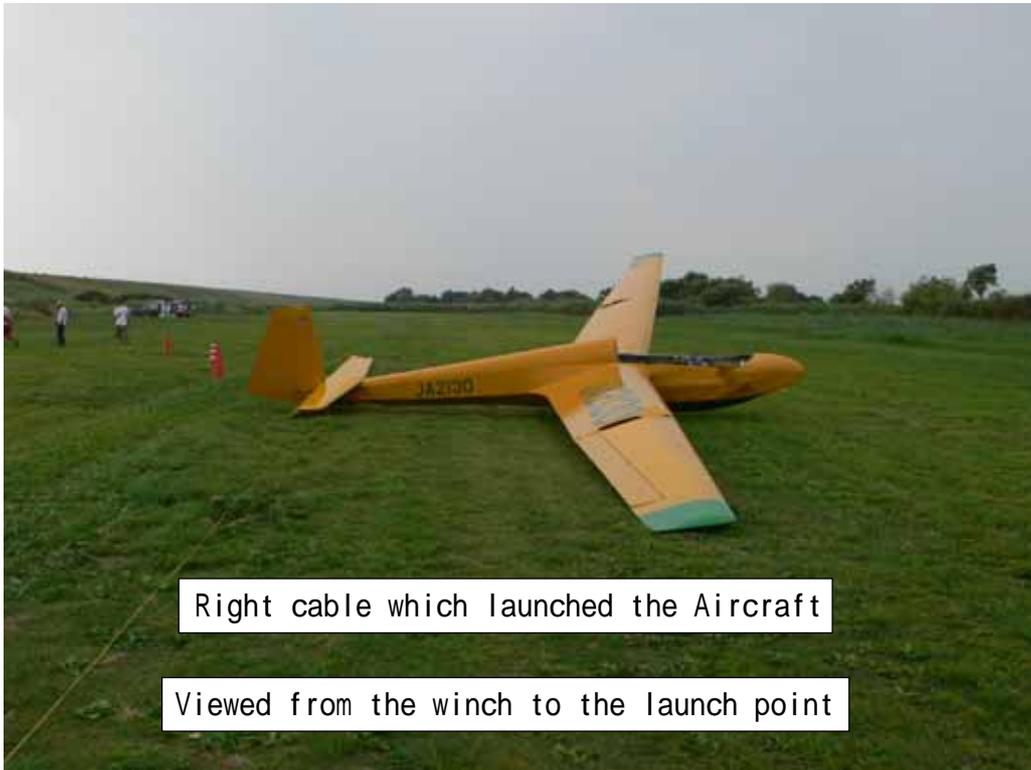
Photo 1 The Aircraft

Fuselage	Nose deformed and its panel cracked, tail skin cracked, instrument panel of front seat detached
Wing	Panels at mid-portion of left and right wings cracked
Empennage	Horizontal stabilizer damaged

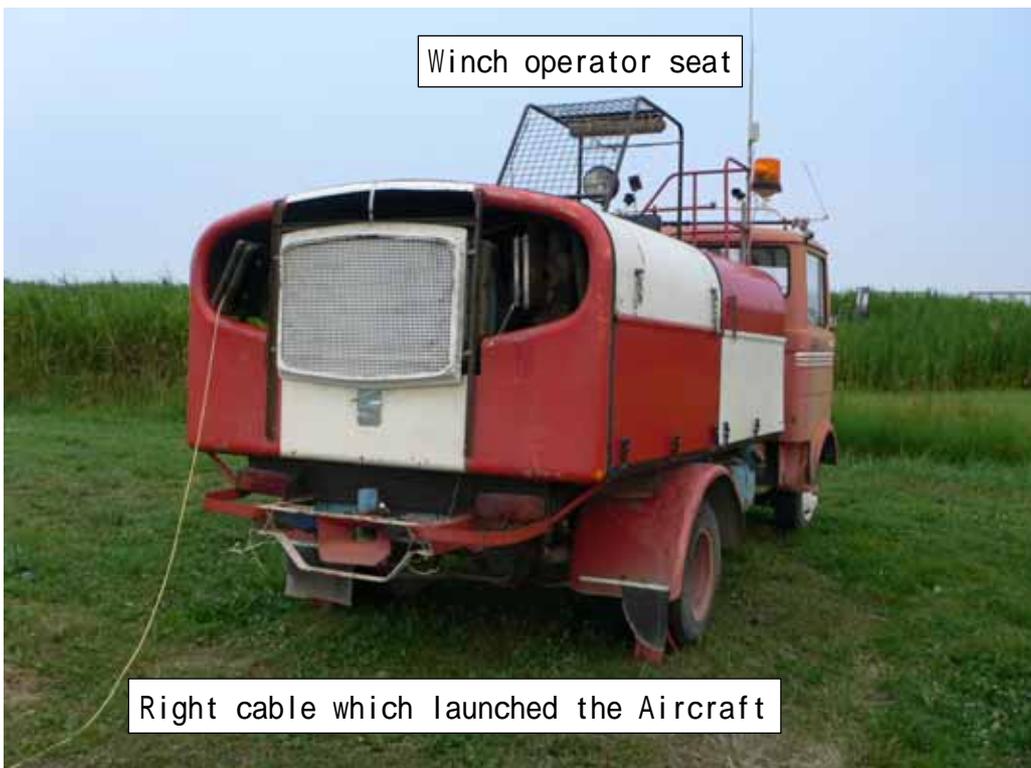
Photo 2 Winch

As described in 2.6 (1), the winch owner did not possess the winch manual at the time of the accident and had not kept an operation log and a maintenance log of the winch, and also as described in 2.6 (5), the owner continued operating the winch without repairing the right selection indicator light, which had been found to be inoperative at the time of import of the winch, so, it is considered highly probable that management of the winch had been inadequate.

The winch should never have been used with the drum selection indicator light, a safety device, in an inoperative condition, and instead it should have been repaired before putting the winch in service, after importing it.
