**AIRCRAFT ACCIDENT
INVESTIGATION REPORT**

PRIVATELY OWNED
SPORTAVIA SF25C (MOTOR GLIDER, TWO-SEATER), JA2168
AT SHINSHINOTSU GLIDING FIELD,
SHINSHINOTSU-MURA, ISHIKARI-GUN, HOKKAIDO, JAPAN
AT ABOUT 10:41 JST, JUNE 12, 2011

April 6, 2012

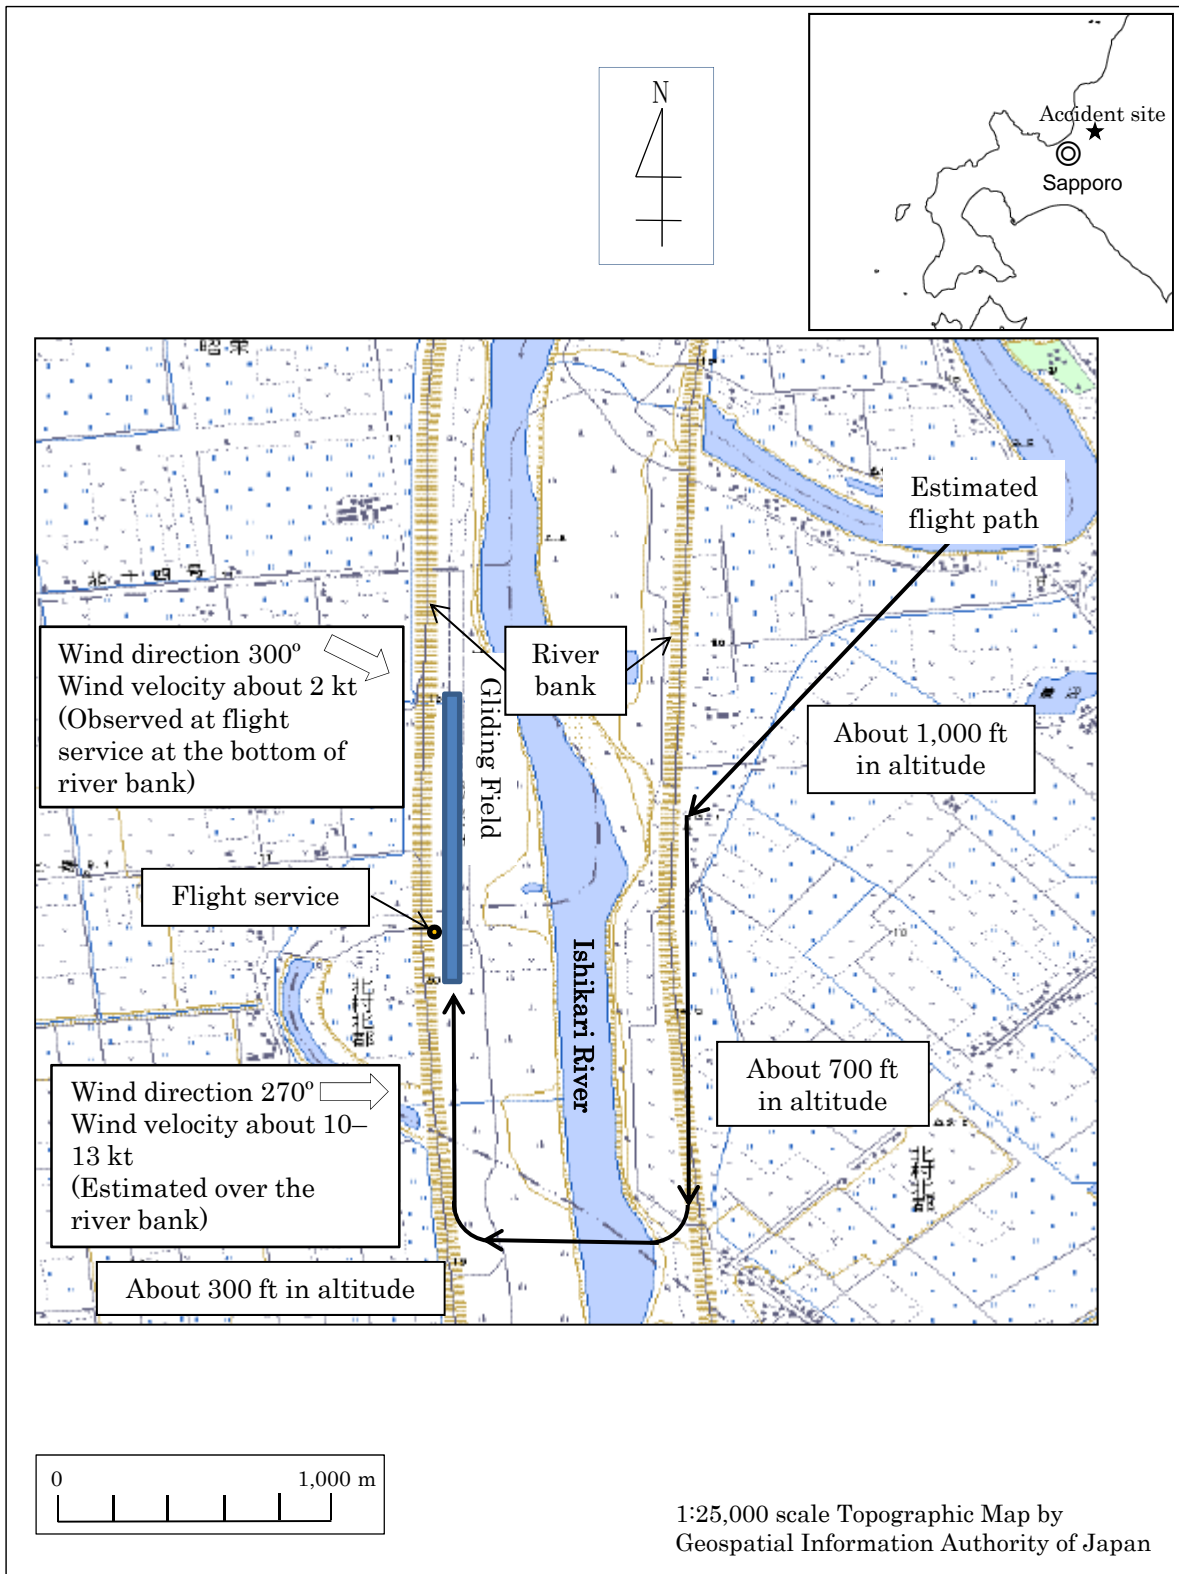
Figure 1 Estimated Flight Path

When the Aircraft was aligned with the final leg at an airspeed of about 90 km/h and an altitude of about 300 ft, the captain determined a point about 100 m from the threshold as the aiming point for the approach, and extended the spoilers*² halfway.

Feeling that the Aircraft was being lifted by air currents at an altitude of about 100 ft,

the captain pulled the spoiler lever with a slightly strong force toward the extending direction.

Against the corrective effect that would normally be expected, the nose of the Aircraft downed more steeply than intended immediately after pulling the spoiler lever and pointed towards the grass area slightly short of the threshold, and the rate of descent increased as well. The captain immediately released the spoiler lever and pulled the control stick, during which he felt that the elevators were lighter to operate than usual and the rise in nose pitch was not as significant as expected.

The Aircraft sank about 10 m, landed violently on the runway with a nose-down attitude, and then slid about 30 m on the bottom of its nose.

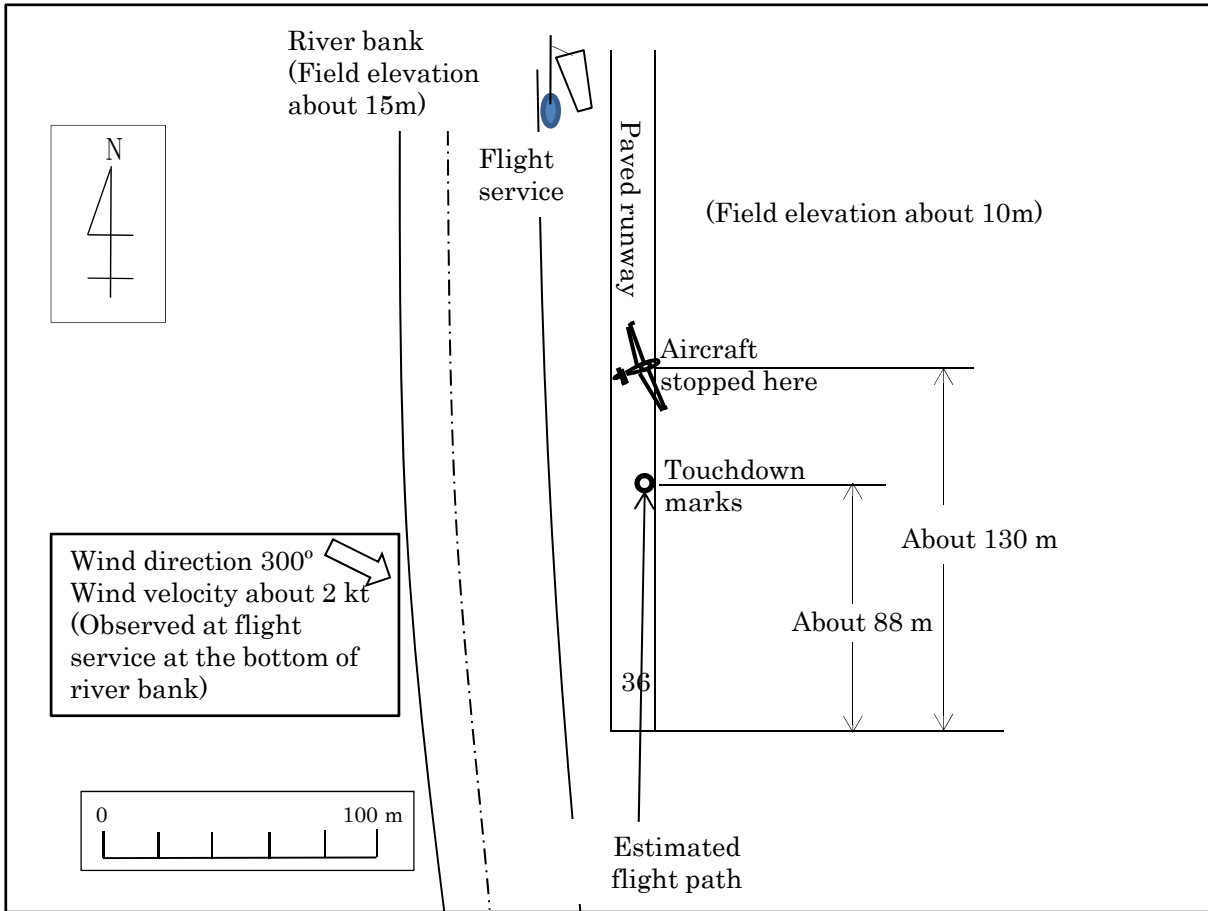
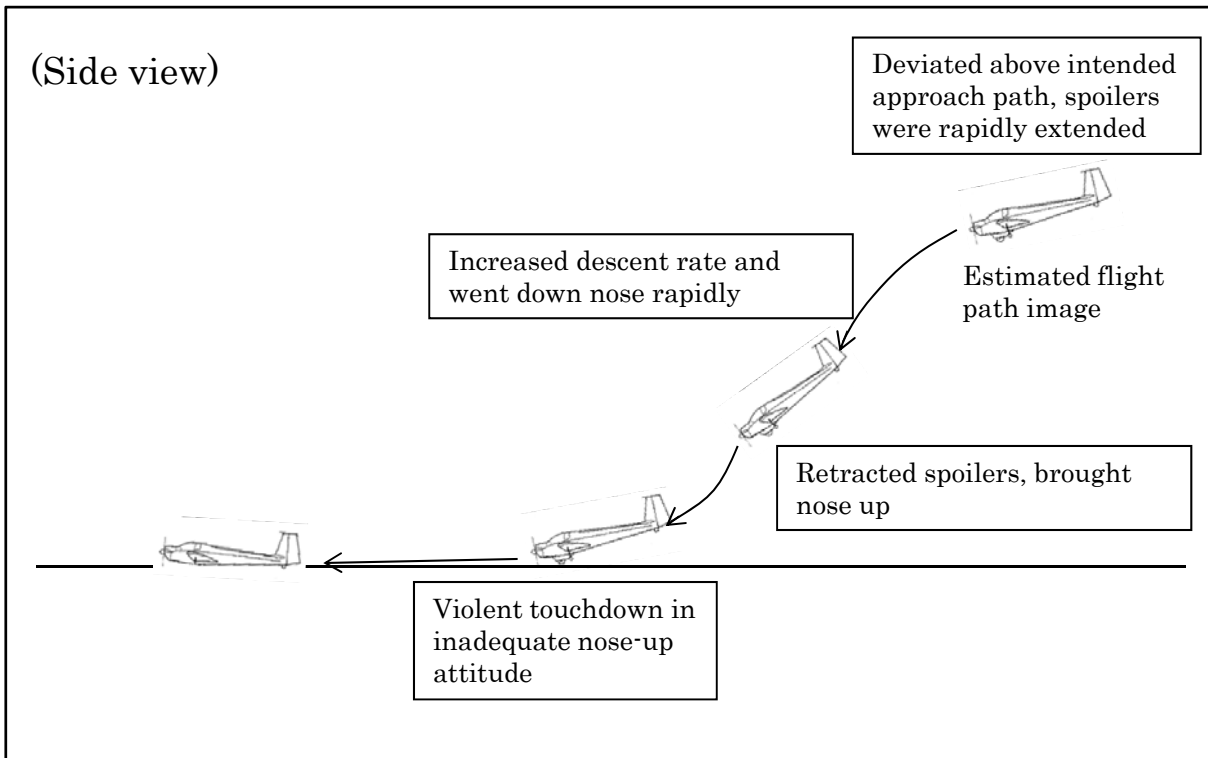
Figure 2 Accident Site and Estimated Flight Path

About 70 m west of the runway was a river bank about 5 m in height (at a field elevation of about 15 m) running from north to south parallel to the runway. The shape of the bank section was such that its surface formed an upward slope starting with a line about 100 m west of the runway and then, beyond the road at the top of the bank, a downward slope declined toward the runway.

On the runway section about 88 m north from the runway's south end, there remained tire contact marks, two groove marks, and propeller slash marks (scars) on the runway. The distance between the slash marks was about 75 cm. The Aircraft had stopped with east-northeast heading on the runway about 42 m north of the contact marks.

Judging from the statements that a rightward drift of the Aircraft was noticed as it entered the final approach as described in 2.1 (1) and (2), and considering the observation records by the Shinshinotsu Automated Weather Station located on the same plain as the accident site as described in 2.6 (1), it is probable that the wind was from about 270° at about 10 to 13 kt in the portion of the final approach where the leg's altitude is higher than the river bank on the west side of the runway as described in 2.7.2 (i.e., about 16 ft AGL or higher).

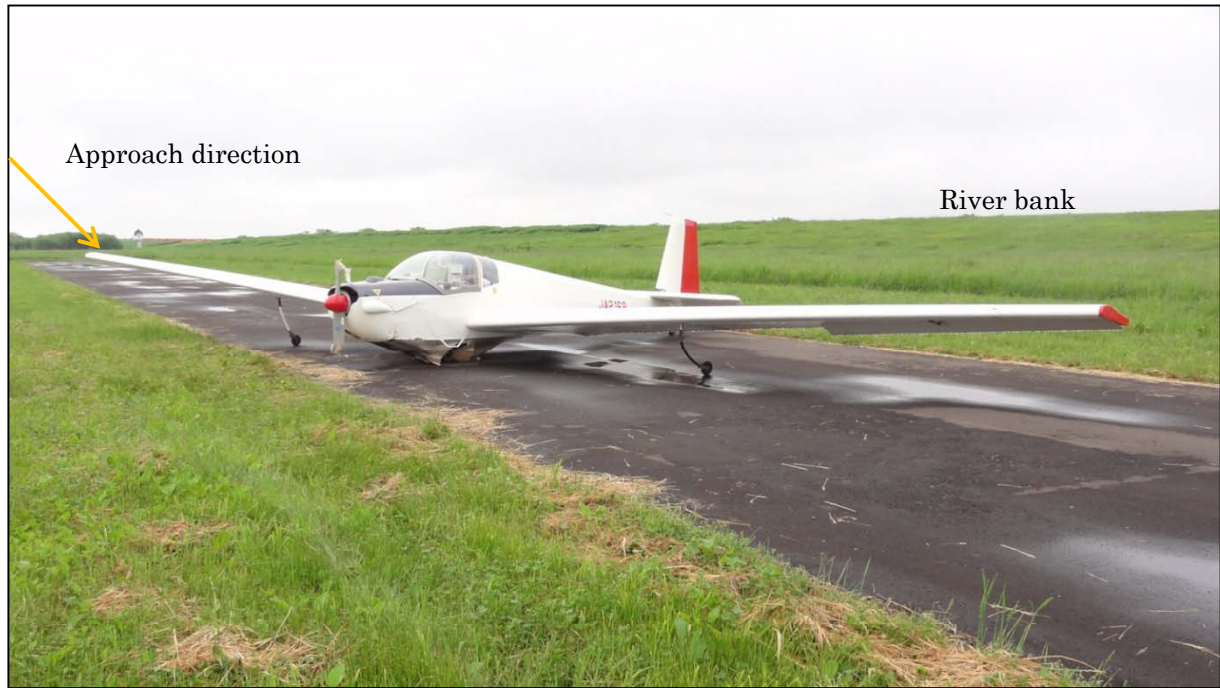
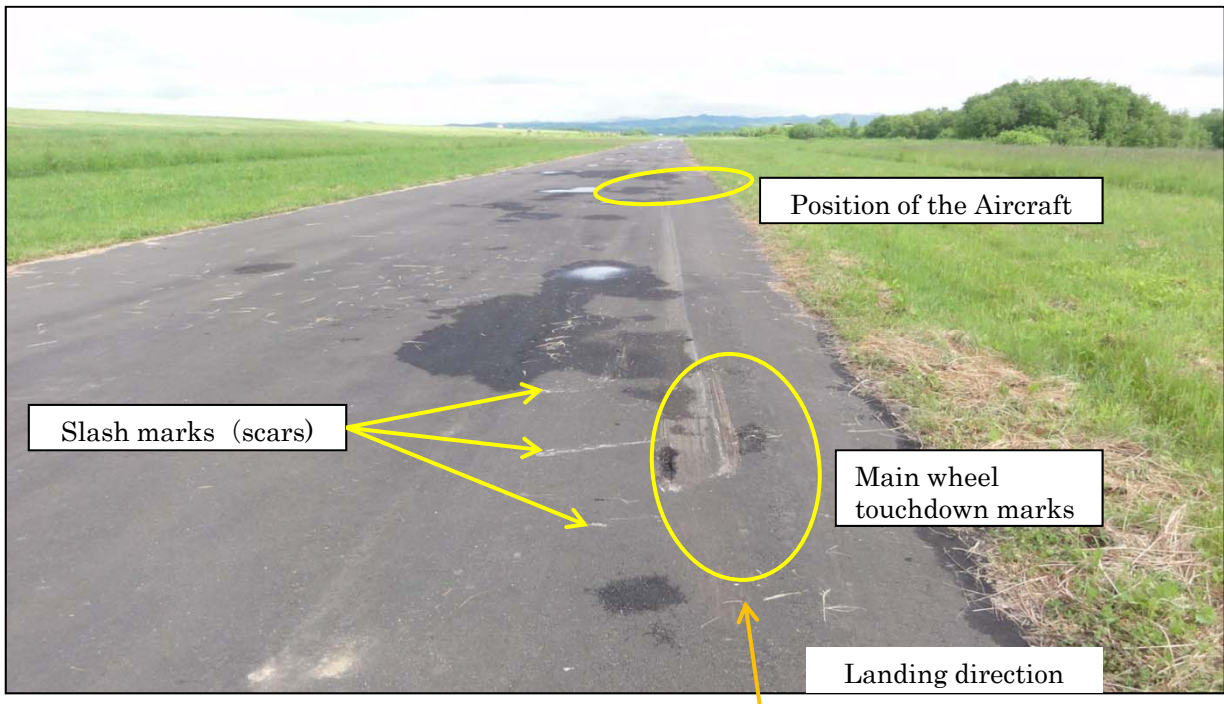
Photo 1 Accident Site

Judging from the marks left on the runway surface as described in 2.7.2 and the rubbing marks on the main wheel bearings as described in 2.7.3 (2), it is highly probable that the component that first violently touched the runway surface was the main wheel, followed by the propeller blades, and then the main wheel bearings after the main wheel came off.

The calculation results reveal that the Aircraft's ground speed was about 48.6 kt (about 90 km/h). When the wind at the time of the touchdown is assumed to be from 300° and at 2 kt as observed at the flight service, the Aircraft's airspeed was almost equal to its ground speed. This means that the Aircraft's airspeed was greater, with a considerably safe margin, than the stall speed of about 65 km/h under the maximum takeoff weight described in 2.8 (1). Also, since the Aircraft touched down at a point about 88 m north of the threshold past the grass area short of threshold against which the Aircraft's nose would assumedly have momentarily faced when it went down steeply, it is highly probable that the Aircraft did not stall and its nose was brought up to some extent before the touchdown despite the decreased effectiveness of the control surfaces.

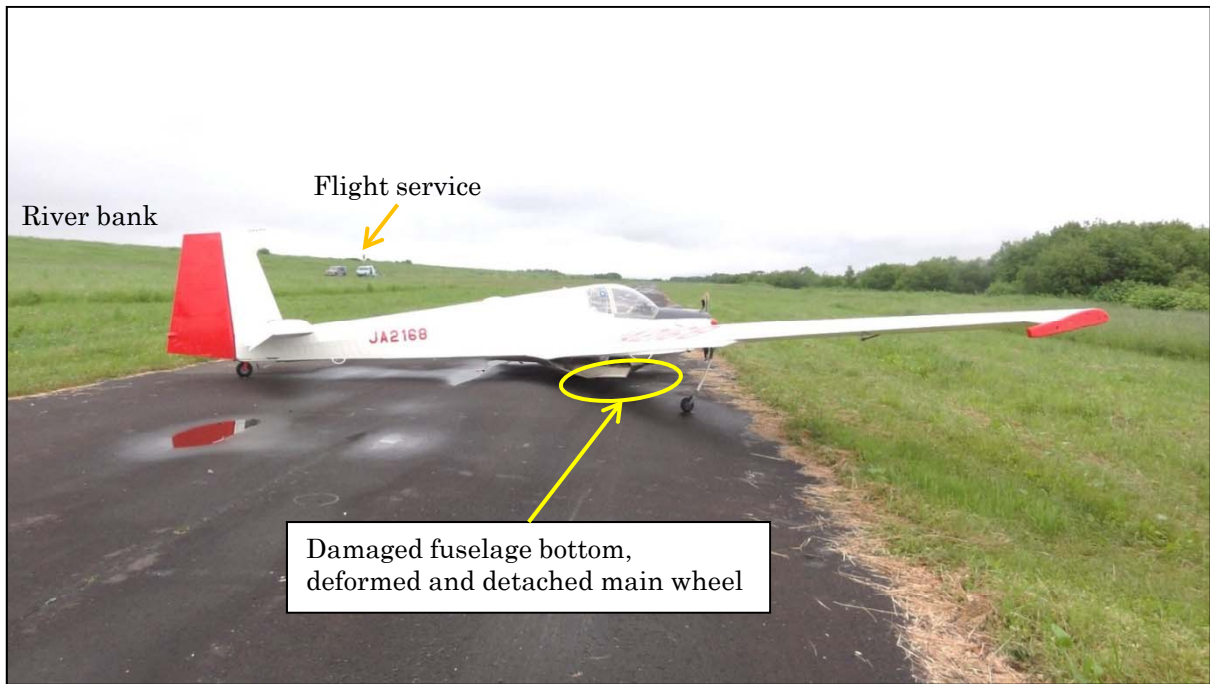
Photo 2 Accident Aircraft

| (1) Propeller: | The blades were broken. |
| (2) Engine: | The intake and exhaust pipes were deformed. |
| (3) Fuselage: | The lower fuselage was damaged. |
| (4) Wings: | There were open cracks. |
| (5) Landing gear: | The main wheel was deformed and detached; the outriggers (wheels on the wing bottoms) were deformed. |

When judged from the damage to the Aircraft described in 2.3.2, it is highly probable that the every damage was caused by the external forces working at the time of the accident. It is also highly probable that there were no abnormality with the Aircraft before the accident when judged from the statement of the captain described in 2.1 (1).

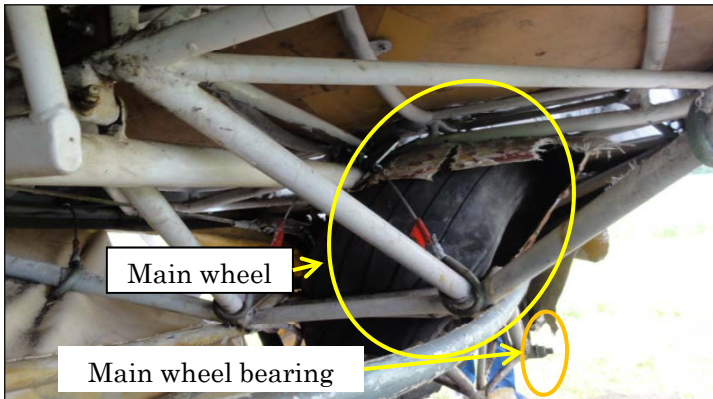
Deformed and detached main wheel

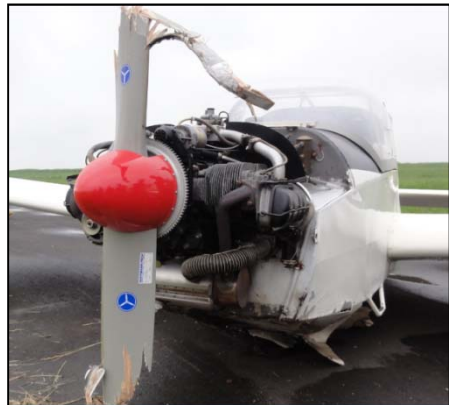
- (1) Propeller: The wooden propeller blades were bent toward the trailing edges and had torn off at a point approximately midway along their length. The tears showed fine splits.
- (2) Fuselage and landing gear: The main wheel at the bottom of the fore fuselage had come off the bearings on both sides and was wedged into the fuselage beneath the pilot's seat in a deformed state. The bottom surfaces of both bearings had rubbing marks.

Broken propeller blades

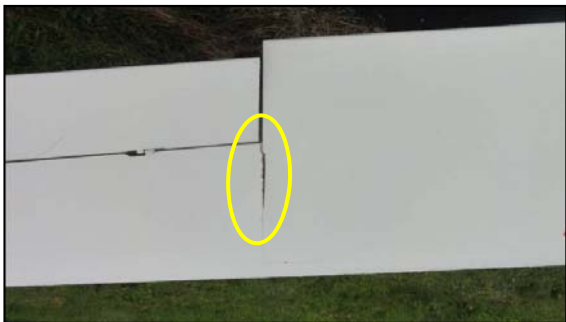
Cracked right wing

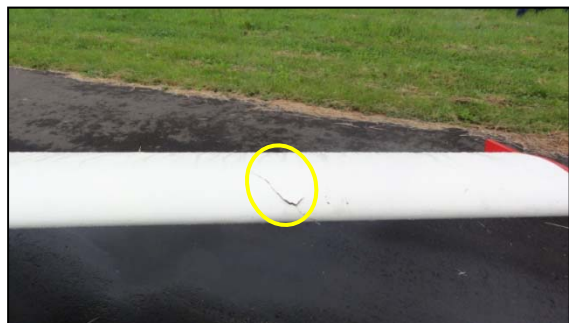
Cracked left wing
