**AIRCRAFT ACCIDENT  
INVESTIGATION REPORT**

**SUWA CITY GLIDER ASSOCIATION  
J A 2 3 2 0**

FUSELAGE DAMAGE CAUSED BY LANDING ON  
THE ROUGH GROUND  
SUWA CITY GLIDER ASSOCIATION  
ALEXANDER SCHLEICHER ASK18 (GLIDER, SINGLE-SEATER),  
JA2320  
KIRIGAMINE GLIDING FIELD,  
SUWA CITY, NAGANO PREFECTURE, JAPAN  
AROUND 12:40 JST, NOVEMBER 8, 2014

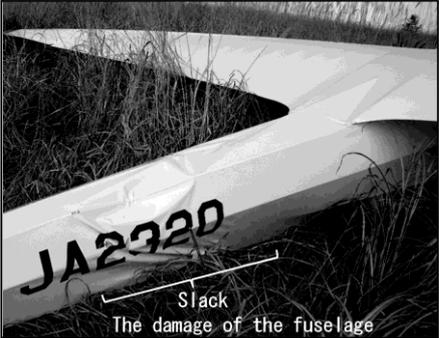
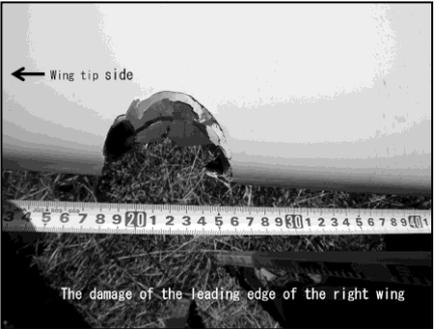
2.7 Other Information	<p>(1) Detailed Information on Damage</p> <p>The fuselage of the Glider was slightly bending just after the main wing with empennage turned right and slack was occurred in the surface. There was a semicircular shaped dent, about eight centimeters wide and about six centimeters depth, at about 146 centimeters from wing tip on leading edge of the right wing. The mounting arm of tail wheel had deformed to the right about 60 degrees from the root. There were no anomalies in the operation of the flight control systems.</p>

3.1 Involvement of Weather	No
3.2 Involvement of Pilot	Yes
3.3 Involvement of Glider	No
3.4 Analysis of Findings	<p>(1) Damages to the Glider</p> <p>According to the conditions of the debris found around the tree, it is highly probable that the semicircular shaped dent on the leading edge of the Glider's right wing was made by collision with the tree. It is highly probable that the right wing collided with the tree; therefore, the nose was shook to right suddenly when the Glider landed on the rough ground. It is highly probable that the bending damage of the fuselage and the tail wheel damage were made by touchdown on the rough ground while turning right about 150 degrees which resulted in acting of the significant force to the fuselage and tail wheel.</p> <p>(2) Involvement of the Pilot</p> <p>It is probable that the captain thought the Glider could fly over the rough ground and tried to fly aiming for flatland, and then it descend as usual possibility by effects of the wind blowing up the slope and the ground effect; therefore, he did not land soon after the release of the towline. Thus, this probably contributed to the captain's decision that he reminded an experience of breaking a tail wheel when he made an immediately landing using dive brakes, and thought such as "I want to fly long time because it is the first flight for me on the Glider."</p> <p>Correspondence when tow speed is low is emergency procedure; therefore, it is highly probable that the captain should land on predetermined area using the dive brakes soon after release of the towline.</p> <p>(3) Falling into the situation to carry out the emergency procedure</p> <p>It is probable that the captain noticed the winch winding speed was low after the nose raised to climb, and then he was unable to release the tow line and instructed "Winch is slow" at once; therefore, the Glider fell</p>

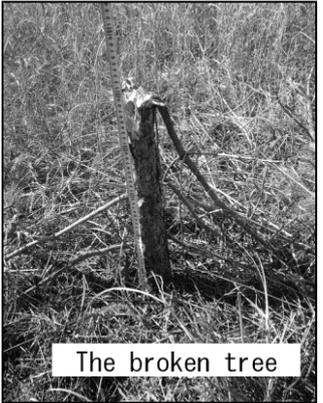
<p>(2) The winch condition</p> <p>There were no anomalies in the operation of the winch.</p> <p>(3) The Accident Site Description</p> <p>Kirigamine gliding field is located on a highland about 1,680 meters height above sea level and have about 1,000 meters length runway. The runway 07/25 are used for landing; the runway 25 is only used for launch. A winch operator cannot see the launch point due to the topographical characteristics that the halfway area is high. The halfway area is grass and woods grown rough ground sloping to left forward; therefore, in the case of a towline cut at a launch, gliders are supposed to land to no grass area short of the rough ground, right hand side or short of the winch and not to land on the rough ground.</p>

<p>The Glider faced about 038 degrees</p>

<p>magnetic bearing on the rough ground. At about 20 meters toward the launch point side from the Glider, there was a tree of six centimeters in diameter broke at about 50 centimeters above ground. A debris found around the tree matched up the shape of damage on the leading edge of the Glider's right wing.</p> <p>(4) Primary performance described in the Flight Manual</p> <p><i>The best glide ratio: 34</i></p> <p><i>Approach speed: about 80 km/h – 90 km/h</i></p>
--	--

- (1) Making a figure clearly indicated the inadequate area to land.
- (2) Making a landing procedure in the case of stop towing (release of towline) at low altitude after launch.
