AA2014-7

**AIRCRAFT ACCIDENT
INVESTIGATION REPORT**

AIRFRAME DAMAGE DURING FORCED LANDING
PRIVATELY OWNED
ROBINSON R22 BETA (ROTORCRAFT), JA23TN
ASANAMIHARA, MATSUYAMA CITY,
EHIME PREFECTURE, JAPAN
AROUND 10:04 JST, MARCH 16, 2013

October 24, 2014

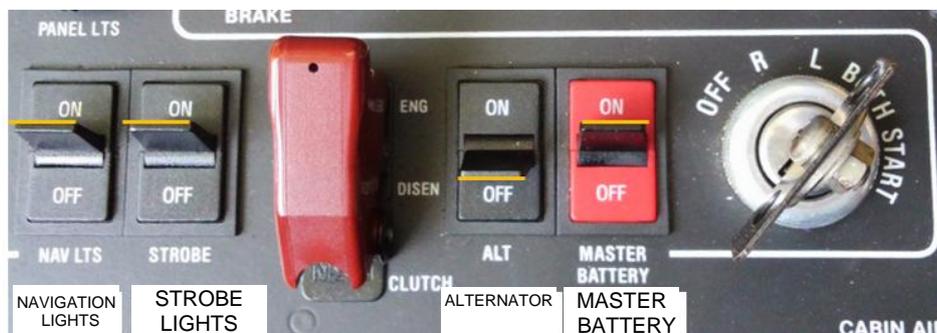
- (1) The operations of the warning and caution lights were examined with an external power source connected, but no abnormalities were found.
- (2) The switches for the navigation lights, strobe lights, and master battery were in the on position, and the switch for the alternator was in the off position.

The switches for the alternator and master battery are of the same construction and arranged right next to each other on the instrument panel.

Portion of the switch panel of the Aircraft (the yellow lines indicate the position of the switches at the time of on-sight investigation)

As described in 2.8.3 (2), the switch for the alternator was in the off position at the time of the on-site investigation. If the alternator power switch was in the off position during the flight, it is somewhat likely that there was no power supply from the alternator, which caused the master battery power to be consumed leading to a lack of the power supply required to operate the governor, which in turn caused the operation of the governor to be suspended.

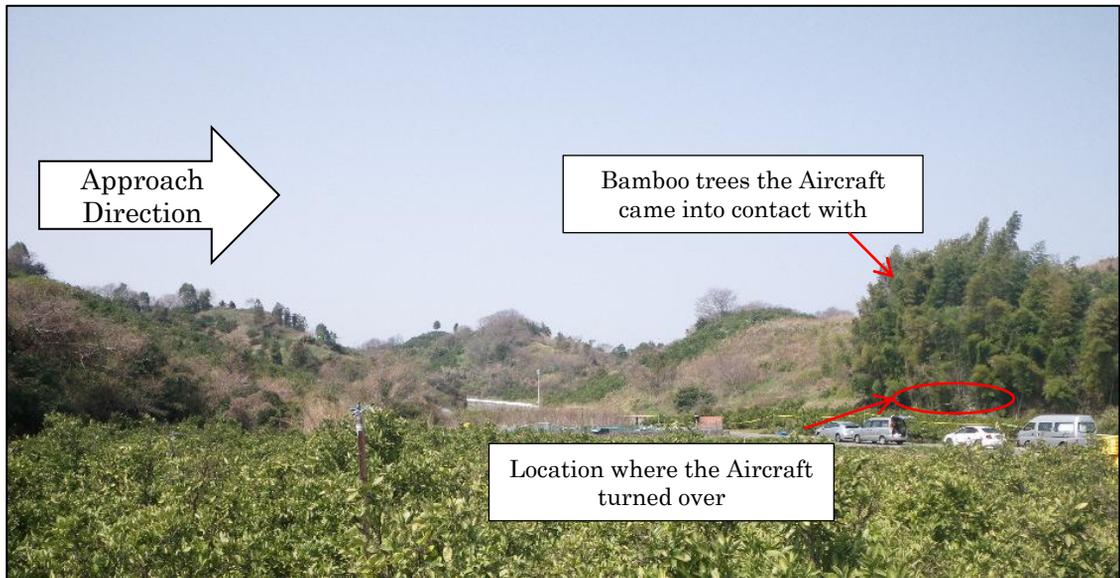
Photo 1 Accident Site

The accident site is a hilly area near the sea located approximately 22 km north-northeast from Matsuyama Airport, and while there is a flat area with rice fields in front of the site, there are mountains with an altitude between 200 to 300 meters above sea level south-southwest from the site in the direction of Matsuyama Airport.

The Aircraft came into contact with bamboo trees with a height of approximately 25 meters and the upper portions of several bamboo trees were cut at an angle. The Aircraft fell to the ground on the tail cone, and the nose fell over to the right facing the northwest with the tail rotor falling off and the tail cone bent significantly.

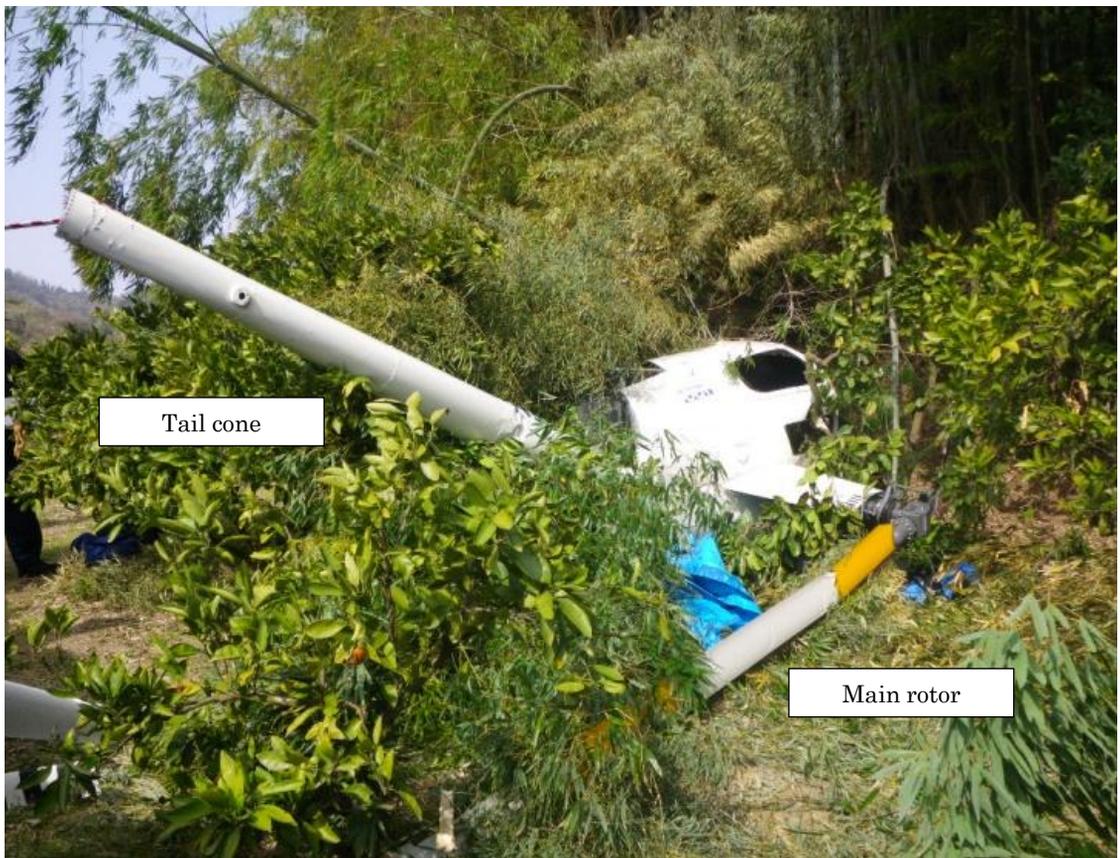
Photo 2 Accident Aircraft

Landing gear and fuselage:	Damaged
Windshield and door:	Damaged
Tail gear box:	Broken
Tail cone:	Bended
Drive system:	Partially broken
Main rotor and tail rotor:	Damaged
