**AIRCRAFT ACCIDENT
INVESTIGATION REPORT**

**FUKUSHIMA MOTOR GLIDER CLUB
JA2406**

CRASH DUE TO STALL

HOFFMANN H-36 DIMONA

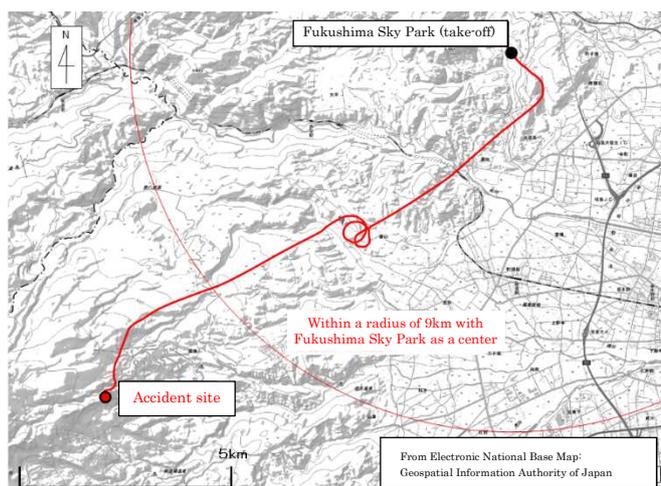
Figure 1: Estimated Flight Route

About 10 minutes after take-off, the aircraft flew near the north ridge of Fudosawa about 12 km southwest of Fukushima Sky Park (See Figure 2). Its altitude above the ground level then was about 30 m.

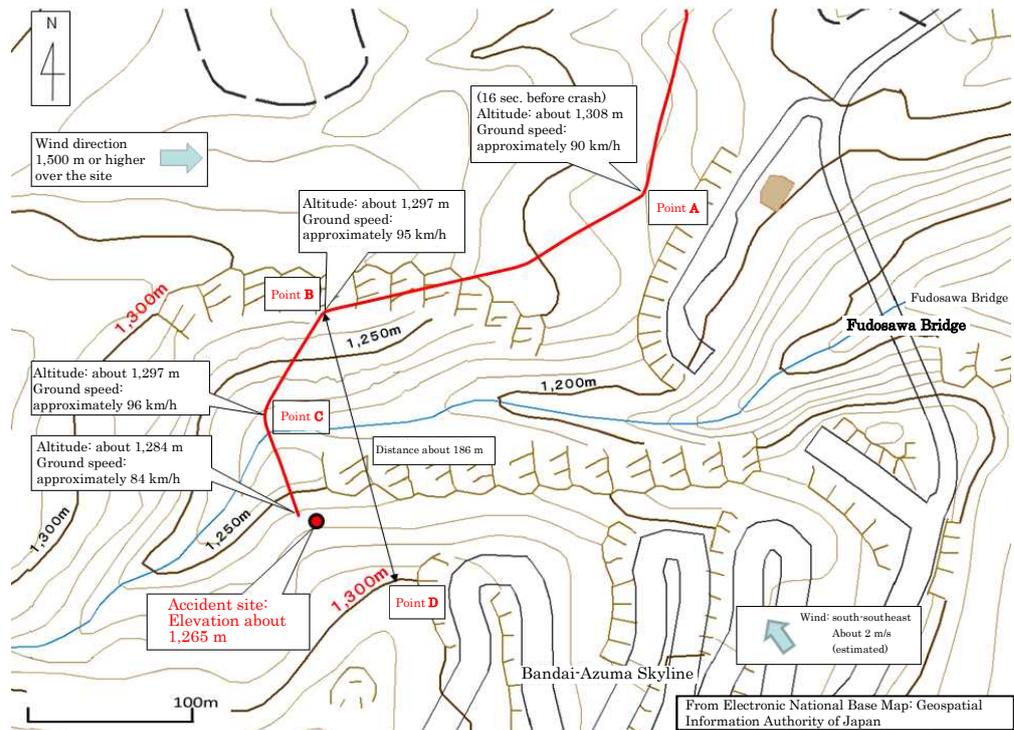
Figure2: Geographic features in the vicinity of the accident site and estimated flight route

Fudosawa in the vicinity of the accident site is a narrow and deep valley that extends from west to east with ridges of about 1,300 m high on the both sides, and that is located about three km east of Issaikyozan mountain (elevation 1,949 m) in the Azuma Mountain Range.

The altitude of the Point B in the Figure 2, where the aircraft commenced to make a left turn from the north side of the valley is about 1,297 m above sea level. Beside, there are mountains higher than 1,300 m high, ranging in the west.

When the captain commenced to make a left turn from Point B to the valley, it is probable that he considered he could turn around short of the south slope, however, in order to make a successful 180° turn between Points B and D (186 m) at a ground speed of 95 km/h at the time of starting to turn, with a calculation under the condition with no wind, it requires a steep turn at a bank angle of about 40° or larger.

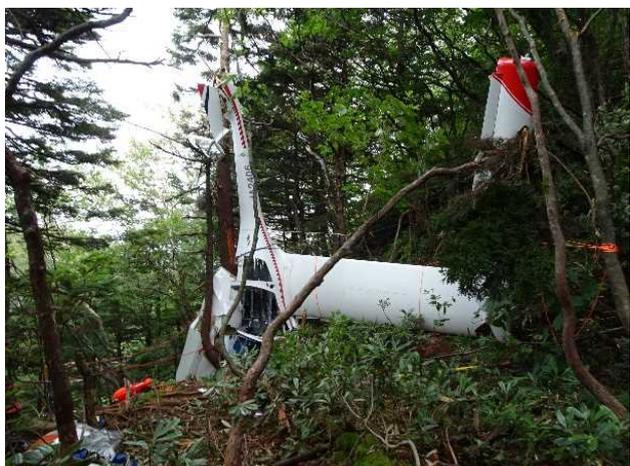
There was the distance of 186 m between the Point B and the Point D which is located on the slope to the opposite side of the Point B. Photo 2: The Accident Site and the Aircraft

The accident site was a slightly flat shelf-like place at elevation about 1,265 m, located along the southern slope of the valley in mountainous regions.

Surrounded by many trees, the crashed aircraft got stuck nearly vertically into the ground with standing upside down and its upper side of the fuselage facing to the northwest; its nose part in which the propeller was severely damaged was buried in the ground; its engine cowl and the cockpit were crushed and damaged.

The left main wing was bent at about 300 cm from the wing tip. The right main wing caught between two trees next to the fuselage had scraped off twigs and barks; it was damaged, torn off at the wing root, and fallen off the cliff.

The rear part of the fuselage was bent toward the nose from the root of the vertical stabilizer in suspending from the fuselage; its rudder and elevator were fractured.
