AA2016-1

**AIRCRAFT ACCIDENT  
INVESTIGATION REPORT**

**PRIVATELY OWNED  
J A 2 4 0 6**

**DAMAGE DURING LANDING  
PRIVATELY OWNED, HOFFMANN H-36 DIMONA  
(MOTOR GLIDER, TWO-SEATER), JA2406  
AT FUKUSHIMA SKY PARK,  
FUKUSHIMA CITY, FUKUSHIMA PREFECTURE,  
AT AROUND 11:54 JST, MAY 17, 2015**

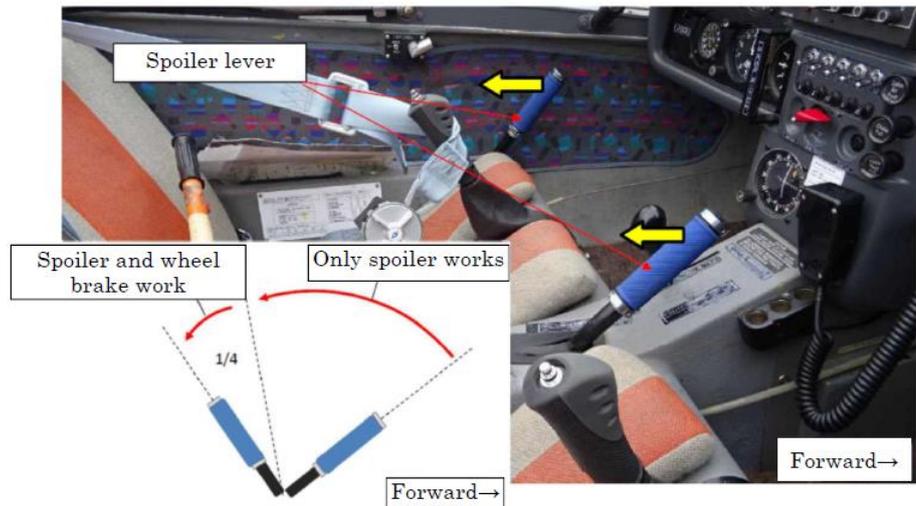
<b>2.7 Additional Information</b>	<p>(1) Wheel brake</p> <p>The wheel brake of the Aircraft is combined with the spoiler lever, the spoiler is extended by pulling the lever toward the pilot, and the wheel brakes of both sides start to be equally applied at the last quarter. If the spoiler lever is fully pulled to the end, the spoiler is fully extended and the wheel brake is fully applied.</p>

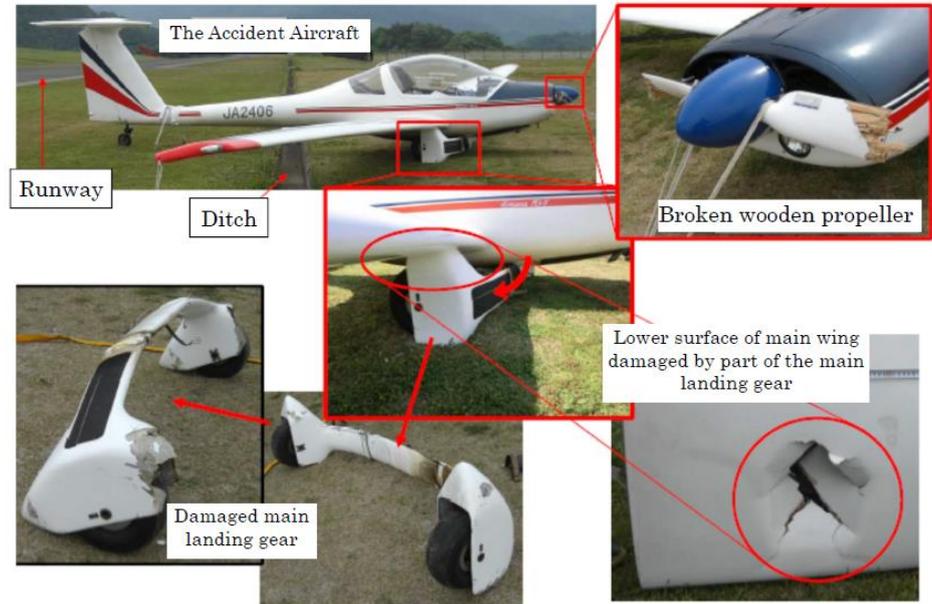
shaped type, and its both ends are equipped main wheels covered with aerodynamical fairing. In the installation of the main landing gear, the part adjacent to the body is held with two short metal belts in the left and right, and the front and back of each belt are fixed on the body with one bolt for each part.

Regarding the Aircraft damage, the bolts of the front of the right and left belts mounting the main landing gear were ruptured and the main landing gear was rotated about 90° to the rearward. When the main landing gear was rotated to the rearward, the rear part of the fairing of the main wheel stuck into the lower surface of the main wing, perforating the lower surface of both main wings about the range of 20 cm in diameter. The mark hit by propeller was left on the ground below the engine of the Aircraft, and two wooden propeller blades were broken. The contact marks of the left and right main wheels of the Aircraft which ran out of the runway while deflecting to the right, went on the runway and grass area, and there were intermittent contact marks of the tail wheel in the left side of the contact mark of the left main wheel.
