**AIRCRAFT ACCIDENT
INVESTIGATION REPORT**

January 25, 2008

**PRIVATELY OPERATED,
ALEXANDER SCHLEICHER
ASK23B (GLIDER, SINGLE-SEAT)
JA2409
NAGANO CITY, NAGANO PREFECTURE
ABOUT 15:24 JST, MAY 12, 2007**

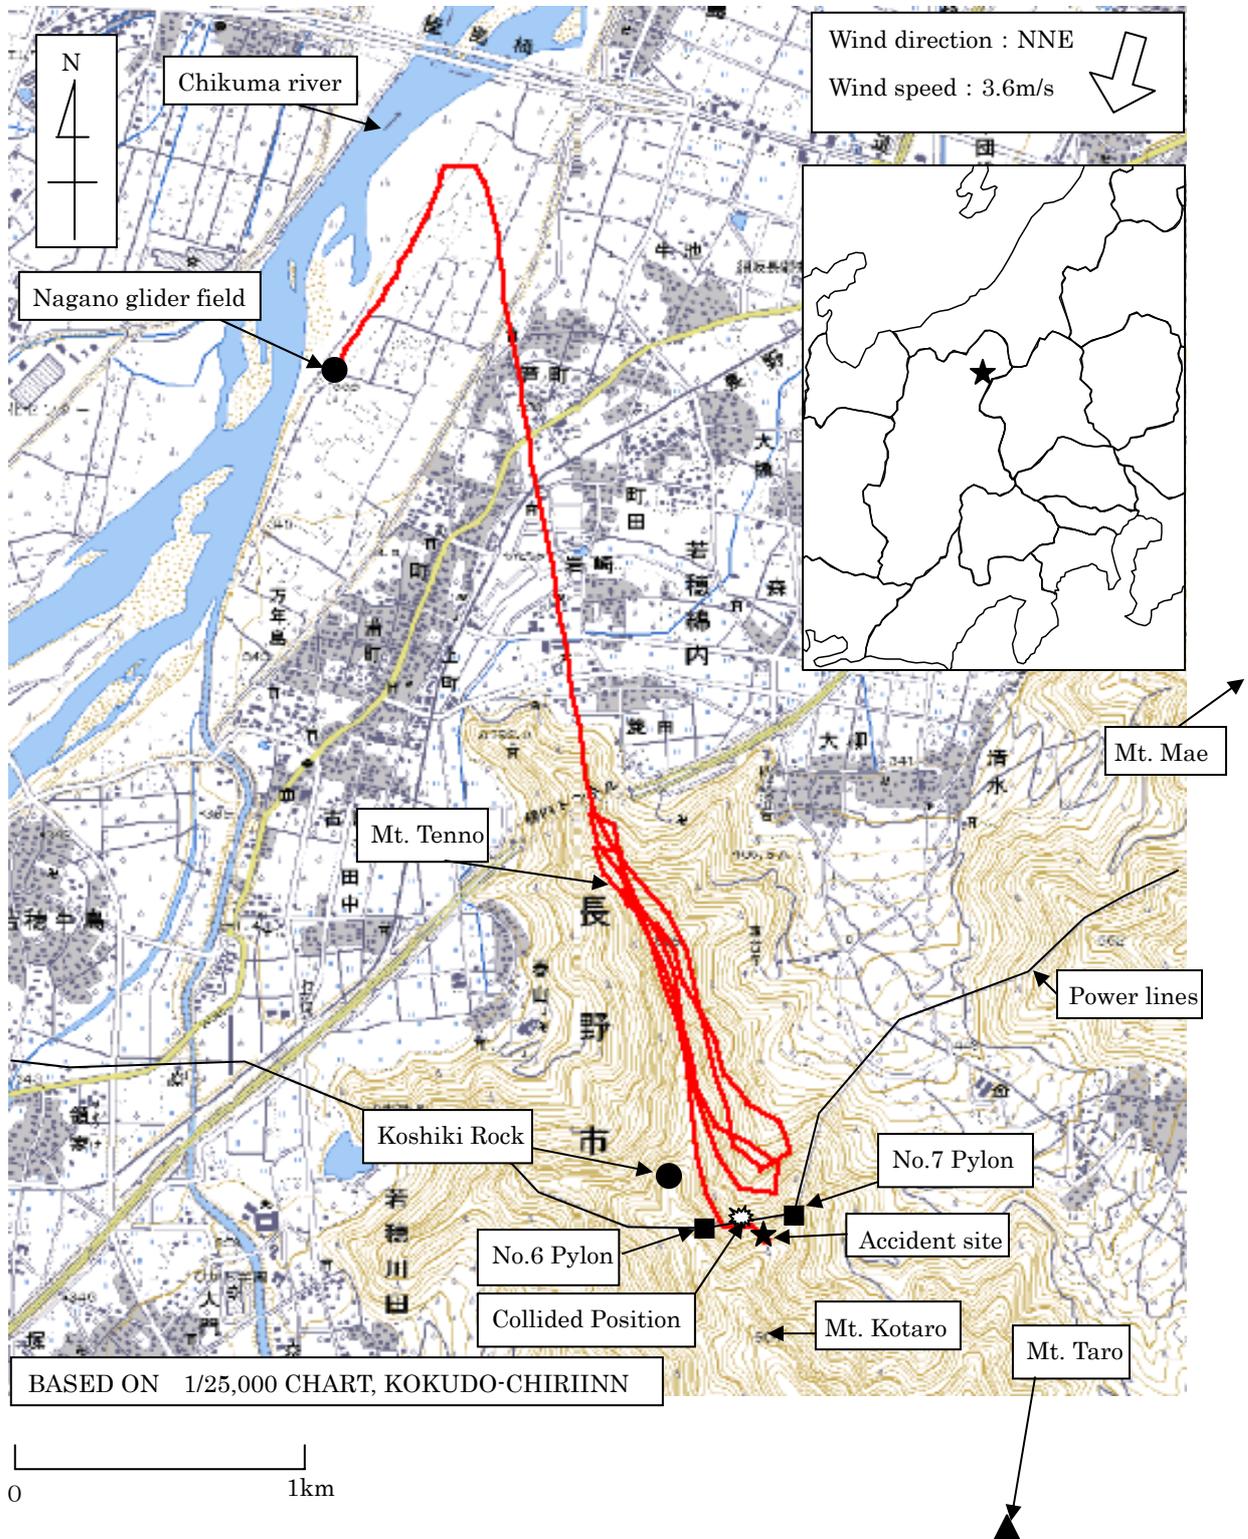
Figure 1 Estimated Flight Route

The glider performed a figure-eight flight twice along the ridge between Mt. Tenno and the power lines before Mt. Taro. On its third from Mt. Tenno toward Mt. Taro, at about 15:24, the altitude of the glider became about 790m at about 100m before the power lines. Immediately after it started turning left, the position information stopped at the crash position, and the altitude lowered to 750m and stopped there.

The accident occurred at about 15:24 in the mountains (N 36° 36’ 22” and E 138° 16’ 09”) near the summit (elevation about 750m) of Mt. Kotaro (elevation 904m) in Nagano City Nagano Prefecture, approximately 3.5km south-southeast of the gliding field.

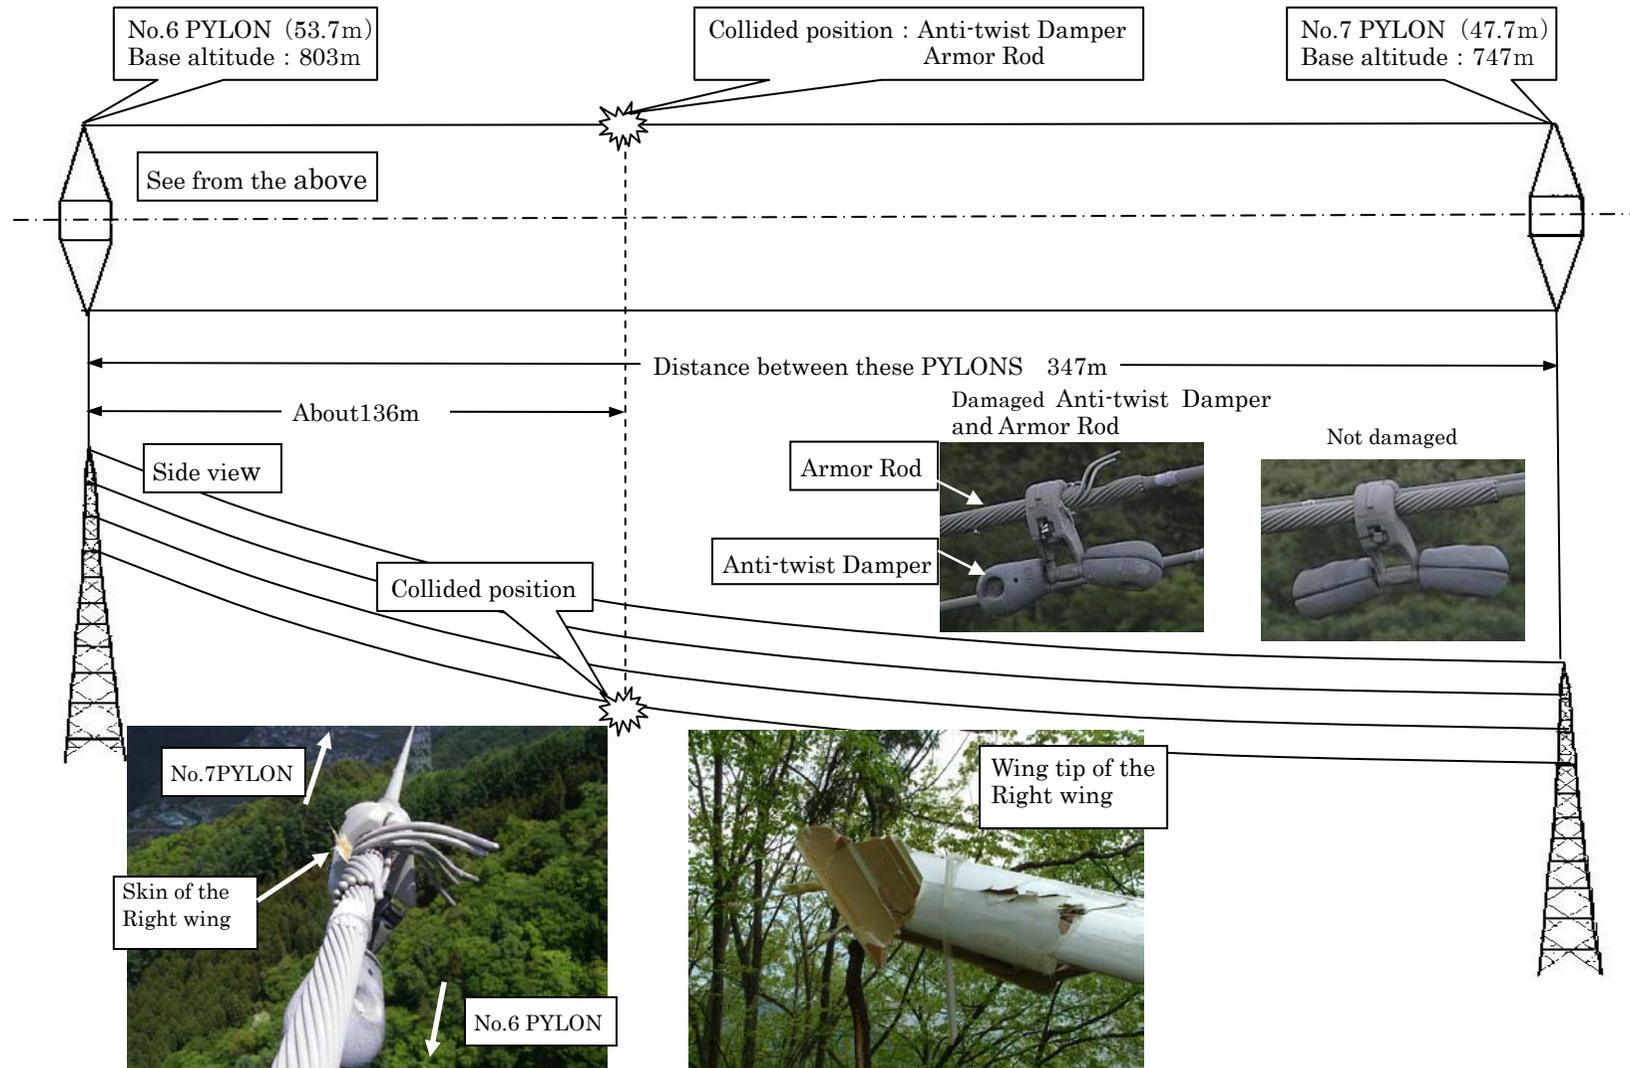
Figure 2 Collided Position of the POWER LINE

To the north of the accident site, there were power lines suspended between No.6 pylon (53.7 m high, base elevation 803m) to the west and No.7 pylon (47.7m high, base elevation 747m) to the east. The distance between the two pylons is 347m. Three power lines were suspended in the valley side (north side), and in the mountain side (southern side), respectively and one overhead ground wire² was suspended over the power lines.

The anti-twist damper³ installed on the lowest (9.7 m downward from the top of the pylon) of the three power lines suspended in the valley side (north side) was partially deformed at about 136 m from No.6 pylon, and the wire of the armor rod⁴ was sprung up. Furthermore, white materials adhered to the power line.

According to Chubu Electric Power Co., that the point of the power line is located about 90 m above the ground and the elevation is 810 m.

It is estimated that the PIC recognized visually the power lines above immediately after he started to turn left, so he made the bank steeper and lowered the nose, but he couldn't make it because the glider was too close to the power lines beyond the limits within which he could avoid them safely and collided with the lowest power line on the side of the valley.

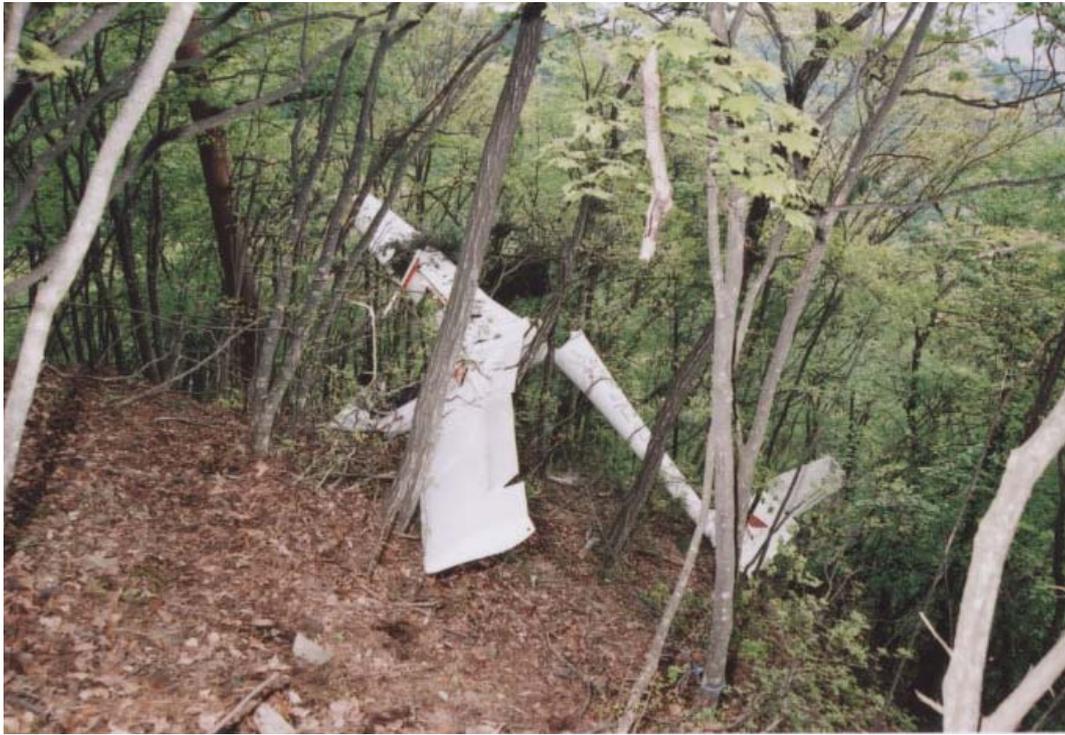
Photograph 1 THE GLIDER

Around the site, there was a natural forest made up of trees as tall as 10 - 20 meters. Just in front of the right wing of the glider, there was a Japanese red pine about 50 cm in diameter. Several boughs of it were broken, and the north-side bark was stripped off at about 2m from the ground. Terrain surface was covered with soft soil made up of leaf mold. The inclination of the slope was about 45° to 60°, and there were rocks here and there which give way easily.

With its nose facing southeast, the glider was broken at about the wing root. Its forward part of the fuselage and the wing barely escaped from slipping down thanks to the surrounding trees.

The broken pieces were scattered on the ground (slope) but a part of the right wing tip could not be found.

High up and to the north of the site, the power lines were suspended in a nearly east-to-west direction.

The nose suffered cracks and dents, of which especially the lower left surface of the forward end was badly damaged.

The fuselage was broken at about the wing root, and the part was hanging on the steep slope.

As to the right wing, the part from the aileron to the tip was broken and the part of about 2m long from the wing root was extensively destroyed due to the collision with the trees.

As to the left wing, a tree had cut into its leading edge at about 1.5 m from its root.
