AA2017-1

**AIRCRAFT ACCIDENT  
INVESTIGATION REPORT**

PRIVATELY OWNED, S.N. CENTRAIR C 101B  
(GLIDER, SINGLE-SEATER), JA2437  
CRASH BY FAILURE OF FORCED LANDING  
AT ASO CITY, KUMAMOTO PREFECTURE, JAPAN,  
AT ABOUT 14:36 JST, APRIL 10, 2016

February 10, 2017

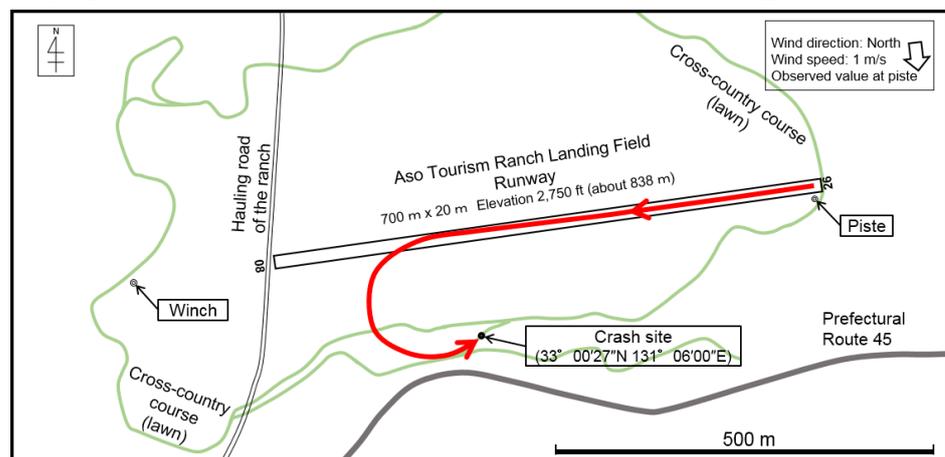
Figure 1 Estimated flight path map

According to the records of the video camera, the AGL was about 49 m and airspeed was from 90 km/h to 100 km/h at the time of retracting the air brakes, and the distance to the winch at that time was about 400 m as shown in Figure 1; accordingly, it is probable that it has been the best option at this point of time to continue the landing straight ahead by the appropriate use of the air brakes.

The Captain, considering that the speed of the aircraft during the turn was slow, kept slightly nose down in order to gain the velocity, as described in Appendix and Figure 1, the aircraft is estimated to have continued the steep turn accompanied by a relatively large descent (a rate of approximately 3.9 m/s).

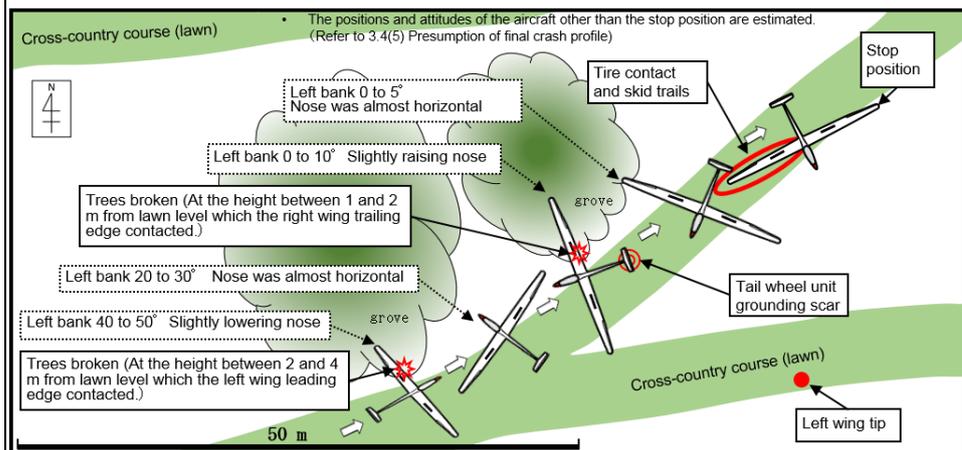
Figure 2 Crash site plan view

Its altitude was actually lower than the visual estimation of the Captain, the Aircraft let the left wing came into contact with the groves, with this it crashed from the tail wheel while rotating counterclockwise. The crash site was a cross country course (lawn) on the south side of the landing field.

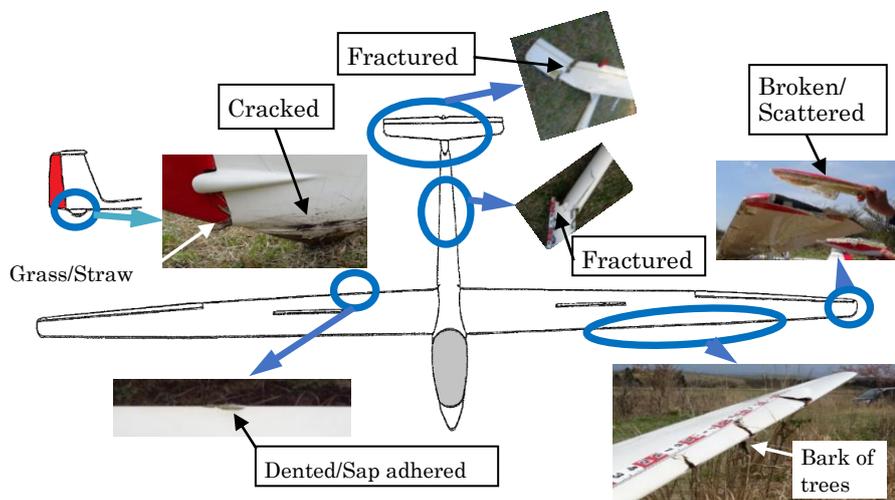
Figure 3 Airframe damage

<p>The Aircraft had been destroyed by the crash, the details are as follows.</p> <p>There were damage considered to have contacted with the groves in the left wing leading edge, and some had been caught bark. In addition, left wing tip was broken. There were dents considered to have been caused by contact with the trees and sap adhered to the trailing edge of the right wing. There was a cracking on the right side of the tail wheel, and grass and straw had gotten stuck between the rudder and vertical stabilizer. The fuselage had fractured at the intermediate portion of the rear part. The right side of the horizontal stabilizer had been fractured in the middle part.</p>
<p>2.4 Personnel Information</p>	<p>Captain: Male, Age 68</p> <p>Private pilot certificate (High-class glider): February 12, 2010</p> <p>Class 2 aviation medical certificate Validity: April 8, 2017</p> <p>Pilot competence assessment /Confirmation –</p> <p>Expiration date of piloting capable period: August 11, 2017</p> <p>Total flight time: 173 hr. 53 min. (310 launches)</p> <p>Flight time in the last 30 days: 0 hr. 20 min. (1 launch)</p> <p>Total flight time on the type of the Aircraft:</p> <p>18 hr. 56 min.(43 launches)</p> <p>Flight time in the last 30 days: 0 hr. 20 min. (1 launch)</p>

It is probable that when the Aircraft came into in a state of nose down by about 45 ° bank to the left then started to rotate counterclockwise by contacting with the groves at the left wing.

It is probable that the Aircraft was further rotating at an angle of about 180 ° while proceeding for about 20 m from there, and the trailing edge of the right wing were in contact with the groves, almost at the same time tail wheel portion grounded in such a way as to stick into the lawn, at this moment the fuselage have significantly damaged and have fractured the intermediate portion of the rear part. At this time the left wing chip was broken by the first contact with the trees, which was then

believed to have scattered by centrifugal force to the discovery point.

It is probable that the Aircraft was further turned by about 90° and was once settled in the lawn from the main wheel and stopped finally after side skidding. It is probable that the right side of the horizontal stabilizer was considered to have broken by contact with the lawn after the fuselage had fractured.

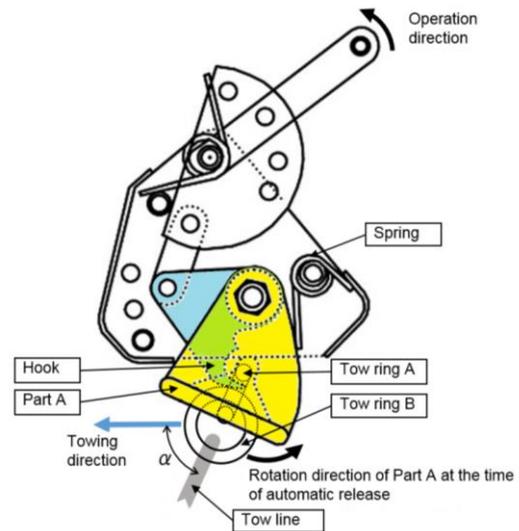
Figure 4 Mechanism of the Tow hook

"Part A" in Figure 4 is set not to be loosed from the "Hook" by clamping the "Tow ring A" to the towing direction by the force of the spring. From this position, when the angle " $\alpha$ " between the towing direction and the tow line direction becomes at  $83^{\circ} \pm 7^{\circ}$  or more if the tow line direction deviates downward, the "Tow ring B" will rotate the "Part A" backward against the force of the spring, the "Tow ring A" will be released from the "Hook" due to the own weight of tow line and others, and this is called an automatic release. When automatic release is done, "Part A" will be returned to the initial position by the force of the spring.

From these matters, after the winch failure which was described in the preceding paragraph, although the tow line hoisting drum did not immediately stop due to inertia, it is probable that its own weight and the drug had been acting the tow line (steel twisted wire) as the traction was weakened. Accordingly, since the angle between the longitudinal axis of the aircraft (towing direction) continued gliding by the inertia though the airspeed decreased and the direction of the tow line reached the angle set in the Tow hook, it is possible that the tow line made an automatic release during the time after the winch failure and before the Captain manipulated releasing operation of the tow line.
