**AIRCRAFT SERIOUS INCIDENT  
INVESTIGATION REPORT**

**ACADEMIC CORPORATE BODY JAPAN AVIATION ACADEMY  
JA 2 4 5 1**

## INABILITY TO OPERATE DUE TO DAMAGE TO LANDING GEAR DURING FORCED LANDING ON A GRASSY FIELD ABOUT 3 KM SOUTHWEST OF NOTO AIRPORT, JAPAN AT ABOUT 15:00 JST, SEPTEMBER 26, 2018

ACADEMIC CORPORATE BODY JAPAN AVIATION ACADEMY  
VALENTIN TAIFUN 17EII (MOTOR GLIDER: TWO SEATER), JA2451

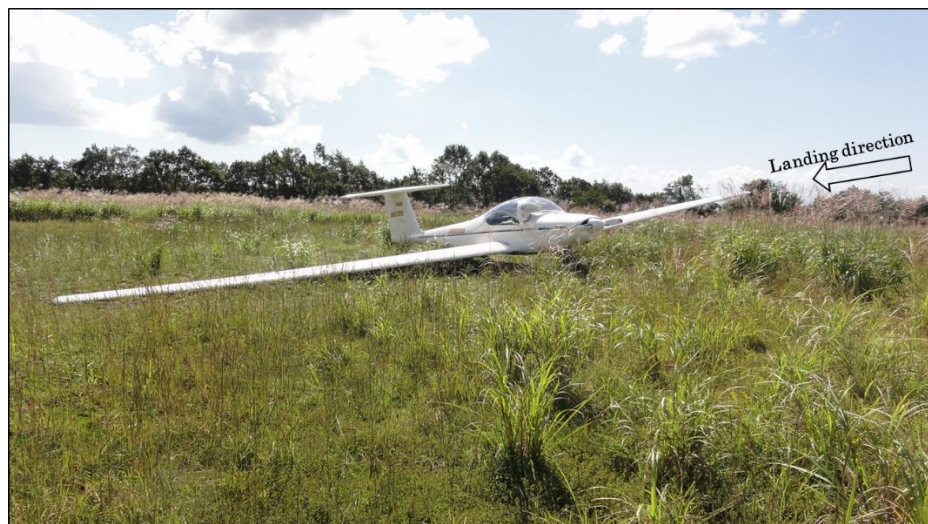
Figure 2: The Condition of the Aircraft after Forced Landing

It was probable that the nose veered to the left after touchdown, and when the Aircraft slowed down rapidly while turning to the left and stopped with its nose facing to the left abeam relative to the approach direction, its right main wheel and the nose wheel received the leftwards force from the ground; and thus, its right main landing gear was damaged to be partially retracted, and the nose landing gear was detached because of the damage to the right hand nose landing gear attaching part, therefore, the operation of the Aircraft could not be continued.

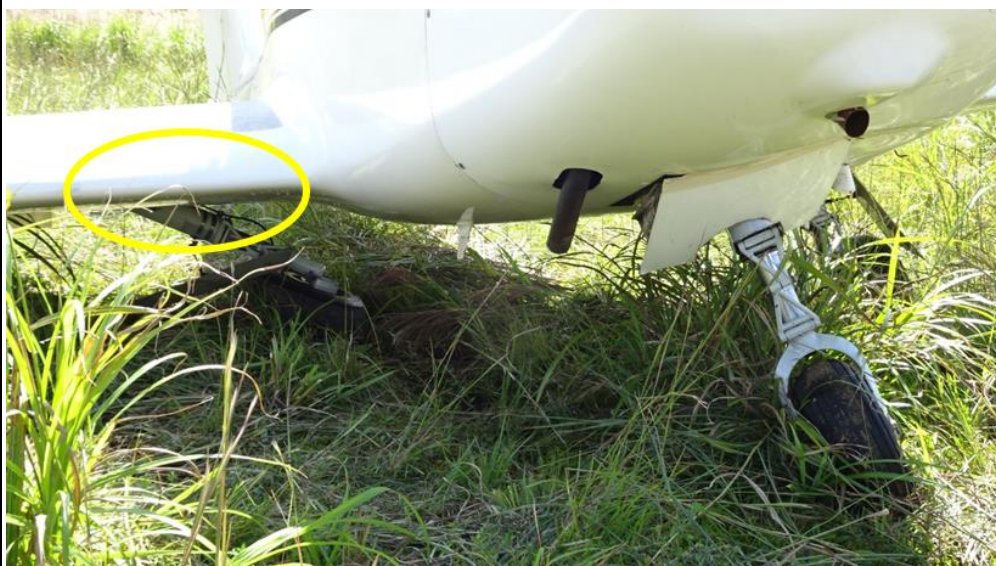
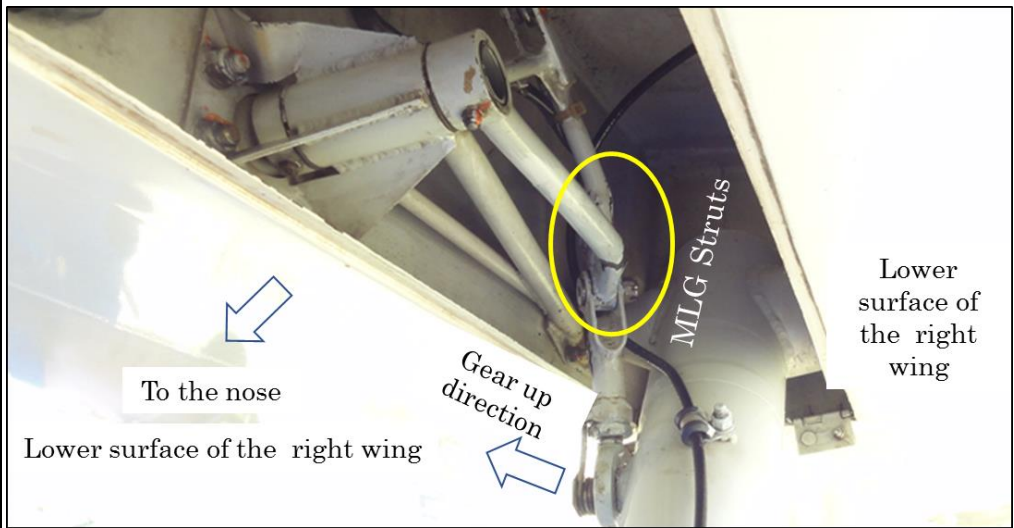
Figure 3: Damaged and deformed gear down lock mechanism of the right main landing gear

(1) Gear down lock mechanism of the right main landing gear: Deformed, damaged

In this serious incident, it is somewhat likely that because at the time of the forced landing on a grassy field, the Aircraft slowed down rapidly while its nose veered to the left due to single-sided braking of left side and stopped with its nose facing to the left abeam relative to the approach direction, its right main landing gear and the nose landing gear were damaged, therefore, the operation of the Aircraft could not be continued.

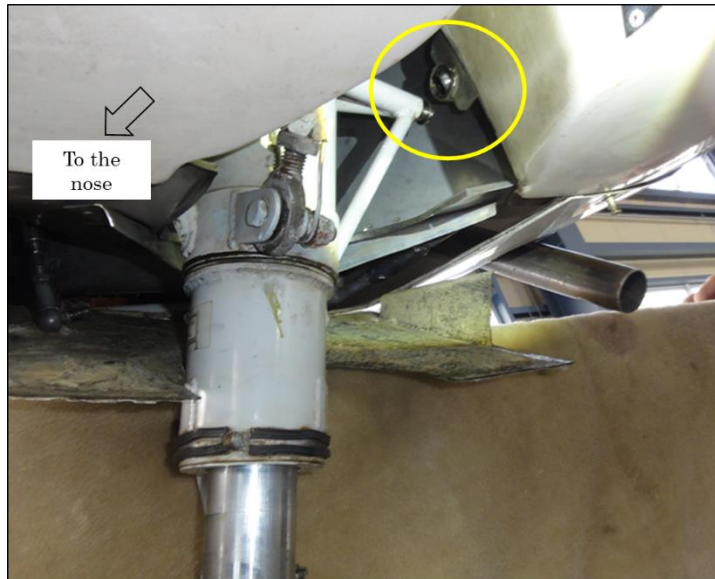
Figure 4: Detached right hand nose landing gear attaching part

(2) Right hand nose landing gear attaching part: Damaged, detached

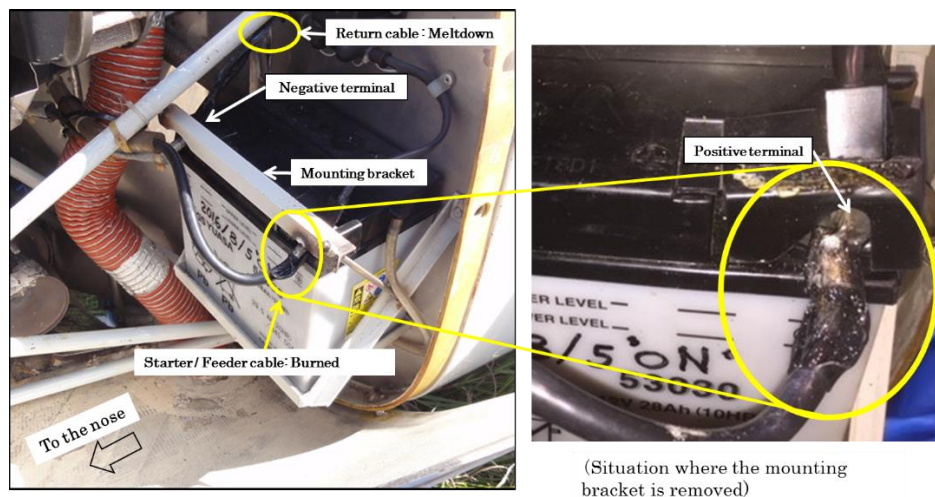
(3) Starter / Feeder cable (part in proximity to the mounting bracket): Burned

(4) Return cable connected to the negative terminal: Meltdown

the mounting bracket in order to protect feeder cables from an electrical short circuit. In contrast to this, the mounting bracket of the Aircraft was installed in such a manner as shown in Figure 5 and by the blue arrow in Figure 7, and the starter/feeder cable without protective covering was installed below the mounting bracket.

It is somewhat likely that because the battery was not properly installed in the Aircraft and the starter/feeder cable was wired without any protective covering, it might be in contact with the mounting bracket.

In addition, at the 100-hour inspection, there was no obvious defect found in the feeder cable, but it is somewhat likely that during the engine ground run after the inspection and the subsequent test flight, the coating of the starter/feeder cable in contact with the mounting bracket sustained damage. However, during the preflight inspection, this defect was not detected,

therefore, it is probable that while the Aircraft climbed through a light turbulence area after take-off, the core wire of the feeder cable contacted with the mounting bracket, which caused an electrical short circuit.

Regarding fumes and a white smoke recognized by the Pilot, it is probable that because the battery was not properly installed in the Aircraft and the defect in the coating of the battery wiring was not detected during the preflight inspection, the core wire of the feeder cable contacted with the mounting bracket of the battery, which caused an electrical short circuit, generating fumes and a white smoke.

In view of these facts that the way of installing the battery in the Aircraft was improper and different from that in the same type of aircraft owned by the School, and an electrical short circuit was caused, it is necessary for the School to establish appropriate battery installation procedures and review the current inspection procedures.

1. The battery shall be installed not to interfere with electrical wiring.
2. At the inspection, it shall be confirmed in detail that the battery and electrical wiring are properly installed, and that there would be no defects in electrical wire.

Battery installation procedures shall be established in consideration of protective covering for feeder cables.

The procedures shall be changed to describe that the engine cover (upper part) shall be opened every time to confirm the battery and wiring installation in the engine room.

The procedures shall be changed to add the confirmation on the position of battery mounting bracket and the connecting condition of electrical wiring and battery terminals

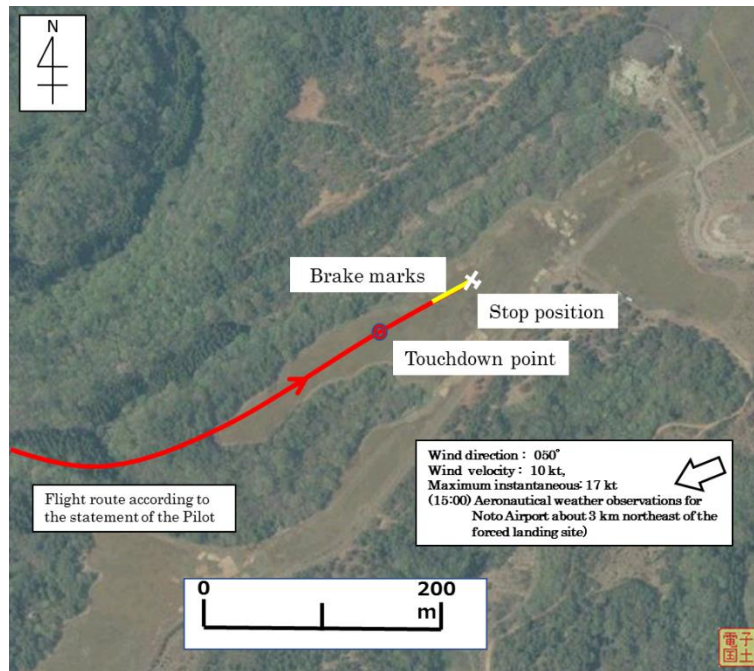
Figure 6: Forced Landing Site Layout

2.7 Forced Landing Site	<p>The forced landing site located about 3 km southwest of Noto Airport was a hard ground grassy field about 30 m wide and 400 m long, which was dotted with silver grass.</p> <p>The brake marks of the left main wheel and then the right main wheel continued intermittently from about 40 m short of the position where the Aircraft stopped to the stop position. The Aircraft stopped with its nose facing to the left abeam relative to the approach direction (070°), its right main landing gear partially retracted and its right wing tip in contact with the ground.</p>

The Pilot stated that he did not apply the main brakes intentionally after touchdown, but it is somewhat likely that judging from the brake marks, the Pilot's hand holding the lever of airbrakes might temporarily move to the full open because of vibrations and others during landing and rolling on the grassy field, and furthermore, the nose veered to the left due to single-sided braking of left side affected by the grassy field condition where slippery places scattered due to the rain on the previous day.

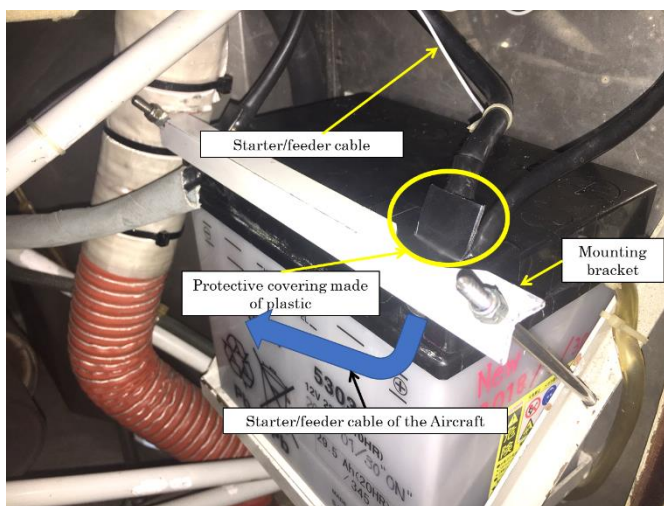
Figure 7: Battery installation for the same type of the aircraft other than the Aircraft in the School

Although there was no rules of the School for battery installation procedures, as shown in Figure 7, when installing the battery for the same type of the aircraft other than the Aircraft in the School, the mounting bracket is installed on the upper part of the battery, all the feeder cables from the positive terminal were wired rearward from under the protective covering made of plastic located below
