**AIRCRAFT SERIOUS INCIDENT
INVESTIGATION REPORT**

**ACADEMIC CORPORATE BODY JAPAN AVIATION ACADEMY
JA 2451**

INABILITY TO OPERATE DUE TO DAMAGE TO LANDING GEAR DURING FORCED LANDING ON A GRASSY FIELD ABOUT 3 KM SOUTHWEST OF NOTO AIRPORT, JAPAN AT ABOUT 15:00 JST, SEPTEMBER 26, 2018

ACADEMIC CORPORATE BODY JAPAN AVIATION ACADEMY
VALENTIN TAIFUN 17EII (MOTOR GLIDER: TWO SEATER), JA2451

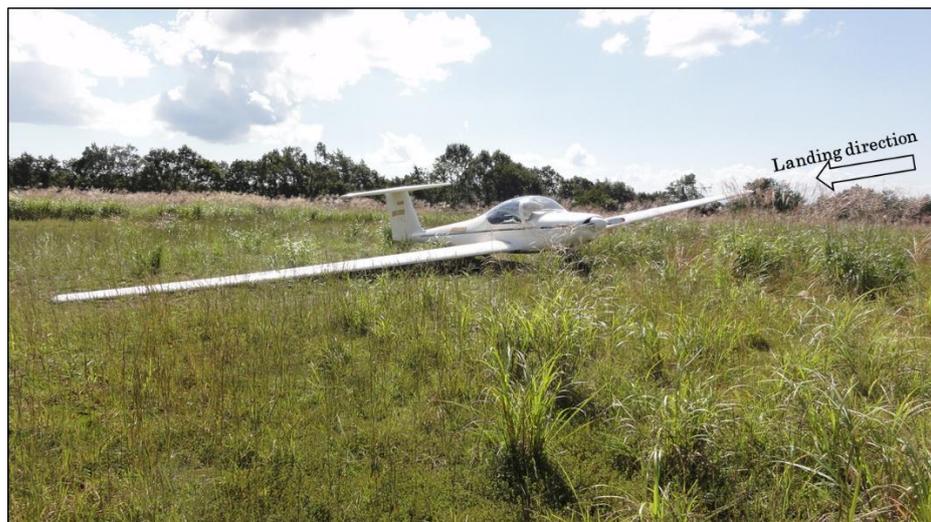
Figure 2: The Condition of the Aircraft after Forced Landing

After confirming that it was at about 15:00 when the Aircraft stopped, the Mechanic got out of the Aircraft and made sure that its landing gear

sustained damage.

It was probable that the nose veered to the left after touchdown, and when the Aircraft slowed down rapidly while turning to the left and stopped with its nose facing to the left abeam relative to the approach direction, its right main wheel and the nose wheel received the leftwards force from the ground; and thus, its right main landing gear was damaged to be partially retracted, and the nose landing gear was detached because of the damage to the right hand nose landing gear attaching part, therefore, the operation of the Aircraft could not be continued.

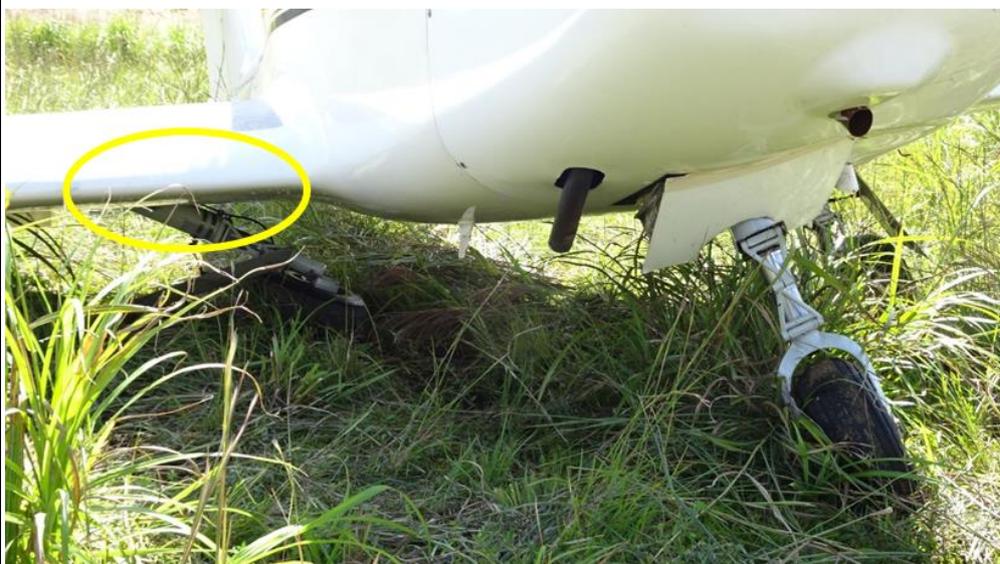
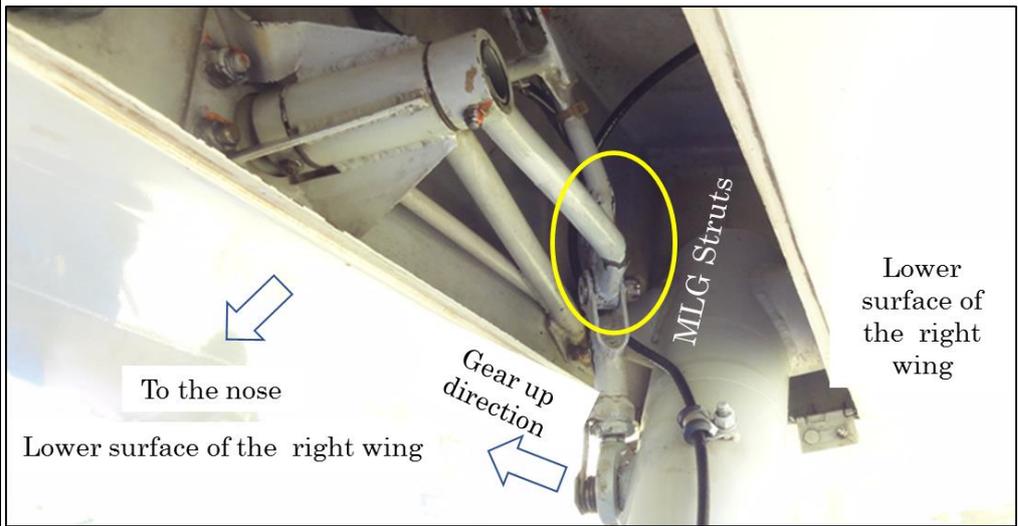
(1) Gear down lock mechanism of the right main landing gear: Deformed, damaged

Figure 3: Damaged and deformed gear down lock mechanism of the right main landing gear

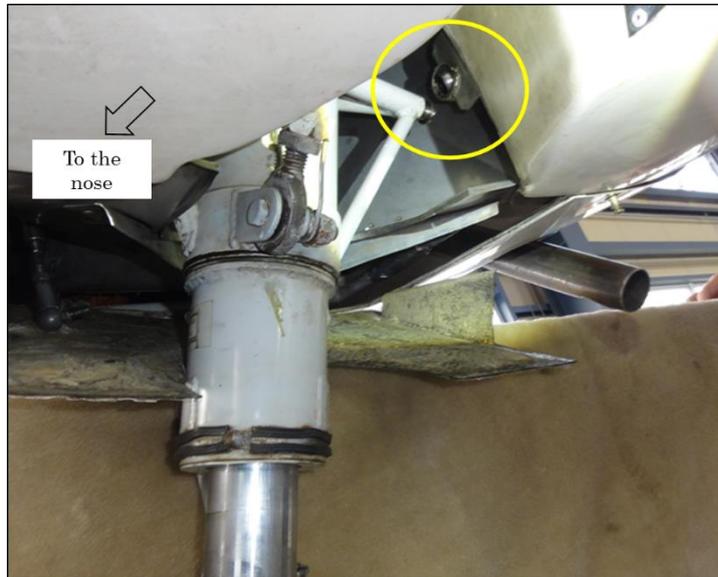
(2) Right hand nose landing gear attaching part: Damaged, detached

Figure 4: Detached right hand nose landing gear attaching part

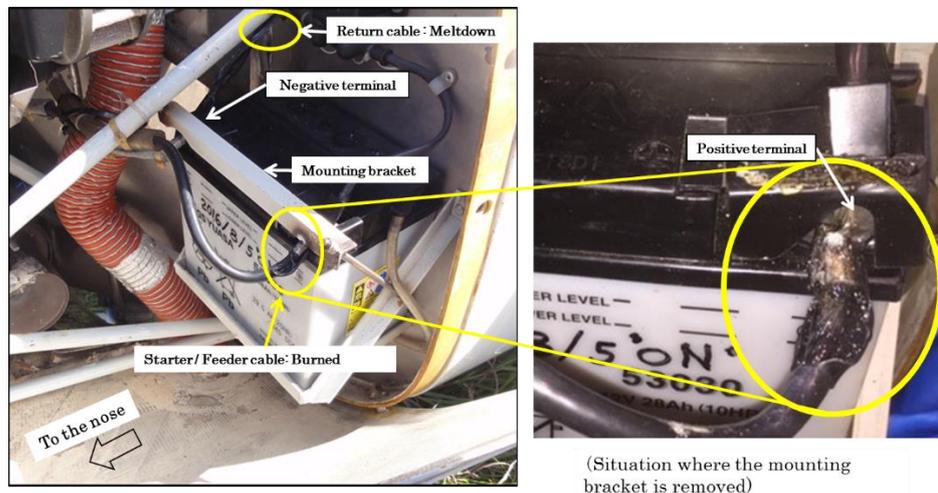
(3) Starter / Feeder cable (part in proximity to the mounting bracket): Burned

(4) Return cable connected to the negative terminal: Meltdown

Figure 5: Damage around the Battery	
2.4 Personnel Information	<p>(1) Pilot Male, Age 58</p> <p>Commercial pilot certificate (Glider) July 2, 1982</p> <p>Type rating for motor glider</p> <p>Pilot competence assessment Expiry of practicable period for flight</p> <p style="text-align: right;">March 19, 2020</p> <p>Class 1 aviation medical certificate Validity date: June 18, 2019</p> <p>Total flight time 16,319 hours 10 minutes</p> <p>Flight time in the last 30 days 21 hours 05 minutes</p> <p>Flight time on the same type of aircraft</p> <p style="text-align: right;">336 hours 45 minutes</p> <p>Flight time in the last 30 days 21 hours 05 minutes</p>

It is somewhat likely that because the battery was not properly installed in the Aircraft and the starter/feeder cable was wired without any protective covering, it might be in contact with the mounting bracket.

In addition, at the 100-hour inspection, there was no obvious defect found in the feeder cable, but it is somewhat likely that during the engine ground run after the inspection and the subsequent test flight, the coating of the starter/feeder cable in contact with the mounting bracket sustained damage. However, during the preflight inspection, this defect was not detected,

therefore, it is probable that while the Aircraft climbed through a light turbulence area after take-off, the core wire of the feeder cable contacted with the mounting bracket, which caused an electrical short circuit.

Regarding fumes and a white smoke recognized by the Pilot, it is probable that because the battery was not properly installed in the Aircraft and the defect in the coating of the battery wiring was not detected during the preflight inspection, the core wire of the feeder cable contacted with the mounting bracket of the battery, which caused an electrical short circuit, generating fumes and a white smoke.

In view of these facts that the way of installing the battery in the Aircraft was improper and different from that in the same type of aircraft owned by the School, and an electrical short circuit was caused, it is necessary for the School to establish appropriate battery installation procedures and review the current inspection procedures.

1. The battery shall be installed not to interfere with electrical wiring.
2. At the inspection, it shall be confirmed in detail that the battery and electrical wiring are properly installed, and that there would be no defects in electrical wire.

Battery installation procedures shall be established in consideration of protective covering for feeder cables.

The procedures shall be changed to add the confirmation on the position of battery mounting bracket and the connecting condition of electrical wiring and battery terminals

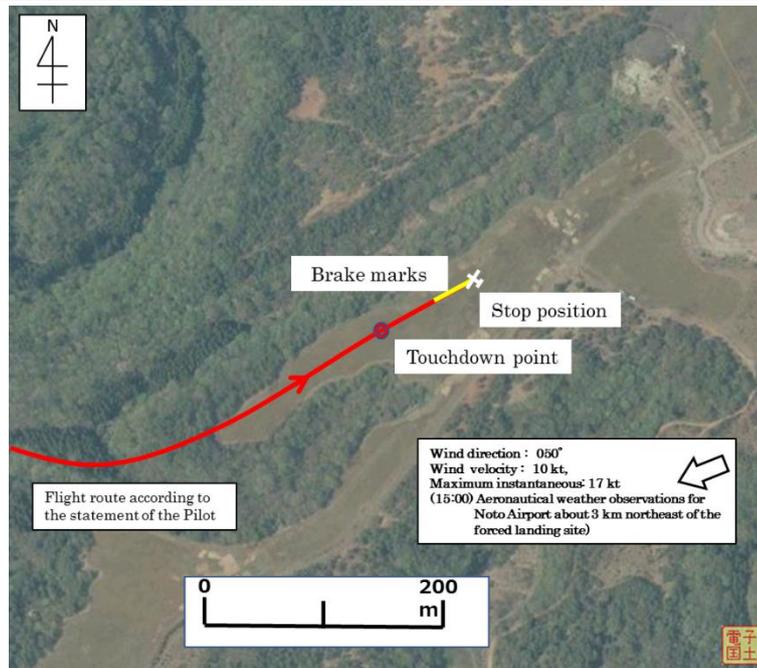
Figure 6: Forced Landing Site Layout

2.7 Forced Landing Site	<p>The forced landing site located about 3 km southwest of Noto Airport was a hard ground grassy field about 30 m wide and 400 m long, which was dotted with silver grass.</p> <p>The brake marks of the left main wheel and then the right main wheel continued intermittently from about 40 m short of the position where the Aircraft stopped to the stop position. The Aircraft stopped with its nose facing to the left abeam relative to the approach direction (070°), its right main landing gear partially retracted and its right wing tip in contact with the ground.</p>

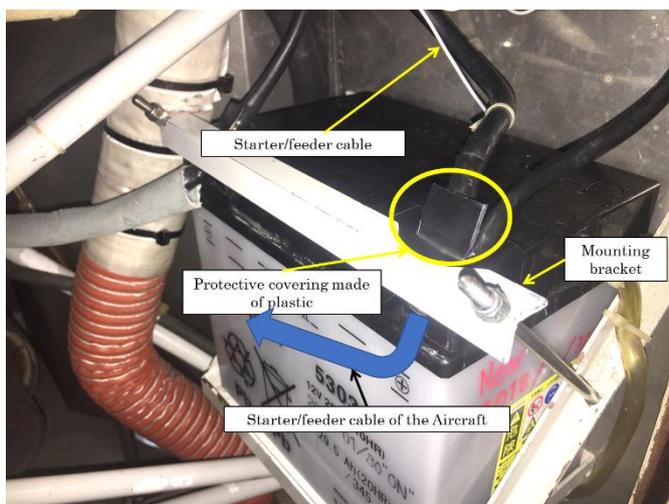
Figure 7: Battery installation for the same type of the aircraft other than the Aircraft in the School

Although there was no rules of the School for battery installation procedures, as shown in Figure 7, when installing the battery for the same type of the aircraft other than the Aircraft in the School, the mounting bracket is installed on the upper part of the battery, all the feeder cables from the positive terminal were wired rearward from under the protective covering made of plastic located below

the mounting bracket in order to protect feeder cables from an electrical short circuit. In contrast to this, the mounting bracket of the Aircraft was installed in such a manner as shown in Figure 5 and by the blue arrow in Figure 7, and the starter/feeder cable without protective covering was installed below the mounting bracket.
