**AIRCRAFT ACCIDENT  
INVESTIGATION REPORT**

**PRIVATELY OWNED  
J A 2 5 0 0**

## AIRCRAFT DAMAGE WHEN LANDING PRIVATELY OWNED GLASER-DIRKS DG-500M (MOTOR GLIDER, TWO-SEATER), JA2500 IWAMI AIRPORT AT AROUND 14:46 JST, APRIL 29, 2019

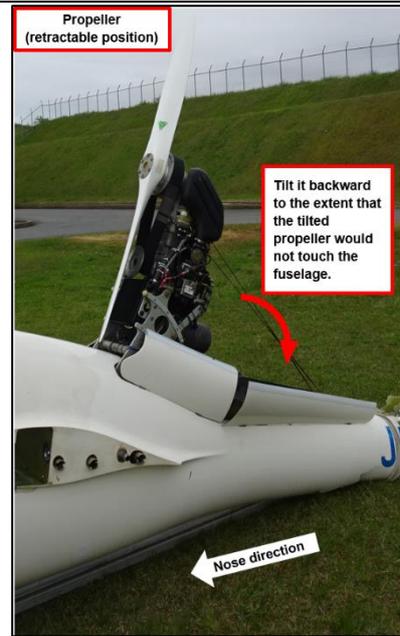
Figure 2: Appearance of the extended engine

When the pilot tried to retract the engine and the propeller, he could not retract them into the fuselage because the propeller did not move to the retractable position. In order to reduce drag, the pilot tilted the engine backward by using the manual extension/retraction switch to the extent that the propeller would not touch the fuselage and retracted the main landing gear located in the lower fuselage by using the main landing gear handle.

The propeller of the Aircraft was locked at the position after rotating about 45° when the engine was restarted for the first time, and it did not rotate even in the following two times of attempt to restart. Even if the fuel is not supplied, the propeller can rotate when the starter system normally works. From this, it is highly probable that because the starter system was inoperative, the engine did not start and the engine and propeller were not

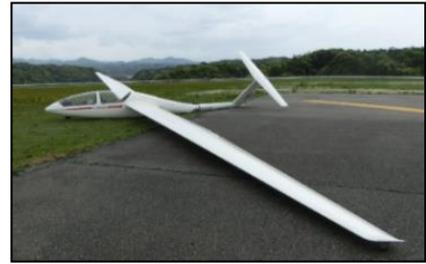
Figure 4: Accident site

On the grass area, a contact mark of about 5.4 m length was left in a 240° direction. The Aircraft stopped with its left main wing and tail onto the overrun area short of Runway 29 threshold.

The pilot tried to avoid a landing on the runway and land on the grass area on the south side of the runway, but as he was afraid that the Aircraft would go straight and land outside of the Airport site, he tried to land on the grass area next to the runway while giving the Aircraft a right turn. However, it is probable that because the altitude loss was large, then the Aircraft's flight altitude was low when entering the Airport, the right wing tip contact the ground surface at the time of making a right turn. After that, it is probable that the Aircraft lost its balance, and fell on the grass area near the end of Runway 29 while spinning 180° clockwise, the aft fuselage was fractured.

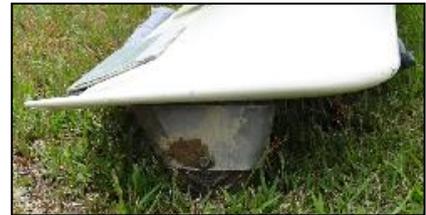
Figure 5: Auxiliary wheel at the right wing tip

The fuselage was broken behind the engine compartment door, however, the flight control system in the empennage remained connected. There was no damage in the wings, but the soil was stuck to the auxiliary wheel at the right wing tip.
