**AIRCRAFT ACCIDENT
INVESTIGATION REPORT**

J A 2 5 2 3

FUSELAGE DAMAGE CAUSED BY UNDERSHOOT
NON-PROFIT ORGANIZATION AERO SPORTS KITAMI
SZD-50-3 PUCHACZ (GLIDER, TWO-SEATER),
JA2523
NEAR THE KITAMI DISTRICT TEMPORARY OPERATION SITE
(FOR AGRICULTURAL USE),
KITAMI CITY, HOKKAIDO, JAPAN
AROUND 14:30 JST, JUNE 15, 2014

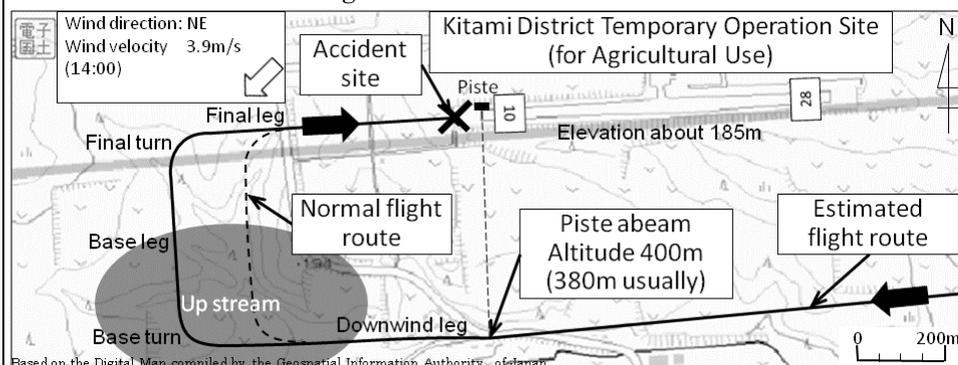
The glider passed an altitude of 400 m, 20 m higher than usual (380 m), abeam a piste¹. Though it maintained the airspeed of 100km/h, it hardly descended due to upstream from around before base turn. Therefore, the captain delayed entering the base turn and extended downwind leg. Even it completed final turn, the approach path was higher than usual. Thus, the captain used dive brakes² to correct the touch-down point. The captain adjusted dive brakes, which led the approach-pass to become and the glider was approaching a grass overrun area. During approach, the glider kept a speed of 100 km/h. The captain performed a flare just before touch-down and closed dive brakes. The captain thought it would be able to touch-down in grass area. But the glider undershot and collided with a metallic fence which was on a boundary of the west side of the Site and a bank which was in front of the grass overrun area. The glider stopped after sliding about 30 m on grass overrun area.

The glider undershot and damaged the fuselage at around 14:30. No anomalies of the glider were found until then.

2.3 Damage	<p>Extent of damage: Substantially damaged</p> <ul style="list-style-type: none"> - Fuselage Breakage - Landing gear Breakage - Empennage Partially Damaged

2.7 Additional Information	<p>(1) Detailed Information on Damage</p> <p>The fuselage of the glider was broken just after the main wing. The cover of the main wheel was broken and scattering around the fence and the bank with which the glider collided. With regard to the flight control systems, elevators and rudder were restricted because of the broken fuselage, but there were no anomalies in the operation of the ailerons and the dive brakes.</p> <p>(2) The Accident Site Description</p> <p>The Site was constructed on the landfill a plateau with gentry rolling, 920 m length and 60 m width (800 m × 25 m paved runway), about 185 m elevation and 10/28 runway direction. There are 60 m length overrun areas with grass in both side of the paved runway.</p> <div data-bbox="1018 1270 1439 1594" data-label="Image"> </div> <div data-bbox="1018 1720 1439 2051" data-label="Image"> </div>
