**AIRCRAFT ACCIDENT  
INVESTIGATION REPORT**

## FUSELAGE DAMAGE FOLLOWING THE RUNWAY EXCURSION

PRIVATELY OWNED, HOFFMANN H-36 DIMONA

(MOTOR GLIDER, TWO-SEATER), JA2528

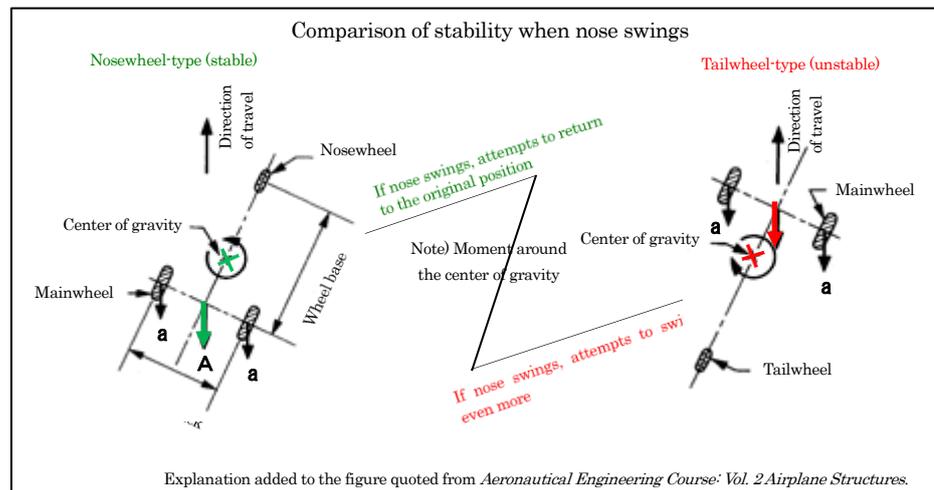
When the nose suddenly swings during ground roll, counter directional force  $a$  against inertial force is applied to the touchdown point between the tires and the ground. This is equal to the resultant  $A$  having actual force on the longitudinal axis of the airplane.

In nosewheel-type landing gear, the center of gravity is located ahead of the main landing gear, giving rise to moment around the center of gravity, which attempts to return the nose to its original position through composite force  $A$ , making the airplane dynamically stable.

On the other hand, in tailwheel type landing gear, the center of gravity is located behind the main landing gear, giving rise to moment around the center of gravity which attempts to swing the nose even more through composite force  $A$ , making the airplane dynamically unstable.

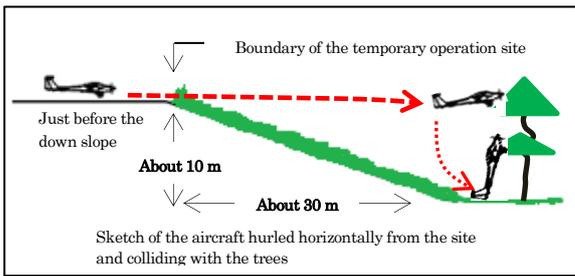
3.1 Involvement of Weather	None
3.2 Involvement of Pilots	Yes
3.3 Involvement of Equipment	None
3.4 Analysis of Findings	<p>(1) Runway excursion</p> <p>It is somewhat likely that the operation of the directional correction by the captain was delayed because the aircraft went closer to the left side of the runway during the after-landing roll. It is somewhat likely that the nose of the aircraft swung significantly to the right because it went closer to the left side of the runway and the captain stepped on the right rudder pedal to correct the direction, and that this was difficult to correct owing to the property stated in 2.7 (2). It is also somewhat likely that the captain stepped hard on the right rudder pedal without reducing the speed of the aircraft, because it banked so hard to the left that the left main wing tip almost contacted the runway owing to centrifugal force.</p> <p>After that, it is somewhat likely that the aircraft rolled to the right; thus, the main wings which had banked to the left returned to the original attitude due to the reaction effect of propeller torque, because the captain maximized engine power soon after hearing the passenger say “Go around”; moreover, the aircraft continued to roll following the runway excursion despite the nose of the aircraft swinging significantly to the right due to the influence of propeller slipstream.</p> <p>(2) Damage to the aircraft</p> <p>It is highly probable, judging from the breakage at the top of the trees at the same height as the site, and the state of damage to the leading edge of the main wings and the propeller spinner, that the aircraft continued to roll without stopping even after the runway excursion, and then it was hurled horizontally from the site, and accordingly, its nose and the leading edges of its main wings collided with the top of the trees.</p>
