AA2020-6

**AIRCRAFT ACCIDENT
INVESTIGATION REPORT**

**PRIVATELY OWNED
J A 2 5 2 9**

Company	Privately owned
Type	Scheibe SF-25C Falke (Motor Glider, Two-Seater)
Registration Mark	JA2529
Accident Class	Damage to the Aircraft during take off
Date and Time of the Occurrence	Around 16:55 JST (JST: UTC+9 hours; unless otherwise noted, all times are indicated in JST in this report on a 24-hour clock), on August 27, 2019
Site of the Accident	Nishio-city, Aichi Prefecture (34°53'19" N, 137°04'52" E)

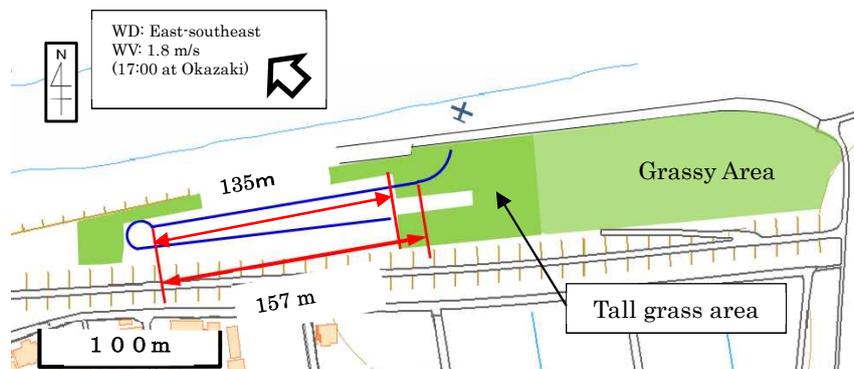
Figure 1: Accident site layout

The Aircraft continued its take off run, but before airborne, it plunged into a tall grass area and tall grass entangled left wing and left outrigger. When the Aircraft reached the point around 157m from the starting point of the take off run, the heading deflected to the left, and the Aircraft fell about 3 m down from the riverbed and stopped.

The left wing leading edge was damaged and propeller was broken. Along the line which the Aircraft made its take off run, there were relatively fewer grass to the point about 135 m from the starting point, but from there on as closer to the edge of riverbed, there were tall grass in high density which exceeded the height of the main wings (about 1 m).

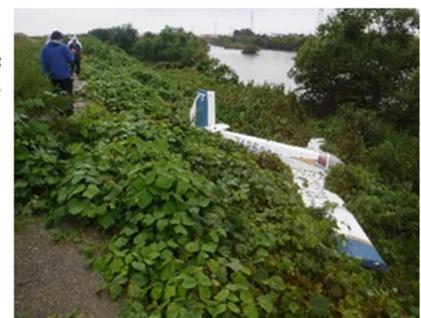
Figure 2: Accident Aircraft

Height of the grass where the Aircraft plunged into were higher than the main wings, therefore, it is highly probable that those grass created a big drag. In addition, it is probable that those outriggers were also entangled with the tall grass, and deflected the heading to the left.

In this accident, when the Aircraft tried to take off, it is highly probable that it was not able to accelerate enough within the riverbed length, plunged into tall grass area before airborne, therefore its left main wing and left outrigger were entangled with tall grass, and veered to the left and fell down from the riverbed, which resulted in the damage to the main wings and propellers.
