**AIRCRAFT ACCIDENT  
INVESTIGATION REPORT**

**J A 2 5 5 3**

**Japan Transport Safety Board**

**PRIVATELY OWNED  
VALENTINE TAIFUN 17EII  
(MOTOR GLIDER, MULTIPLE SEATS), JA2553  
TAKASU GLIDING FIELD  
TAKASU-CHO, MATSUZAKA CITY, MIE PREFECTURE  
AT ABOUT 14:45 JST, JUNE 12, 2010**

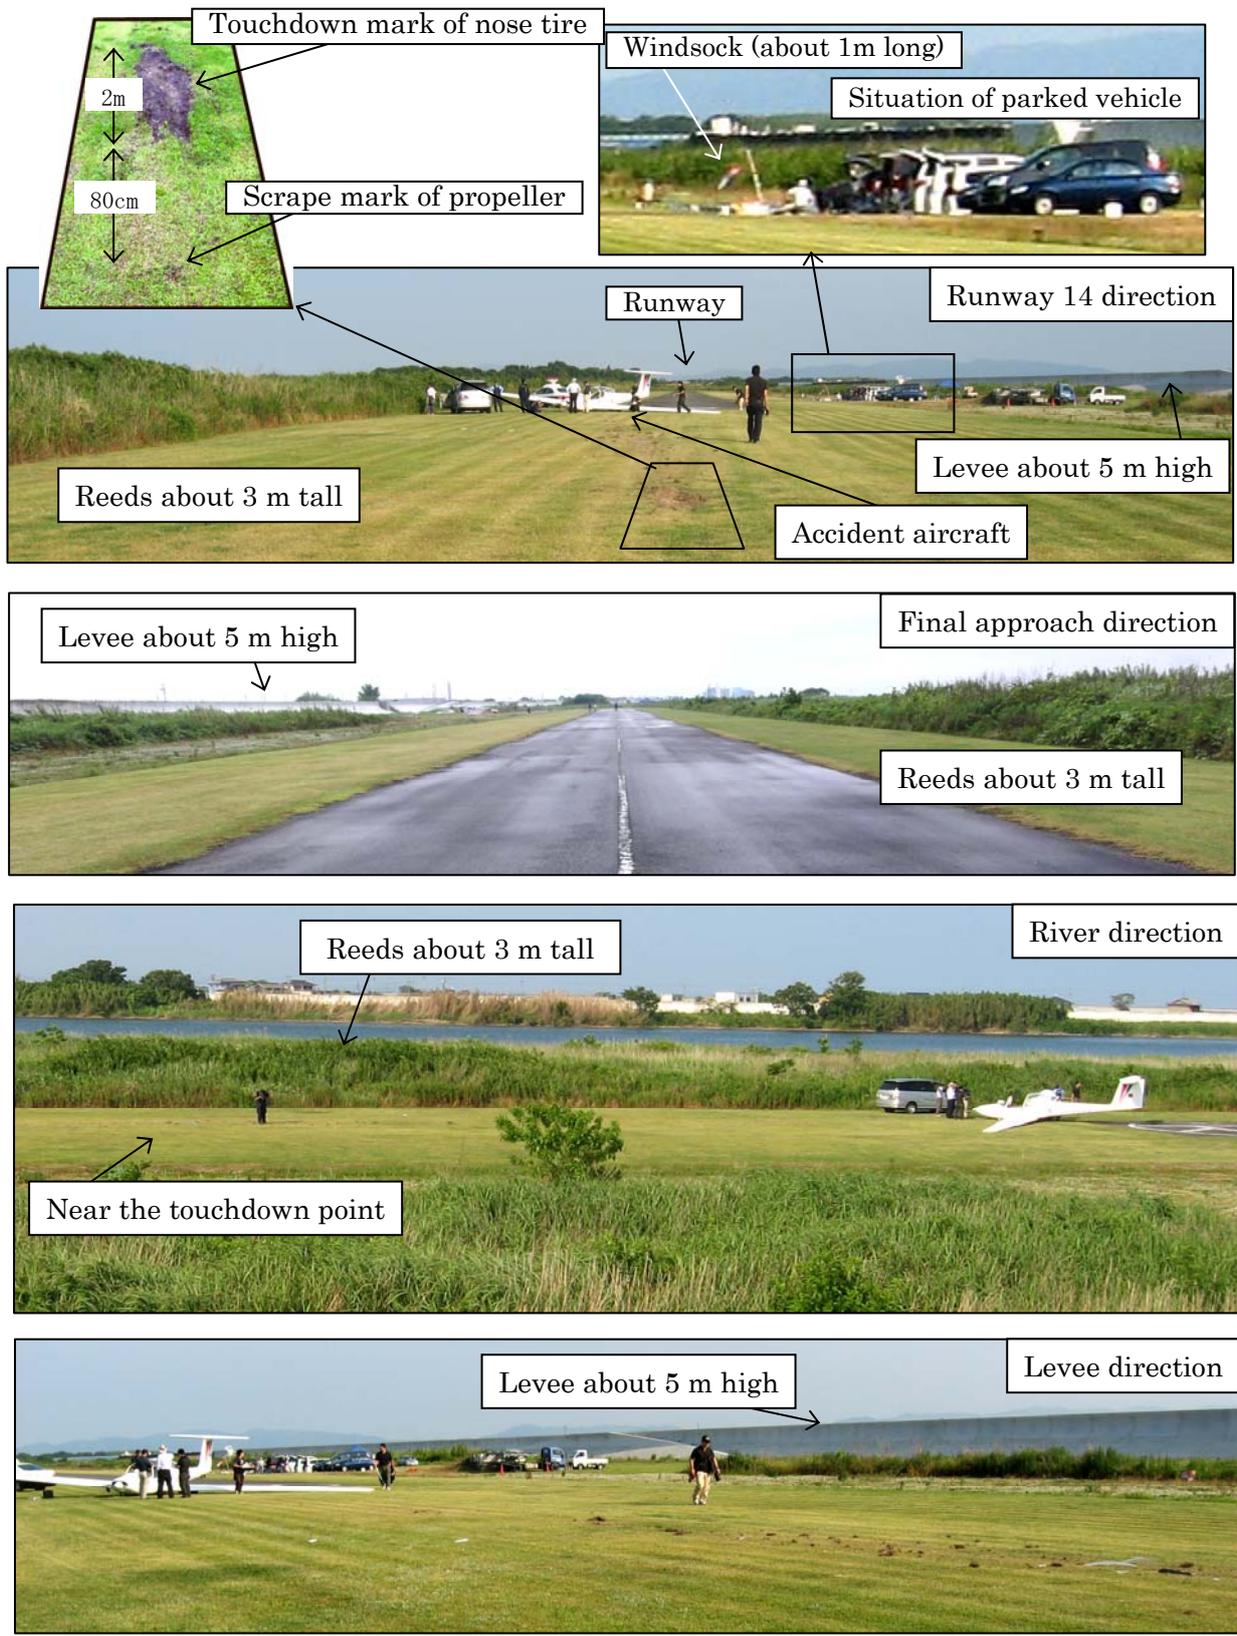
Photo 1: Accident Aircraft and Accident Site

The Aircraft was at a stop with its nose turned 005° and with its tail on top of the threshold of Runway 14. There was a scrape mark about five cm in width and ten cm in length across the entry direction about 59.3 m northwest of the spot where the Aircraft stopped. Further, there was a touchdown mark about 20 cm in width and about two m in length about 80 cm advanced from the scrape mark (equivalent to about 58.5 m northwest of where the Aircraft stopped) in the direction of the runway. In addition there were tire marks between the touchdown mark and where the Aircraft stopped, which had been left during landing roll, and propeller and windshield glass fragments were scattered around.

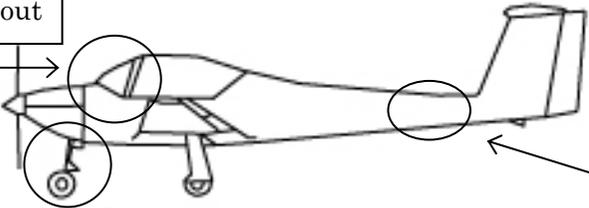
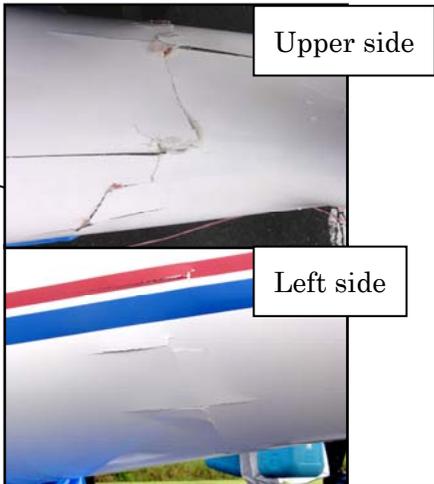
- (1) Fuselage: The front windshield glass in the cockpit was broken and fallen

Front windshield glass was broken and fallen out
