**AIRCRAFT ACCIDENT
INVESTIGATION REPORT**

**WAVE SOARING HIDA
J A 2 5 6 9**

COLLISION WITH A MOUNTAIN SLOPE WAVE SOARING HIDA GROB MODEL GROB G109B (MOTOR GLIDER, TWO-SEATER), JA2569 NYUKAWA-CHO, TAKAYAMA CITY, GIFU PREFECTURE, JAPAN AT AROUND 14:38 JST, MAY 1, 2015

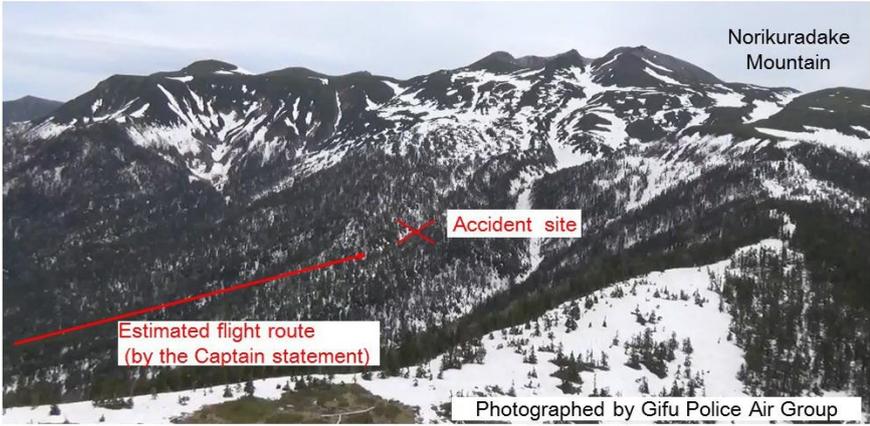
<p>intermontane regions within nine km radius from Hida Airpark for the hope of the passenger that he wanted to look at mountains, however it flew toward Norikuradake Mountain because of fine weather.</p> <p>The Glider flew at the speed of 90 to 100 km/h while undergoing the updraft in the north side of the ridge ranging from east to west, and reached the altitude of 200 to 300 m above the ridge before Norikuradake Mountain. Afterward, when the Glider was approaching Norikuradake Mountain while climbing along the west gradually-inclined upwardly slope in the north side of the ridge, the Glider suddenly encountered the downdraft causing its descent.</p> <p>Although the Captain tried to make the Glider climb with V_x^{*1} by opening the throttle, sufficient climb could not be obtained against the gradient of the slope. When the Captain tried to turn around, the altitude was already too low to avoid the contact of the wing end with trees if the main wing was tilted, so that the Glider collided with the slope in a climbing attitude without circling.</p> <p>The propeller pitch of the Glider was set at Climb mode ^{*2} from the time of taking off, the air brake was not used, and there were no anomalies in the engine and the control system.</p> <p>The Captain and the passenger escaped out of the fuselage after the Glider collided with the slope. Although the Captain tried to request rescue, the radio was out of order and his cellular phone was out of range, so that he could not request rescue.</p> <p>Afterward, they made a short climb on the slope, requested rescue by cellular phone, and were rescued by helicopter of Gifu Police.</p> <p>The accident occurred in the mountains in Nyukawa-cho, Takayama-city, Gifu prefecture (36°06'30" N, 137°31'41" E) at around 14:38, May 1, 2015.</p>

<p>Geographic features near the accident site and estimated flight route</p>

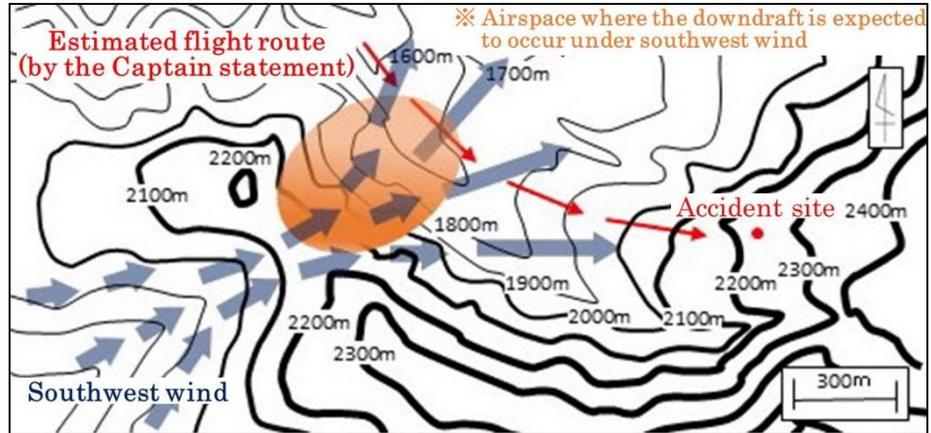
3.1 Involvement of Weather	Yes
3.2 Involvement of Pilot	Yes
3.3 Involvement of Glider	No
3.4 Analysis of Findings	<p>(1) Effects of downdraft</p> <p>It is somewhat likely that the airspace in about 500 to 1,000 m west-northwest of the accident site was the lee side of the ridge under the southwest wind and the wind over the ridge was concentrated to cause the downdraft due to the geographic features.</p> <p>It is probable that the Glider got into the airspace described above while climbing from the west along the mountain slope whose gradient is gradually upward and encountered the downdraft to descend the altitude, when the accident occurred.</p> <p>(2) Involvement of pilot</p> <p>Even if a pilot encountered unexpected change of air current such as mountain wave, or the downdraft, it is important to fly through a flight route and at altitudes to surely avoid the collision with the ground.</p> <p>It is probable that the Captain was approaching without expecting the occurrence of downdraft in the airspace described above (1).</p> <p>It is highly probable that the Captain encountered the downdraft to descend the altitude and tried to turn around to avoid the collision with the slope; however, the Glider already approached the ground too close to avoid the contact of the wing end with trees if the main wing was tilted, so that it could not be circled. In addition, it is highly probable that</p>

the Glider could not make a climb corresponding to the gradient and collided with the slope that time.

It is somewhat likely that it is because the Captain approached the mountain slope too close and did not fly at the altitude enough to avoid the downdraft that it fell to the altitude preventing the turnaround.

Geographic features near the accident site, wind direction and estimated flight route (Based on Electronic Map 25,000, Geospatial Information Authority of Japan as a reference)
