**AIRCRAFT SERIOUS INCIDENT
INVESTIGATION REPORT**

PRIVately OWNED MAULE AIR M-7-235C
JA30HT

INABILITY TO OPERATE DUE TO DAMAGES OF THE
LANDING GEAR OF THE AIRCRAFT
AT OTONE TEMPORARY AIRFIELD
KAWACHI TOWN, INASHIKI-GUN, IBARAKI PREFECTURE
JAPAN
AT AROUND 11:30, DECEMBER 4, 2015

May 26, 2017

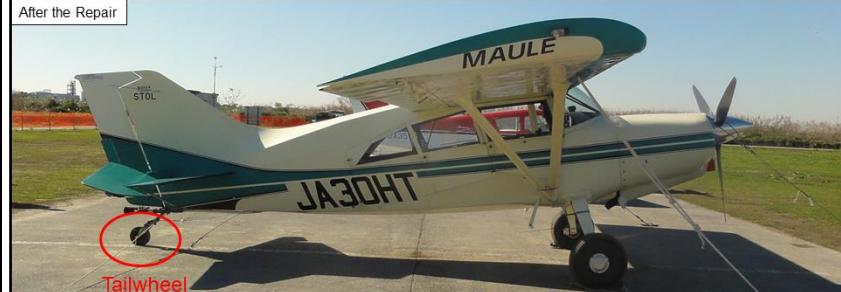
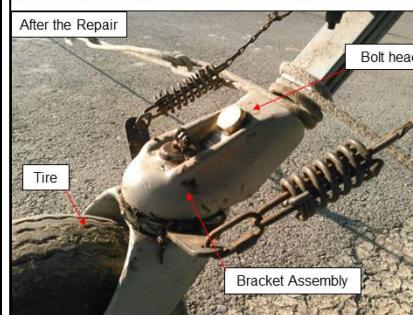
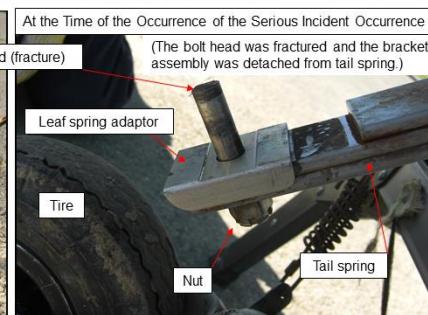
Photo1 The Condition of the Aircraft and the Tailwheel

<p>After the Repair</p> <p>Tailwheel</p> </div> <div style="display: flex; justify-content: space-around;"> <div style="text-align: center;">

<p>After the Repair</p> <p>Tire</p> <p>Bracket Assembly</p> <p>Bolt head (fracture)</p> </div> <div style="text-align: center;">

<p>At the Time of the Occurrence of the Serious Incident Occurrence</p> <p>(The bolt head was fractured and the bracket assembly was detached from tail spring.)</p> <p>Leaf spring adaptor</p> <p>Tire</p> <p>Nut</p> <p>Tail spring</p> </div> </div> </div>

<p>from the runway at the speed of about five kt after the landing, the captain felt something unusual; therefore, he stopped the aircraft. When the captain got off the aircraft to check the airframe, the bolt which had connected the tailwheel bracket assembly of the tailwheel with the tail spring of the airframe side was fractured at the bolt head; therefore, the tailwheel was detached and fallen.</p> <p>The serious incident occurred at around 11:30 on December 4, 2015, at the Otone Temporary Airfield ($35^{\circ}51'29''$ N, $140^{\circ}14'16''$ E).</p>

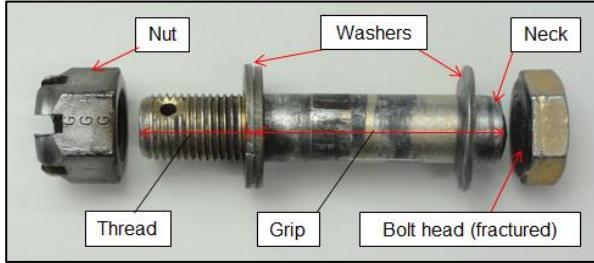
<p style="text-align: center;">Photo 2 The Bolt, the Washers and the Nut</p>

2.2 Injuries to Persons	None
2.3 Damage	<p>(1) Extent of damage to the aircraft: Slightly damaged (2) Damage to the aircraft component: Detachment of the tailwheel</p> <p>The tail spring and the tailwheel bracket assembly were connected by using three pieces of washers in total which were used one for the bolt head side and two for the nut side, the damages were found as follows:</p>

<p>a. The Bolt was fractured at right below the bolt head (Neck).</p> <p>b. A shaved dent in the size of 0.6 mm (3/128 in) was found around the bolt hole at the bolt head side of the tailwheel bracket assembly.</p> <p>c. The washer at the bolt head side was curved along the shaved dent, had multiple crimping marks by the bolt head and decreased its thickness.</p> <p>(3) Investigation by using unused items</p> <p>Replacing to a new bolt and new washers and applying a standard torque on the bolt of the tailwheel bracket assembly with a shaved dent used in the aircraft, the washer was slightly curved at the afloat state from the shaved dent but had no crimping marks and did not decrease in its thickness like the washer used for the aircraft.</p> <p>(See Appendix 1: Diagram to Install a Tailwheel)</p>

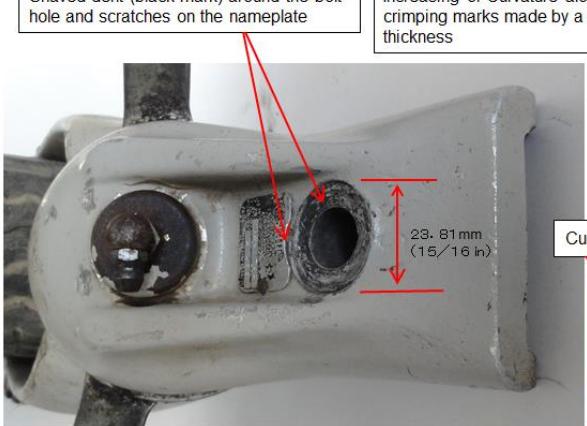
<p>Shaved dent (black mark) around the bolt hole and scratches on the nameplate</p> <p>Increasing of Curvature along the shaved dent. Multiple crimping marks made by a bolt head, decreasing of the thickness</p> <p>23.81 mm (15/16 in)</p> <p>22.23 mm (14/16 in)</p> <p>(At the bolt head side)</p> <p>Curvature along the shaved dent</p> <p>(At the back side of the washer)</p> <p style="text-align: center;">Photo 3 The Tailwheel Bracket Assembly and the Washer</p>

<p>of the tailwheel.</p> <p>It is probable that when the company had confirmed the shaved dent on the tailwheel bracket assembly, the curvature on the washer of the bolt head side and the decrease of the thickness at the time to implement the maintenance work, the tailwheel bracket assembly and the washer should be required to replace. It is probable that the bolt should be inspected in details and then it was required to replace.</p>
--	--

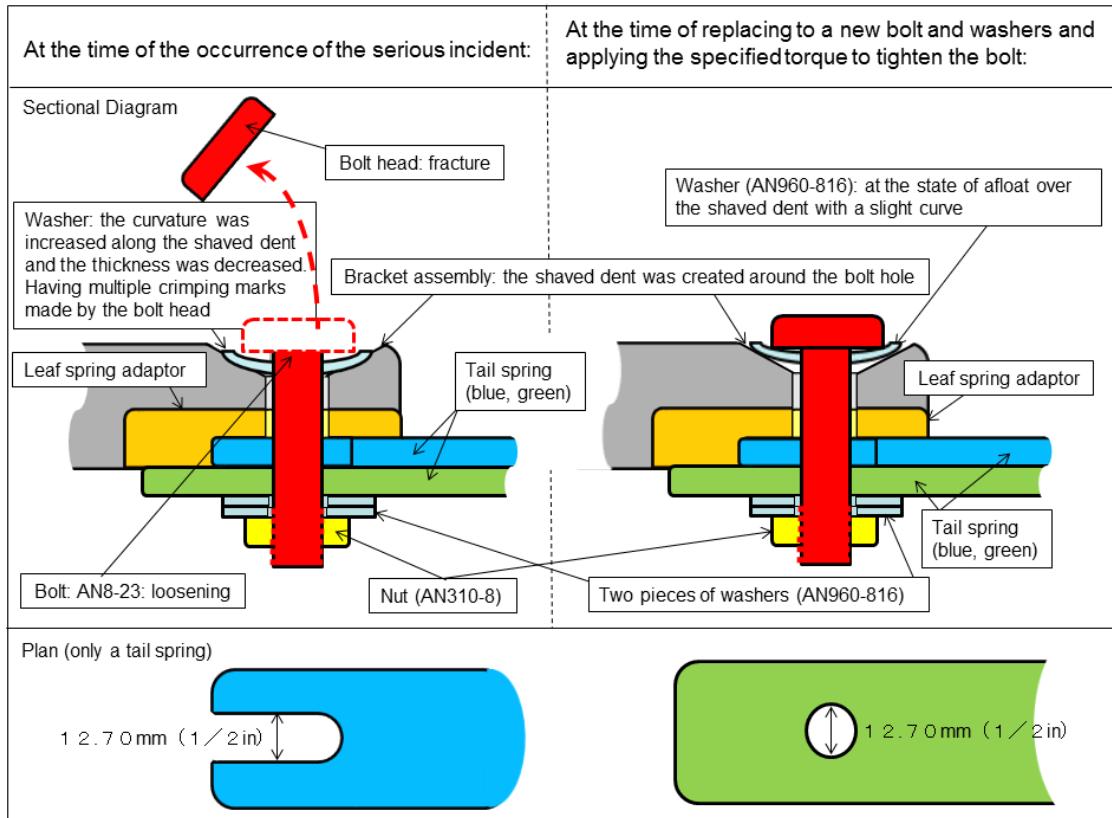
Appendix 1 Diagram to Install a Tailwheel

the aircraft maintenance work") issued by Federal Aviation Administration, which describes a detailed work criteria regarding the inspection and maintenance of an aircraft, has a description that in general, a grip length equals to the thickness of a members, when the bolt grip is slightly longer, a washers could be used under the nut and bolt head, but the total thickness of the washers should be 3.175 mm (1/8 in) or less.

On the other hand, the grip length of the bolt being in use to connect the tailwheel bracket assembly to the tail spring was longer by 4.763 mm (3/16 in) than the tightening members and using three sheets of 1.588 mm (1/16 in) thick washers (one washer on the bolt head side and two on the tail spring side of the airframe), the total thickness was thicker by 1.588 mm than the value of the criteria for the aircraft maintenance work.

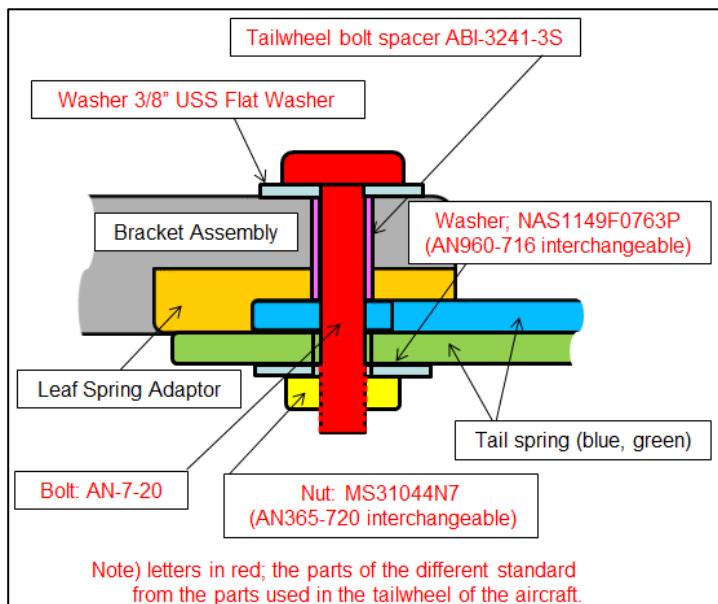
Figure 1 Interchangeable Tailwheel Manufactured by Other than Scott Aviation Corporation and approved by FAA

On the other hand, the tailwheel parts of the aircraft at the time of the serious incident occurred did not use a tailwheel spacer, but using one AN^{*5} 8-23 bolt (comparing to the AN7-20 bolt, the diameter is bigger by 1/16 in, the length is longer by 3.8 in and the grip length is longer by 1/4 in), three sheets of AN960-816 washer and one AN310-8 nut to connect.

After the serious incident, the parts being in use to connect the tailwheel, manufactured by other than Scott Aviation Corporation and approved as an interchangeable parts by FAA, is a combination of one AN7-20 bolt, one sheet of 3/8 in USS^{*2} FLAT washer, one sheet of NAS^{*3} 1149F0763P (AN960-716 interchangeable) washer, and one MS^{*4} 21044N7 (AN365-720 interchangeable) nut with a cylinder shaped tailwheel bolt spacer to match the inner diameter of the bolt hole of the tailwheel bracket assembly.

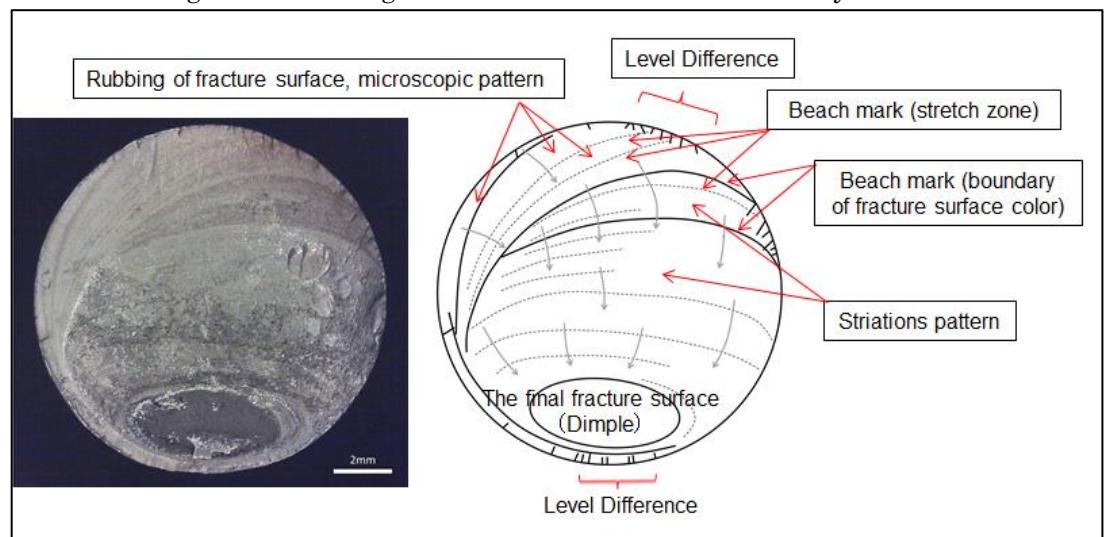
Figure 2 Fracture Surface Investigation of the Bolt

- (2) As the result of having observed the fracture surface, it is probable that the intergranular fractured surface which is a characteristic of a delayed fracture could not be observed, the striation patterns (a regular stripe pattern) which is a characteristic of a fatigue fracture could be observed, multiple level differences near the surface which is a characteristic of the fatigue fracture surface at the stress concentration portion was observed, and a characteristic relatively fine pattern on the fracture surface near a fatigue crack initiating point was observed, therefore, this fracture of the bolt was occurred due to the fatigue.

- (3) Based on the deformation of washer and the abrasion status of the bolt side, it is somewhat likely that the bolt was loosened from the time of the use.

- (4) It is probable that the cause of the fracture of this bolt was a fatigue fracture due to loosening of the bolt.

- (1) The curvature of the washer was increased and the thickness of it was decreased during the use.
- (2) Uneven hits were generated to the bolt, because the bolt axial tension was released and resulted in the bolt loosened status due to the increase in the washer curvature and decrease in thickness.
- (3) A bending moment was generated to the tailwheel assembly.

- (4) The crack was generated due to high-cycle fatigue (about 10^4 to 10^6 times) because excessive stress exceeding the fatigue limit had concentrated onto the neck.
- (5) The repetition times with only number of the takeoff and landing are insufficient to lead to the high-cycle fatigue, because the times to takeoff and landing of the aircraft with the bolt are only 1,400 times, therefore, mostly the stress due to vibration at the taxiing at takeoff and landing developed the fatigue crack. In addition, the plastic blunting of fatigue crack point due to the excessive load slightly stronger than normal at the time of landing created a stretch zone (beach mark), regularly.
- (6) The acting stress on remaining cross section area which is exceeding the tensile strength of the materials created a ductile fracture and a dimple to break and drop the bolt.

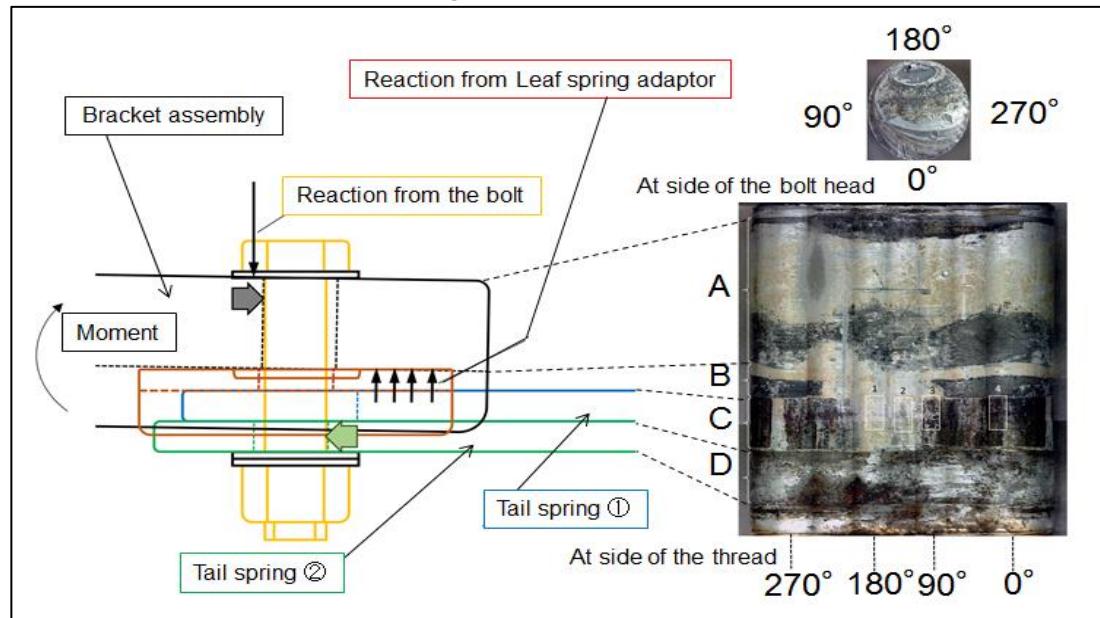
Figure 3 Stress when the Bolt at Loose and the Side View of the Bolt

The photo of Figure 3 shows the elevating view by pasting images taken on all around bolt by a microscope together. For a new bolt, it is normally metal plated and has the yellow appearance.

However, the region of A to C of the bolt connecting the tailwheel has becomes black due to the adhered substances or peeling of the plating. Besides, it is probable that the D region has no traces of plating, scars in the circumferential direction and more sever abrasion comparing to the regions of A to C. Moreover, within the C region, some area have more sever abrasion than some places, the some area with severe abrasion has wide scars to the longitudinal direction.
