**AIRCRAFT ACCIDENT  
INVESTIGATION REPORT**

**HONDA AIRWAYS CO., LTD.  
J A 3 1 H A**

**FUSELAGE DAMAGE DURING LANDING  
HONDA AIRWAYS CO., LTD.  
CESSNA 172S, JA31HA  
HONDA AIRPORT  
OKEGAWA CITY, SAITAMA PREFECTURE, JAPAN  
AT AROUND 11:09 JST, SEPTEMBER 22, 2015**

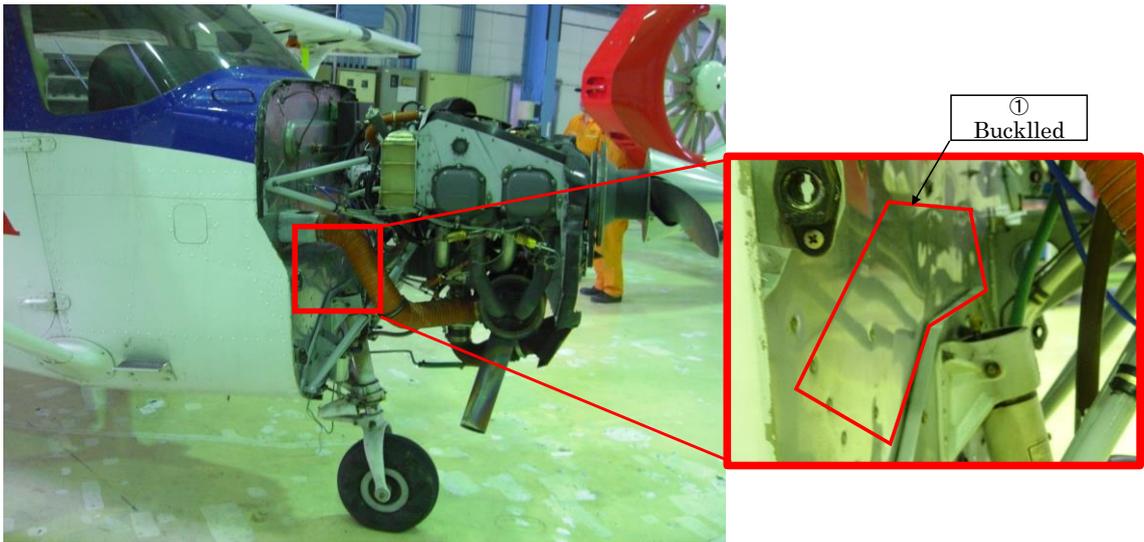
Photo 1 Damage to the Airframe (# 1)

- (1) Nose portion (near the nose strut attachment onto firewall aft of engine):  
Buckled (photo 1-①)
- (2) Empennage (lower skin): Worn (photo 2-②)
- (3) Empennage (bottom part of rudder): Scratch marks (photo 2-③)
- (4) Tie-down ring: Detached (photo 2-④)
- (5) Vertical stabilizer (lower skins on left and right): Buckled (photo 2-⑤)
- (6) Horizontal stabilizer (left and right hinge sections): Buckled (photo2-⑥)

Based on the description in 2.1 (1), it is probable that the aircraft had no abnormality up to the accident occurred. It is highly probable that the damage of the nose portion (near the nose strut attachment onto firewall aft of engine) described in 2.3.2 (1) was caused by receiving an overload acting upward at the nose landing gear section. It is highly probable that the damage to the empennage of the airframe described in 2.3.2 (2) was caused because its bottom surface hit and scratched the runway, and received the impact by the upward load.

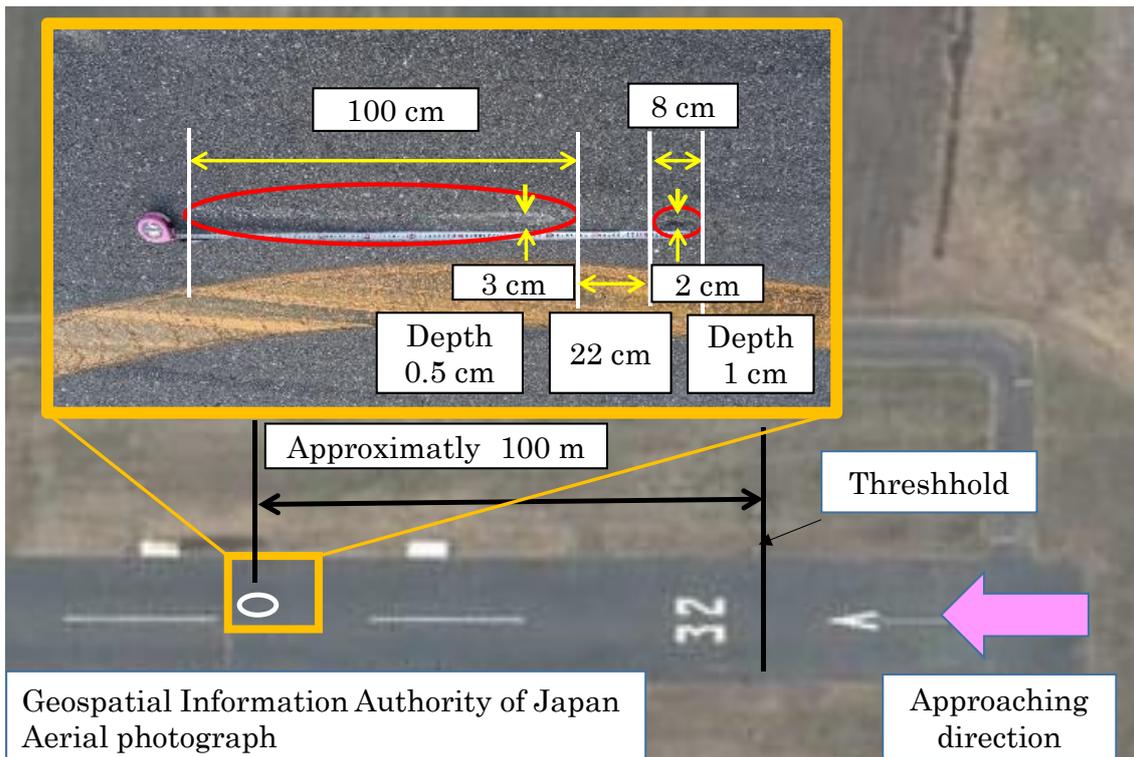
Photo 3 Scratch Marks on the Runway

The scratch marks of 8 cm in length, 2 cm in width and 100 cm in length, 3 cm in width, respectively, were left near the centerline of the runway at approximately 100 m from the threshold of the Runway 32.
