**AIRCRAFT SERIOUS INCIDENT  
INVESTIGATION REPORT**

**TOHOKU AIR SERVICE, INC.  
J A 3 3 2 T**

<b>Company</b>	Tohoku Air Service, Inc.
<b>Type, Registration Mark</b>	Eurocopter AS332L1 (Rotorcraft) JA332T
<b>Incident Class</b>	Dropping of Object during External Cargo Sling Operation Item 15, Article 166-4 of the Ordinance for Enforcement of the Civil Aeronautics Act of Japan prior to revision by the Ministerial Ordinance on Partial Revision of the Ordinance for Enforcement of Civil Aeronautics Act (Ordinance of Ministry of Land, Infrastructure, Transport and Tourism No. 88 of 2020)
<b>Date and Time of the Occurrence</b>	At about 09:50 Japan Standard Time (JST: UTC + 9 hours; unless otherwise stated, all times are indicated in JST in this report on a 24-hour clock), August 28, 2020
<b>Site of the Serious Incident</b>	Nagaoka City, Niigata Prefecture (37°29'04 N, 139°02'19 E)

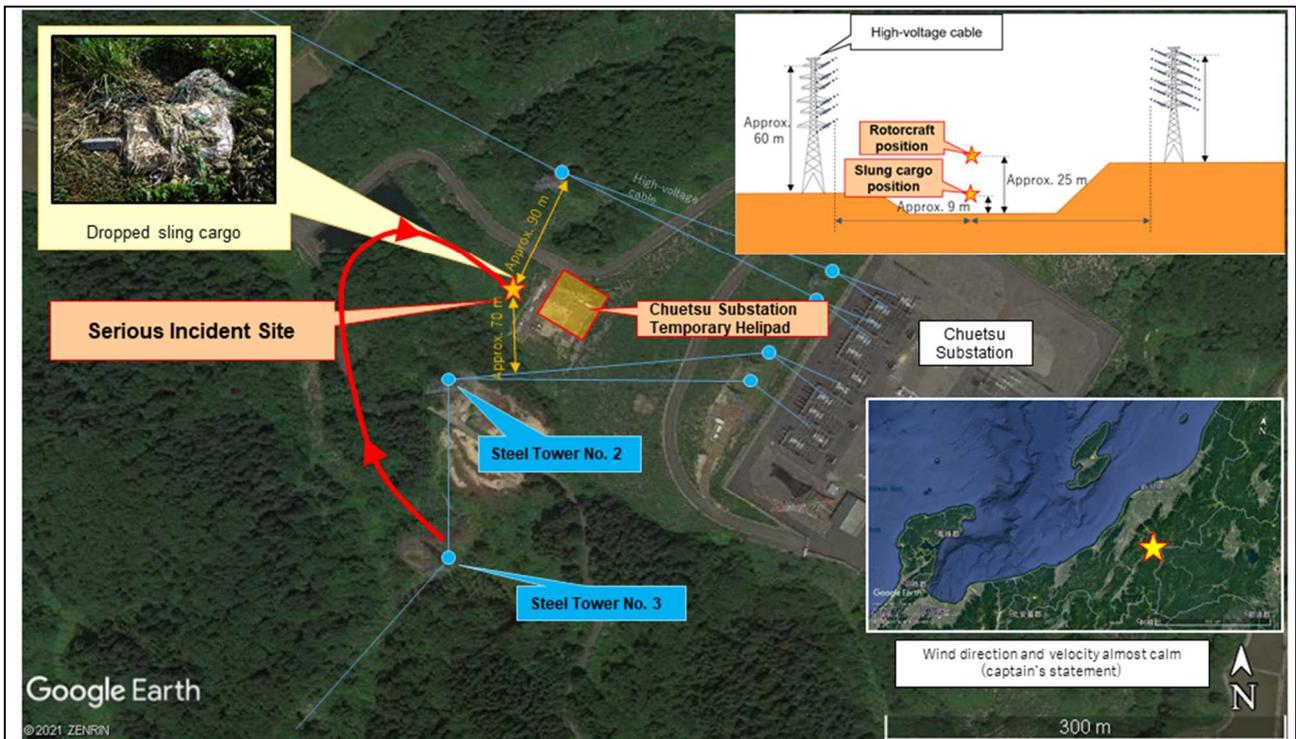
Figure 1 Estimated flight route

The helicopter equipped with two hooks in red and yellow, respectively, which were independent from each other, moved to over the cargo to be transported in the next operation under the control of the captain guided by the signal person and the onboard guide after transporting a winch weighing approximately 2.7 t from the helipad to the side of the steel tower No. 3 with the red hook. The hook person who had been on standby for the next transportation grasped the yellow hook that was guided in front of him or her, the load beam of which was in locked condition and the keeper in unlocked condition, and opened the keeper to hook the hanging ring of the wire, which combined two cargo nets containing the materials of the steel tower (weighing approximately 790 kg), on the load beam of the yellow hook. The hook person confirmed in accordance with the procedures that the hanging ring was securely hooked on the load beam, strongly pulled the wire of the sling cargo twice to securely lock the keeper, and confirmed with the signal person that the hook lock indicator and the keeper unlock lever were in lock position. After the captain by the indicator installed in the pilot seat and the onboard guide by the indicator installed in the left rear seat, respectively, confirmed that the load beam and the keeper were in lock condition and they verbally confirmed each other, the helicopter commenced a 10<sup>th</sup> transportation of the day to transport the sling cargo to the helipad. When the helicopter climbed and the sling cargo left the ground, the load beam and the keeper were locked. When the helicopter turned from the northwesterly direction and was flying at an altitude of approximately 25 m above ground level with the nose facing the helipad, the sling cargo suddenly dropped. The worker assigned as communication personnel in the helipad saw the moment the load beam suddenly opened, and the sling cargo dropped without largely swinging.

Take-off and landing at the helipad were performed from the northwesterly side, and the serious incident occurred during a fourth approach of the day to the helipad with the cargo externally slinging.

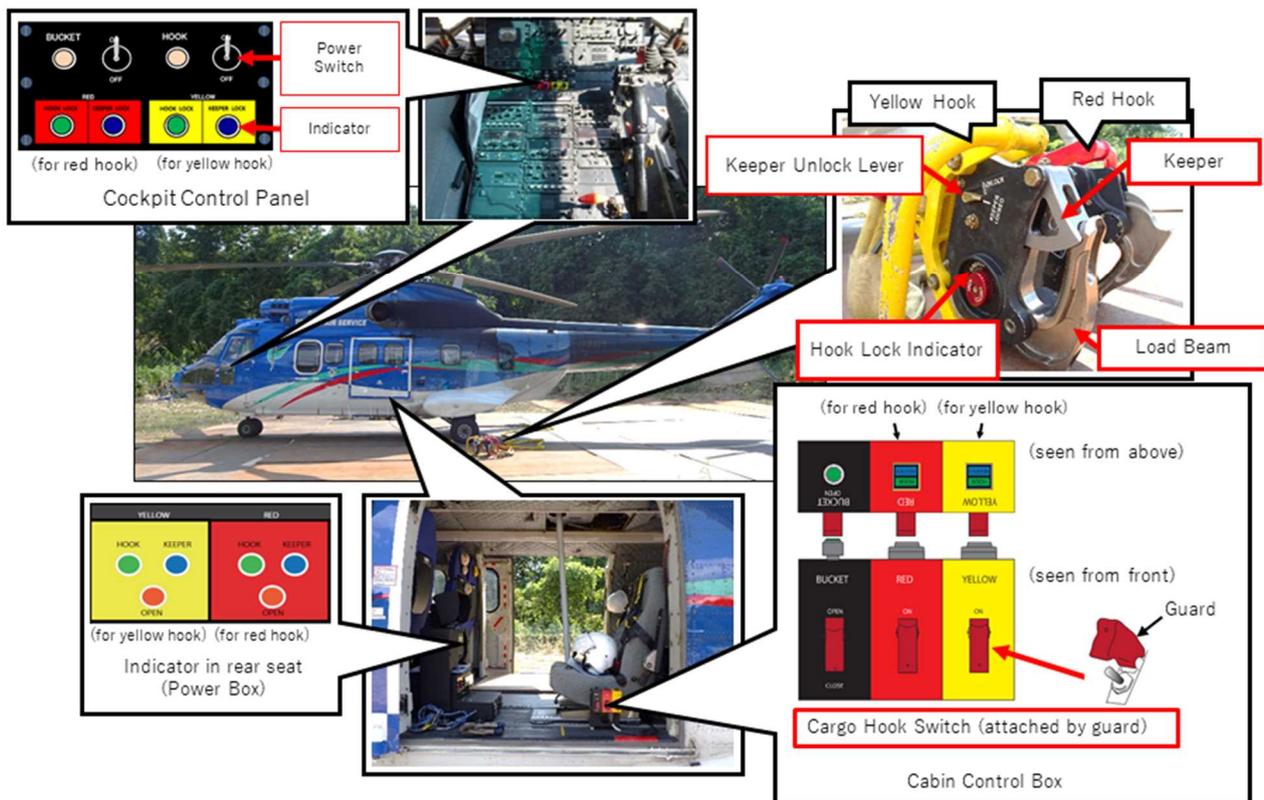
Figure 2 Arrangement of hooks, switches, and indicators

The external cargo sling system had specifications that electricity was supplied by switching “ON” the power switch of the cockpit control panel, and switching “ON” the cargo hook switch of the cabin control box installed on the side of the rear seat activated the relay inside the power box and released the lock of the load beam and the keeper. The cargo hook switch was attached by the guard that functioned as a measure to prevent malfunction. The load beam had a mechanism to return to lock position by the inner spring after it opened by the cargo hook switch onboard, or it

manually opened from the hook. Despite that the keeper had specifications to be kept unlocked until it was locked by applying a load on the load beam, it often returned to lock position.

Besides, once the load beam and the keeper were locked, they mechanically kept a locked status until the hook was manually unlocked, or a signal was sent to open the hook by switching "ON" the cargo hook switch. During the series of external cargo sling operations, the power switch was kept "ON" all the time.

It is probable that there occurred no problem with the sling work such as improper wire roping \*1, etc. since the load beam, the keeper, and the hanging ring did not sustain any damage. Besides, it is probable that the closed load beam and keeper after landing were explained by the keeper that returned to lock position when the hanging ring came off and the load beam returned to lock position since the keeper often returned to lock position.

The possibility that the sling cargo dropped by an operation error of the cargo hook switch is probable to be low since the onboard guide stated that he or she did not touch the cargo hook switch and faced the front putting his or her hands on the door when the sling cargo dropped, and the cargo hook switch was attached by the guard to prevent an operation error.

From the perspective of preventing recurrence, that it is probable that measures to improve fail-safe and fool proof of the external cargo sling system are effective so that the lock of the load beam cannot be released by immediate activation of the relay even in the case of a temporary malfunction of the system or an operation error of the cargo hook switch.

After the serious incident, the company suspended the use of the subject external cargo sling system, and external cargo sling operations were performed by other existing equipment (manual hook) that was allowed to be equipped to the subject helicopter until improvements in fail-safe of the system operation and enhanced information function to flight crew are implemented.
