**AIRCRAFT ACCIDENT  
INVESTIGATION REPORT**

**J A 3 3 T H**

**Japan Transport Safety Board**

**PRIVATELY OWNED  
ROBINSON R44 (ROTORCRAFT), JA33TH  
MIHO TEMPORARY OPERATION SITE  
SHIMIZU-KU, SHIZUOKA CITY, SHIZUOKA PREFECTURE  
AT ABOUT 11:30 JST, SEPTEMBER 5, 2009**

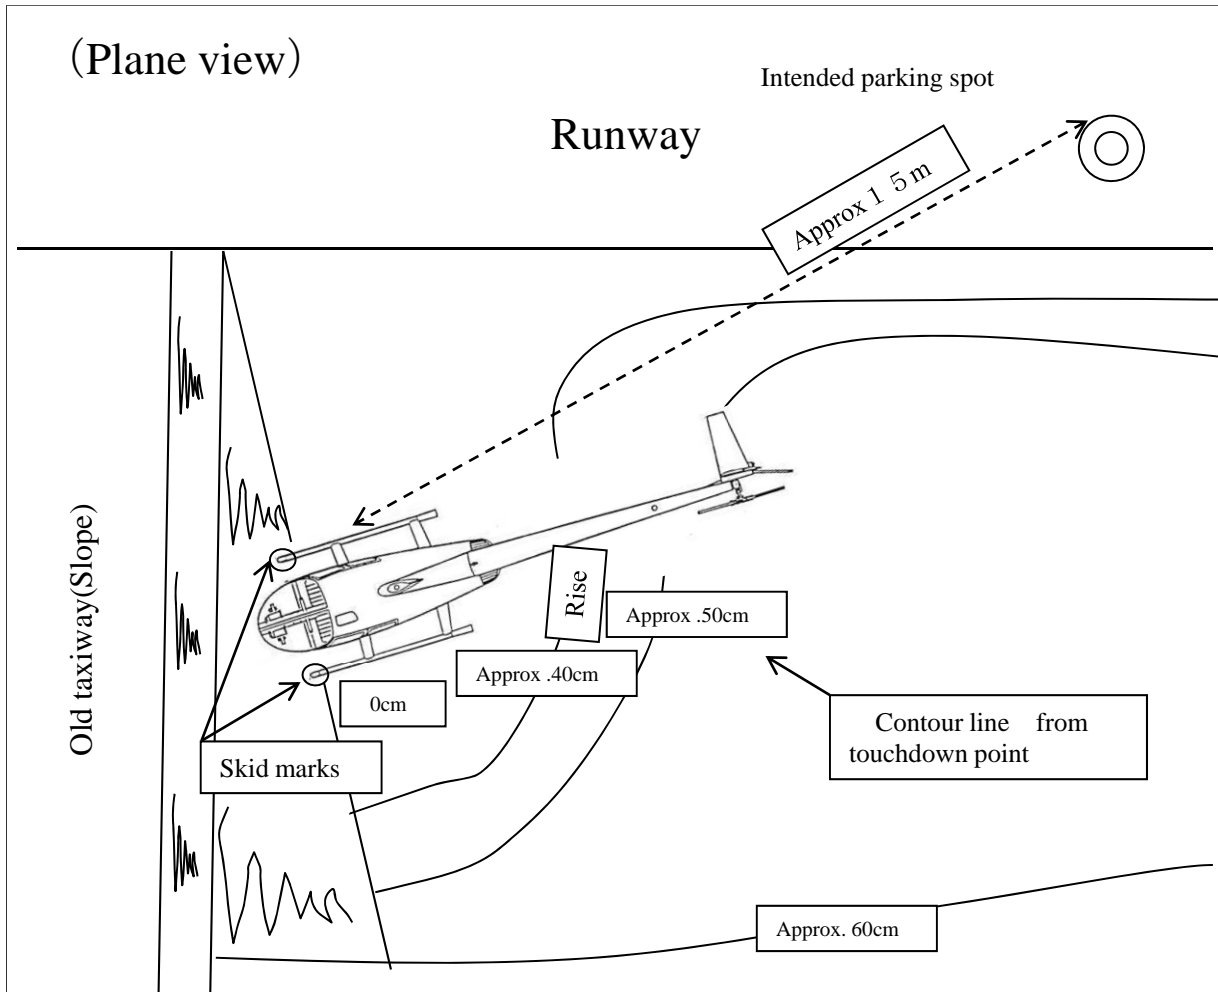
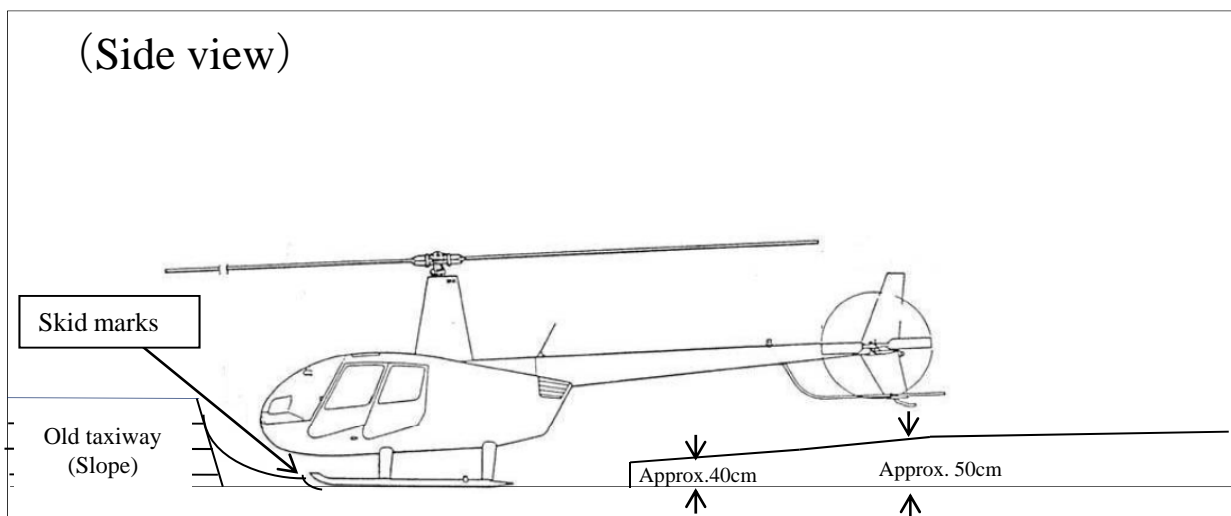
**Figure 2 Accident Site**

The grassy area on the west of the runway where the Aircraft touched down had a rough surface which includes slopes and stepped terrain. This rough surface extended about 14 m westward from the left edge of Runway 33 and was bordered by a bank.

In the grass, there were marks made by the skids at the time of the touchdown, indicating that the Aircraft came to a stop at a heading of about 310°. The area ahead of the skid marks was an upward slope extending towards an old taxiway, whereas there was a nearly flat surface in the area aft of the marks, which extended over a distance of about 4 m. Beyond the flat surface, there was a rise about 40 – 50 cm high when measured from the touchdown surface.

Since the site, as described in 2.7.2, where the Aircraft touched down had a rough surface which includes stepped terrain that has a rise in surface height of about 50 cm, it is considered probable that the ground clearance of the tailskid at that step was less than half of the tail skid height as described in 2.5.3. In addition, as the Aircraft's touchdown involved a landing so hard that the resulting loads caused deformation even to the frame structural member as described in (1) above. Therefore, it is considered probable that the tailskid came in contact with the ground at the time of the touchdown and the lower half of the vertical stabilizer in the tail assembly was then damaged.

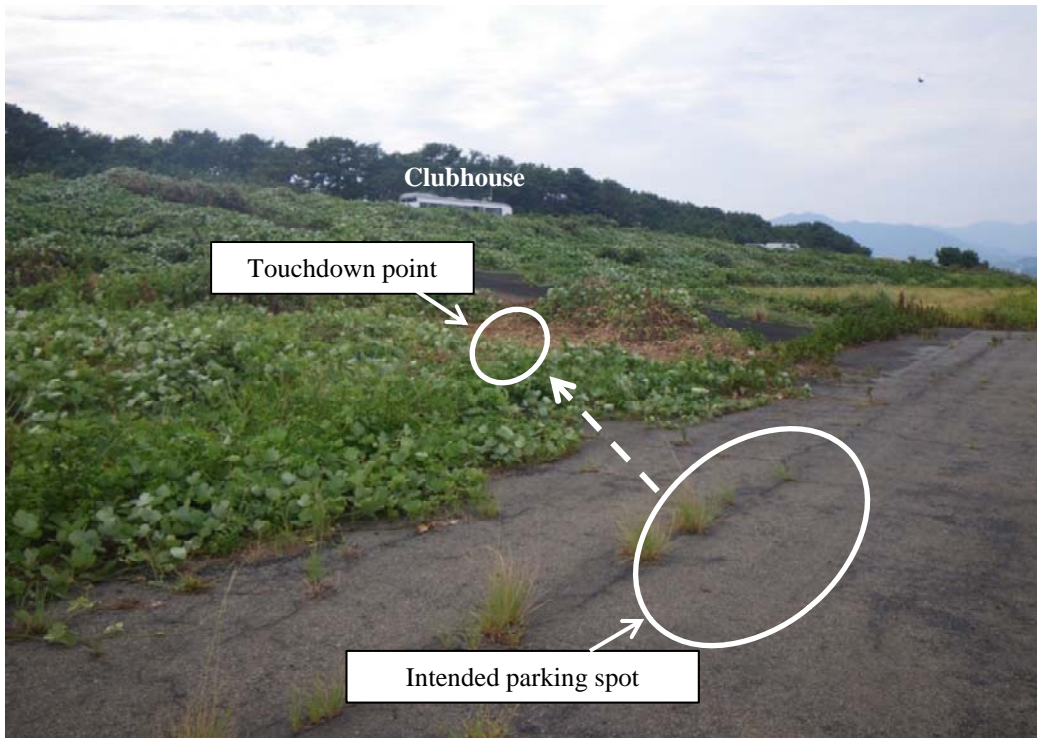
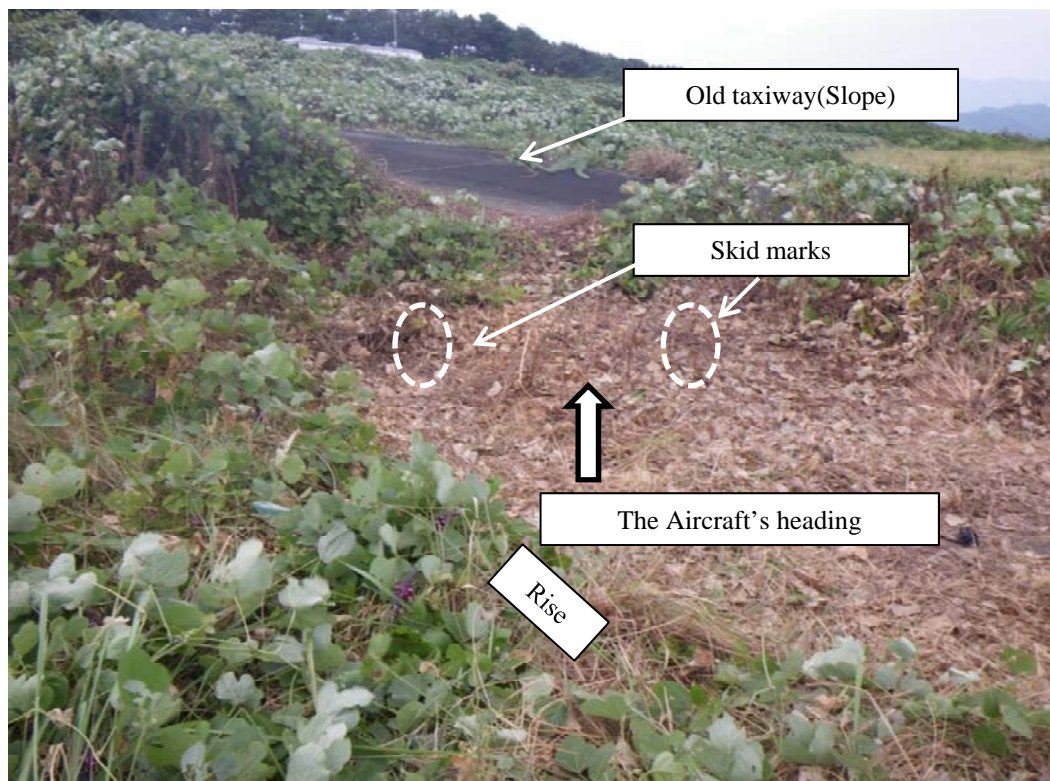
# Photo 1 Accident Site

The accident occurred at about 11:30 on the grass to the west and near the end of the Runway 33 of the Miho Site (Latitude 35°01'N, Longitude 138°32'E).

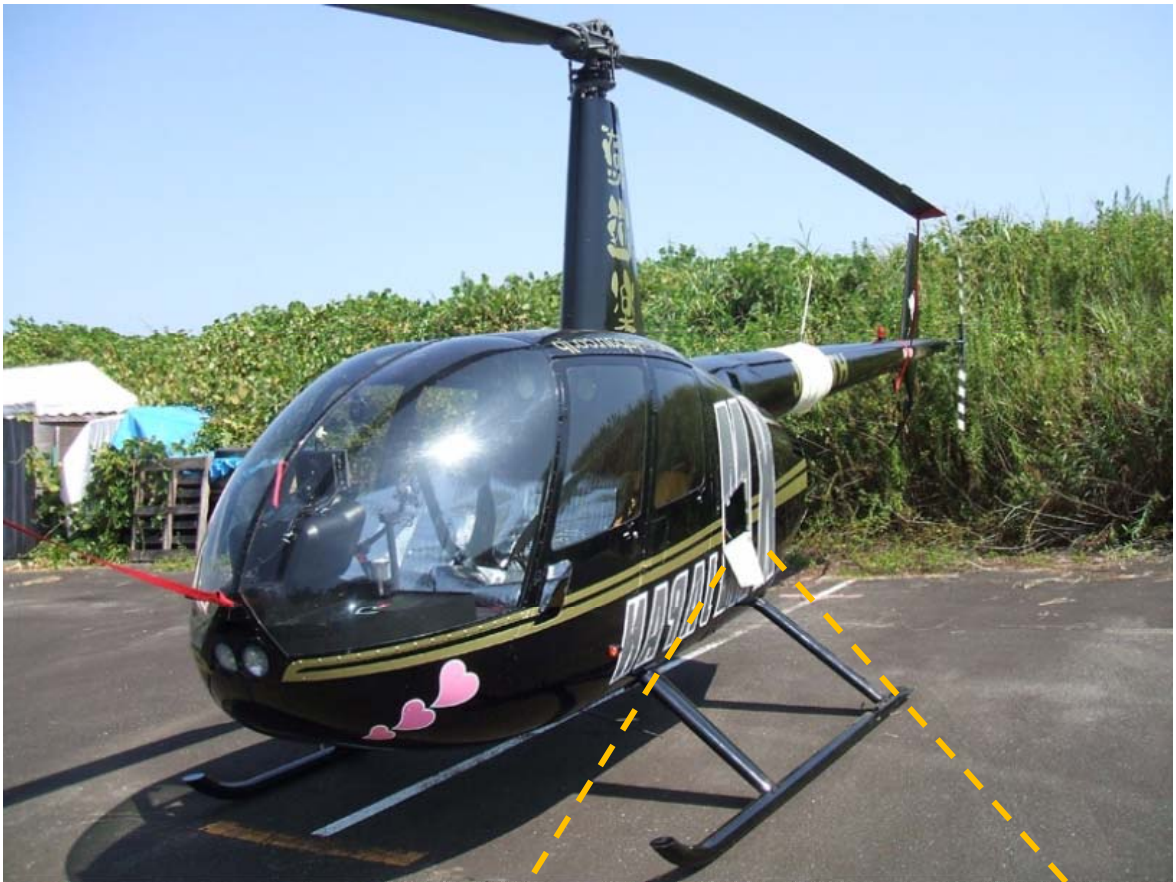
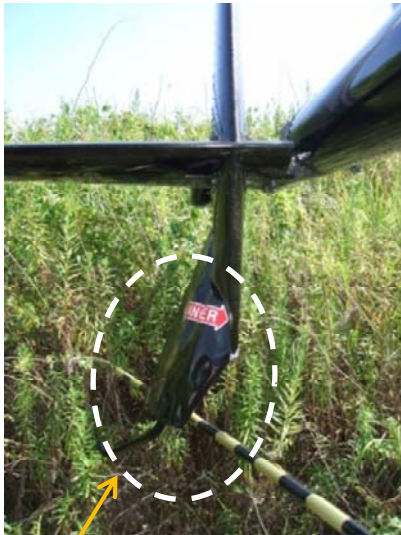
Deformed Vertical Stabilizer

Tail assembly                Lower half of the vertical stabilizer was deformed.

- (2) Deformation of the lower half of the vertical stabilizer of the tail assembly

According to the statement in 2.1, the instantaneous pitch-up angle at a height of 1 ft before touchdown was about one-half to one-third of the angle of 15–20°, which is usually used during the “quick stop” control. When deduced from these angles, the pitch-up angle at that time should have been less than or comparable to the angle of 10°. On the other hand, the measurement conducted at Robinson Helicopter Company, U.S.A. gave an angle of 12° when the tailskid touched the ground as described in 2.5.3. And, the Captain also said in his statement that he felt nothing that indicated contact with anything. Judging from all of the above, it is considered probable that, at the time of occurrence of the instantaneous pitch-up, the Aircraft did not experience any contact at its tailskid that would have been hard enough to deform the lower half of the vertical stabilizer of the tail

assembly which has an integral structure.

To prevent damage to the airframe due to a hard landing during normal touchdown, it is necessary for a helicopter pilot to operate following controls. First, select an appropriate touchdown spot and bring the helicopter in a stable hovering attitude over the spot. And then make such control moves as lowering the collective control lever gradually until the helicopter comes in contact with the ground surface. Whenever the pilot feels it is inappropriate to keep attempting touchdown, he should immediately abort the operation and start the descent procedure over again and, make another touchdown attempt after calmly stabilizing the helicopter attitude.

When a helicopter is hovering with the position of the center of gravity shifted rather aft and the tail rotor in a lowered position, the pilot can stabilize the helicopter's attitude by operating a rudder pedal smoothly enough to suppress the possible generation of a roll moment.

If the helicopter is to hover under weather conditions involving gust of wind, turning the nose against the wind can stabilize the helicopter's attitude, as this eliminates the weathercock effect and thus minimizes and facilitates necessary rudder pedal operations.

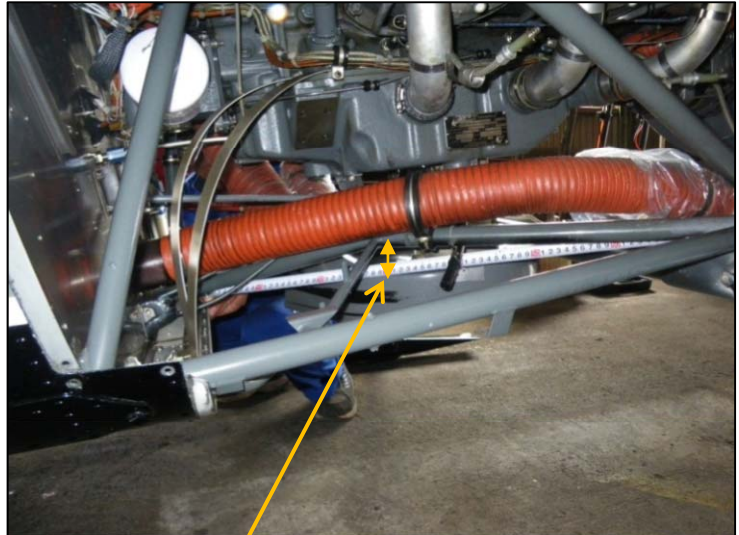
Deformed Lower Frame

Fuselage                      Left-hand lower frame was deformed.

- (1) Deformation of the left-hand lower frame of the fuselage

Because the left-hand lower frame of the fuselage are attached to the skids, it is considered highly probable that the upward force applied to the skid during the touchdown caused compressive deformation in the frame.
