**AIRCRAFT SERIOUS INCIDENT  
INVESTIGATION REPORT**

**PRIVATELY OWNED  
J A 3 4 4 T**

## ATTEMPTED LANDING ON CLOSED RUNWAY PRIVATELY OWNED ROBINSON R44 II, JA344T IKI AIRPORT AT ABOUT 12:30 JST, AUGUST 12, 2014

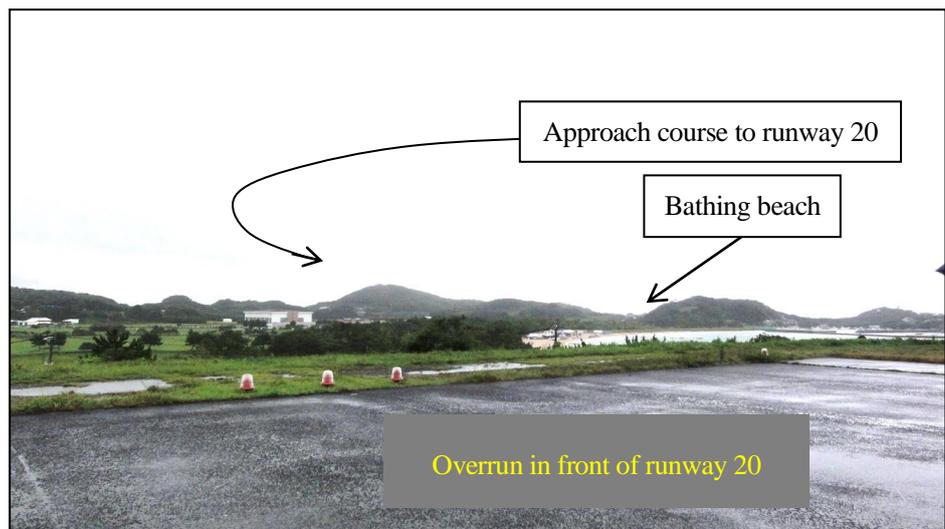
Photo: The approach course side

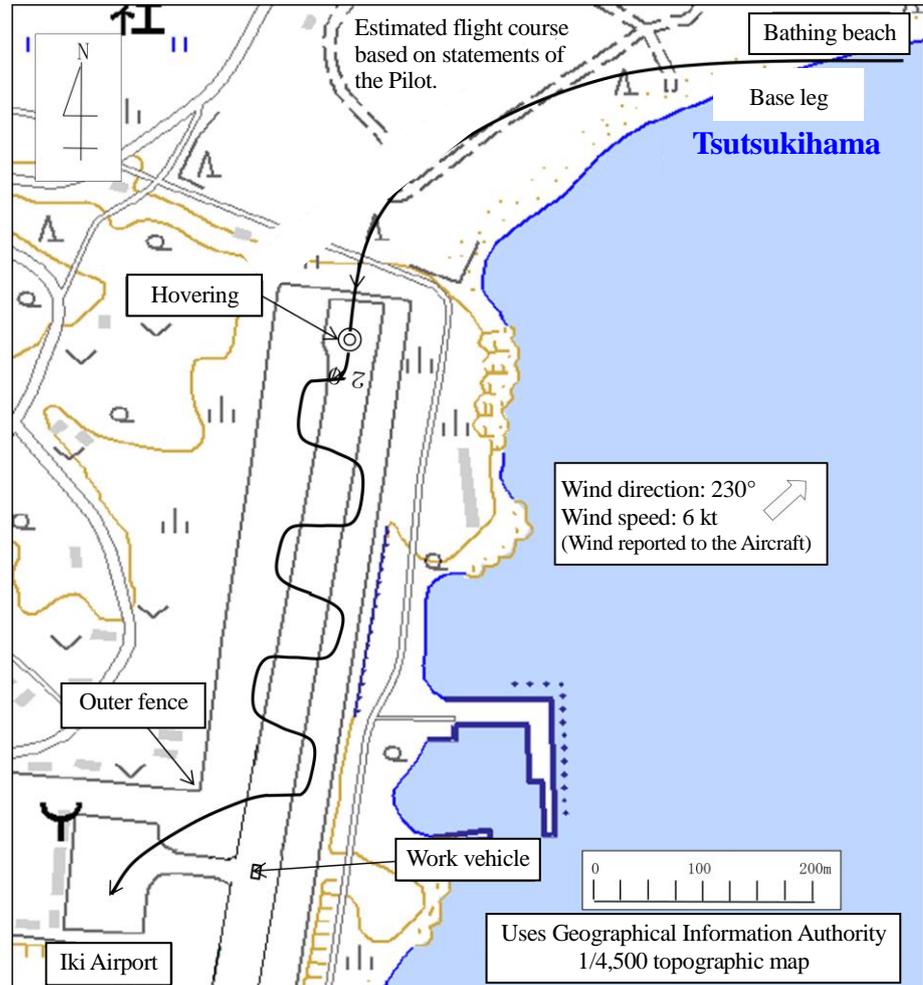
Estimated flight course

runway 20 approach end. Then, seeing that the Workers on the runway had placed the carcass of the bird into a bag and boarded the vehicle, the Pilot began to move by air-taxiing\*<sup>3</sup> toward the middle of the runway while meandering so as to ensure enough time for the work vehicle to clear the runway.

The Workers who were working on the runway suddenly noticed that the Aircraft, which they thought was holding in the air, started to come from the runway 20 approach end side while meandering, and observed how the Aircraft passed through the area between vehicle which was around the middle of the runway and the fence at the perimeter of the aerodrome and entered the apron, and then after circling for a while over the apron, touched down at the south spot while being guided by the crew of the Single engine plane that had landed earlier.
