**AIRCRAFT ACCIDENT
INVESTIGATION REPORT**

J A 3 4 9 2

DAMAGE TO AIRCRAFT DURING EMERGENCY LANDING PRIVATELY OWNED FUJI HEAVY INDUSTRIES FA-200-160, JA3492 OSAKI, YACHIYO CITY, CHIBA PREFECTURE, JAPAN AT ABOUT 14:25 JST, SEPTEMBER 23, 2013

June 13, 2014

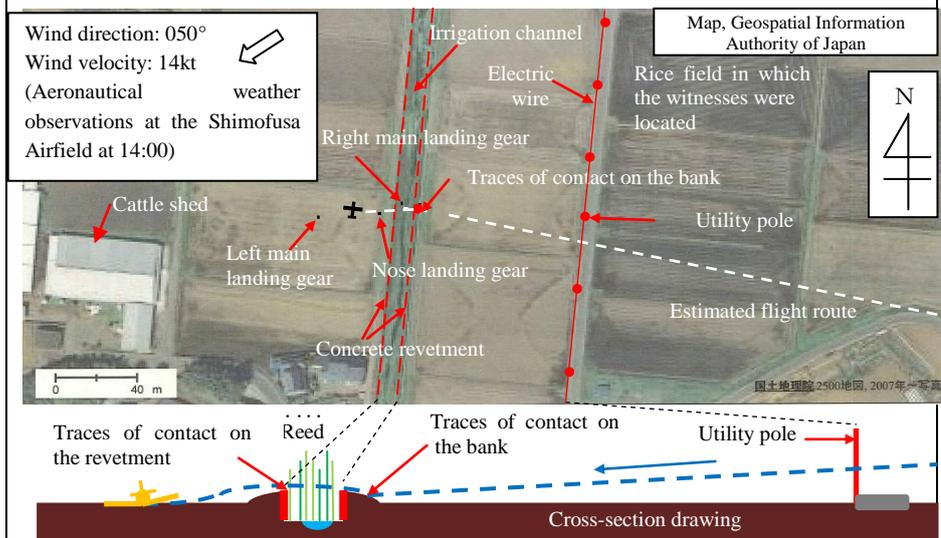
The aircraft made an emergency landing in a harvested rice field in Osaki, Yachiyo City, Chiba Prefecture at around 14:25 after following the estimated flight route illustrated in the figure below. During the emergency landing, one of wheels was seen to break off and hit to the vertical stabilizer on the tail of the aircraft.

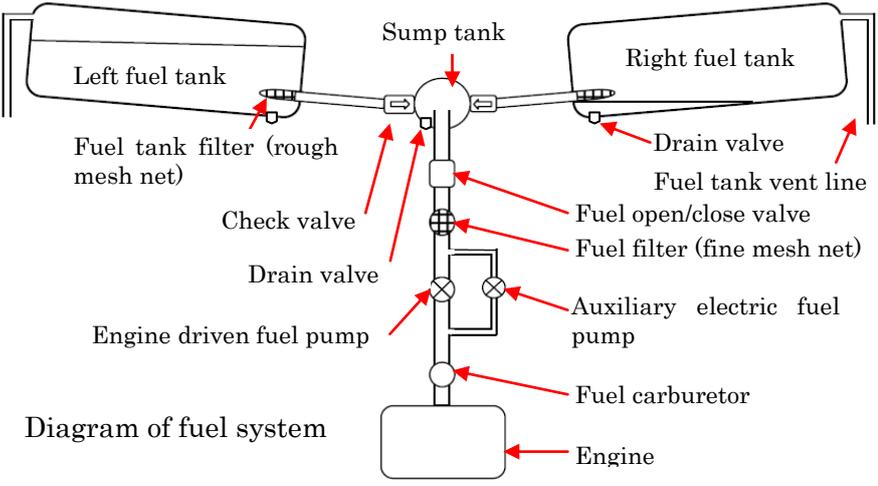
<p>The diagram illustrates the fuel system architecture. It features two fuel tanks: a 'Left fuel tank' and a 'Right fuel tank'. Fuel from both tanks flows into a central 'Sump tank'. From the left tank, the flow passes through a 'Fuel tank filter (rough mesh net)' and a 'Check valve'. From the right tank, it passes through a 'Drain valve' and a 'Fuel tank vent line'. The fuel then enters the 'Sump tank' and proceeds to a 'Fuel open/close valve', followed by a 'Fuel filter (fine mesh net)'. The system includes two pumps: an 'Engine driven fuel pump' and an 'Auxiliary electric fuel pump'. The fuel then passes through a 'Drain valve' and a 'Fuel carburetor' before reaching the 'Engine'.</p> <p>Diagram of fuel system</p> <ul style="list-style-type: none"> - Aircraft fuel is drawn from the right and left fuel tanks to the sump tank via the respective fuel tank filters (rough mesh nets) and check valves, and is then supplied to the engine via the fuel open-close valve, the fuel filter (fine mesh net), fuel pump, and fuel

<p>carburetor. There was no trace of fuel leakage in this system.</p> <ul style="list-style-type: none"> - The capacity of the each fuel tank is about 98 ℓ (26 gal), respectively. - The capacity of the sump tank is about two ℓ (0.54 gal). - The amount of fuel remaining in the right fuel tank was 0.146 ℓ (0.0386 gal). - The amount of fuel remaining in the left fuel tank and sump tank were about 75 ℓ (20 gal) in total. - No fuel remained in the fuel carburetor. - There was no clogging in any of the fuel tank filters, fuel filters, or fuel tank vent lines. - Each of four engine cylinders has two ignition plugs, at its top and bottom. The ignition plug at the bottom of the second cylinder was wet with oil, but the other seven plugs only showed traces of normal combustion. - Maintenance for the aircraft was as follows: maintenance was entrusted to specific mechanics only at scheduled maintenance times and upon inspection for renewal of the airworthiness certificate. Daily maintenance did not include the engagement of specific mechanics or maintenance companies, and no mechanics familiar with the condition of the aircraft were available. - The aircraft had a tendency to consume fuel from the right and left fuel tanks asymmetrically. - The check valves to the right and left of the sump tank were not mounted with the hinge positions up in accordance with the manual, and had moved down from the hinges under their own weight, but were not fixed in position. In addition, there were post-mounting slippage marks on the check valves different from the marks from the time of manufacture. - Although foreign substances were not discovered when extracting the remaining fuel from the sump tank via the drain valve, a large amount of mud and foreign substances, such as dust, were extracted from the interior of the sump tank when it was cleaned after removal from the airframe. <div style="text-align: right; margin-top: 10px;">

sump tank had been interrupted because the right fuel tank was almost empty whereas the left fuel tank remained at the pre-flight level. A fuel tank filter and a drain valve are mounted on each pipe between each fuel tank and the sump tank. Since foreign substances which could cause obstructions were not discovered in the left fuel filter or the left pipe, it is probable that the left check valve stuck in the closed position, interrupting the fuel flow. It is probable that the left check valve became stuck in the closed position since the first flight of the day of the accident, because the amount of fuel in the left fuel tank did not change during the first flight. It is possible that the left check valve became stuck in the closed position both because it failed to satisfy the pressure drop standards due to age-related degradation of the left check valve and because of the presence of foreign substances, but this could not be determined.

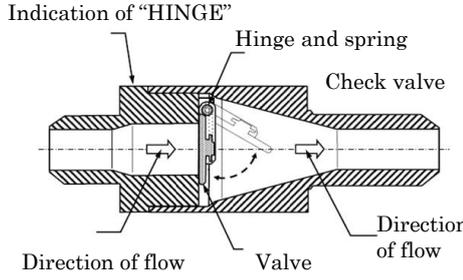
<p>Discovered foreign substances</p> </div>

level gauges should not exceed 1/2 of a tank in any flight.
<p>2.11 Inspection of Check Valve</p>	<p>The designer and manufacturer of the aircraft conducted the following functional inspections of the check valve.</p> <p>(1) Pressure drop inspection</p> <p>During the pressure drop inspection, which injects a certain volume of fuel into the inside of a check valve, the left check valve had a larger pressure drop and opened less than the right check valve.</p> <p>Moreover, the left check valve did not satisfy operating standards established for the time of shipment during the pressure drop inspection.</p> <p>(2) Functional inspection of the closing mechanism</p> <p>In the functional inspection of the closing of the valve due to the difference in static pressure in front of and behind the check valve, the closing force of the left check valve was weaker than that of the right check valve. The left check valve, in particular, could not fully close because of the incorrect angle at which it had been mounted at the time of the accident, resulting in no pressure difference.</p> <p>(3) Effects of the mounting angles</p> <p>The check valves were not mounted with the hinge positions up in accordance with the manual. The “HINGE” indications were at angles of 93.6° and 104.0° on the center axis of the pipe for the left and right valves, respectively. As a result of the above inspections conducted at each angle, it was discovered that valves were difficult to open and close. However, the valves did not become stuck during the functional inspections.</p>
