**AIRCRAFT SERIOUS INCIDENT  
INVESTIGATION REPORT**

1. NOEVIR AVIATION CO., LTD.  
EUROCOPTER AS 350 B3, JA35BB

2. JAPAN AIR COMMUTER CO., LTD.  
BOMBARDIER DHC-8-402, JA849C

A TAKE-OFF FROM THE ENGAGED RUNWAY BY THE OTHER  
AIRCRAFT  
ON RUNWAY OF YAKUSHIMA AIRPORT  
AT 11:18 JST, OCTOBER 31, 2012

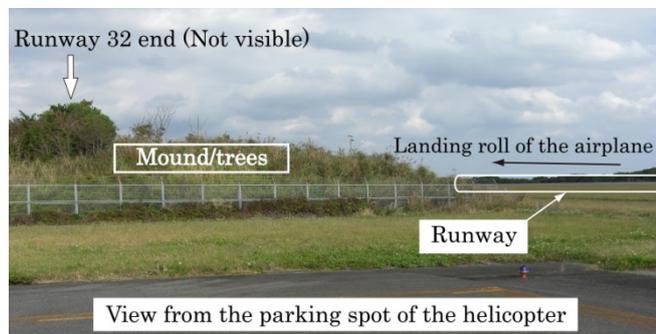
There are small mounds to the south and north of the apron, and low trees grow on them. They make it impossible to see the Runway 32 end, where the airplane made a 180° turn.

The JTSB checked the view from the point about 5 m above the apron, simulating the helicopter's hovering; however, the Runway 32 end was not visible.

The Runway 32 end is visible from the runway holding position marking on the taxiway.

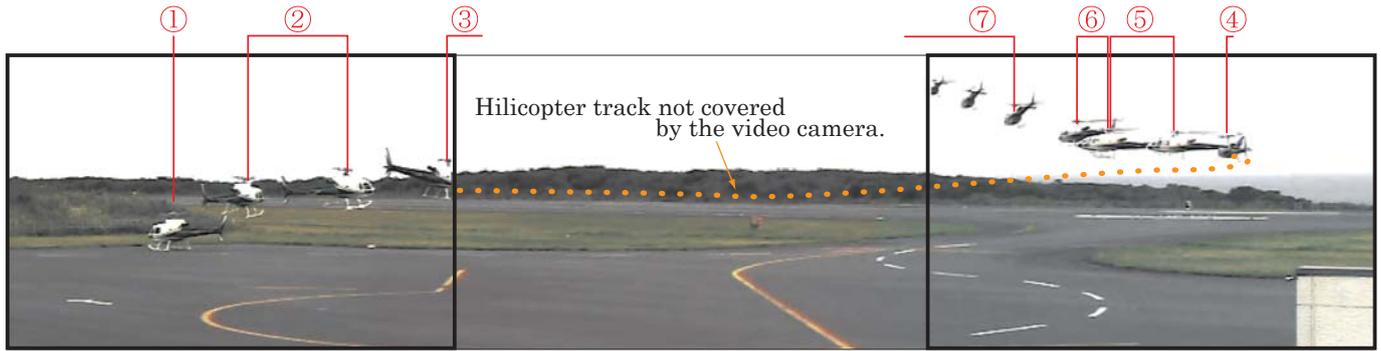
# Attachment: Video Imagery Analysis/Records of Communications

Initial field of view of the video camera

Video field of view at the time of the serious incident
