**AIRCRAFT SERIOUS INCIDENT
INVESTIGATION REPORT**

CONTINUED LOSS OF POWER OF ENGINE

HK36R SUPER DIMONA (TWO-SEAT MOTOR GLIDER)

JA36HK

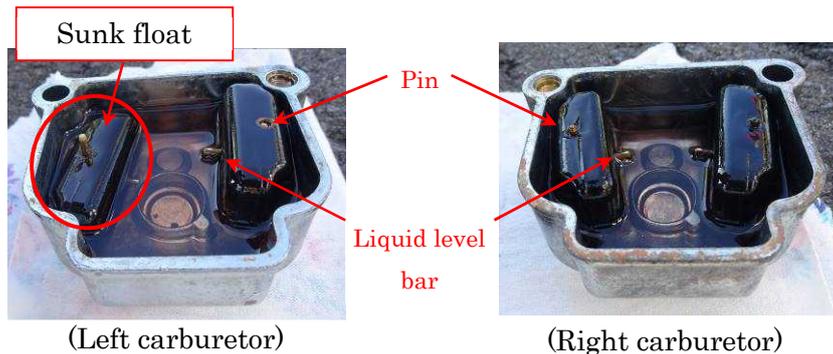
Figure 5 Floats in carburetors of incident aircraft

During the inspection the engine after landing, it revealed that one of the floats in the left carburetor sank in the fuel. (see Figure 5)

(Left carburetor)

(Right carburetor)

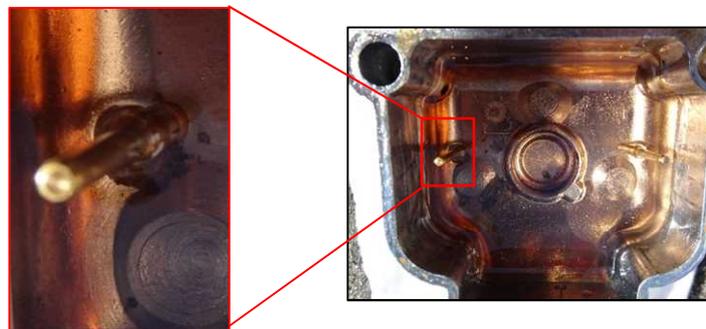
Figure 6 Float chamber of left carburetor

The pin of the abnormal float sunk in the fuel was not bent or adhered by foreign substance. (see Figure 6)

Close-up photo of left pin

Inside of float chamber

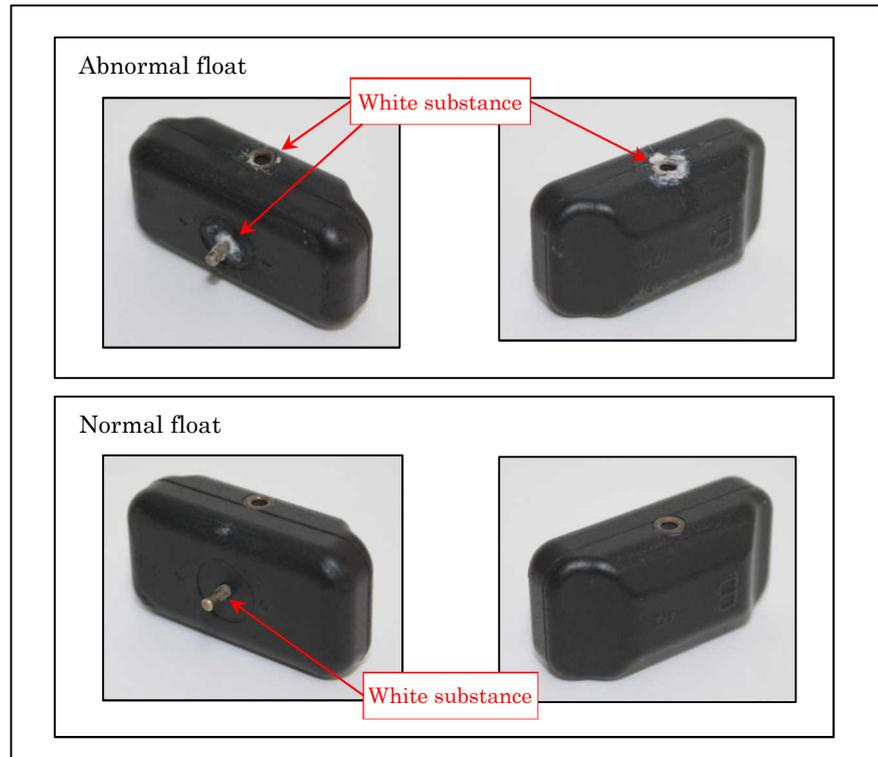
Figure 7 Float comparison

• Abnormal float

A white substance was adhered to both ends of the insert to which the pin of the float chamber was passed through and a bar that indicated the liquid level (hereinafter referred to as “the Liquid level bar”). Particularly, a large amount of the white substance was adhered to the lower hole of the insert and the Liquid level bar.

• Normal float

A very little amount of the white substance was adhered to the Liquid level bar although it was not observed on both ends of the insert as was observed in the abnormal float.

The JTSA concludes that the white substance adhered to the abnormal float is probable to have been the adhesive that was used in an attempt to solve imbalance of float sinking. When a malfunction such as abnormal imbalance of float sinking is detected during carburetor inspection, the repair method of which is not stipulated in maintenance manual, it is important for ensuring the safety of flight to replace with serviceable parts in good quality or inquire manufacturers and follow their instructions for repair work not using repair methods based on own judgement.

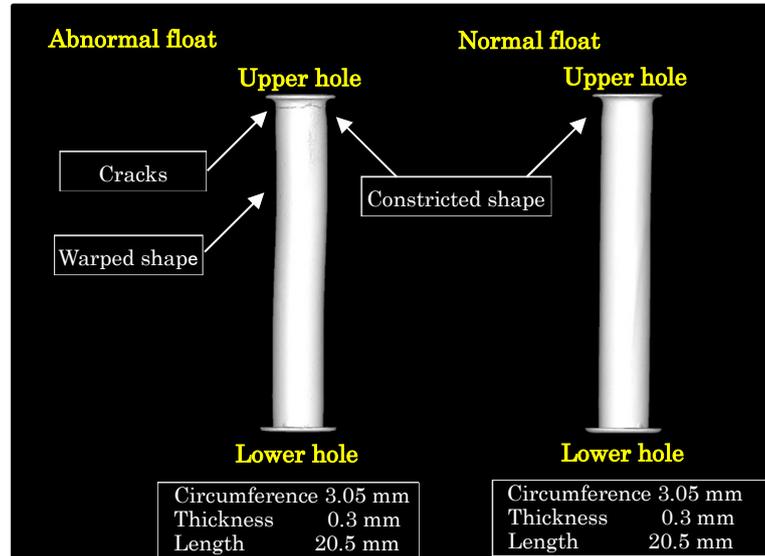
Figure 8 Insert shape (X-ray CT image)

The insert in the float was an integrated type with wall thickness of approximately 0.3 mm. The insert in the abnormal float was warped

in S-shape. Computation by CT image showed that the width of the warp was 0.2 mm. Besides, the end of the upper hole of the insert in the abnormal float had a remarkable change in its shape with cracks generating along the whole circumference of the end of the upper hole.

The insert in the Normal float was straight with no cracks generating. There were some changes in the shape near the lower hole.

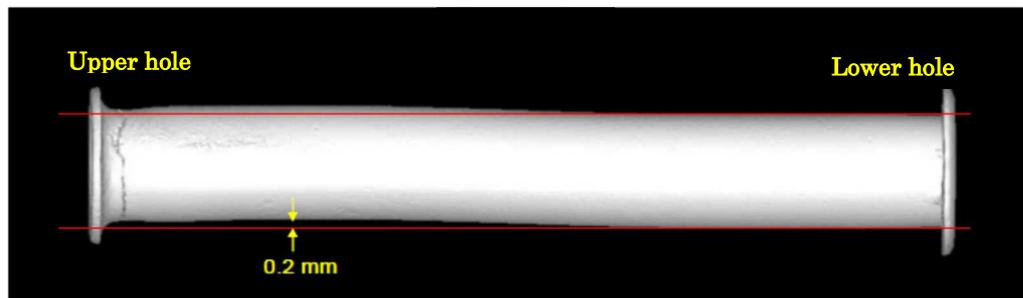
Figure 9 Warped insert in abnormal float

Although deformation in the insert of the abnormal float is probable to have been caused by some external force added such as inappropriate handling in the manufacturing processes or maintenance work, etc., it could not be determined.

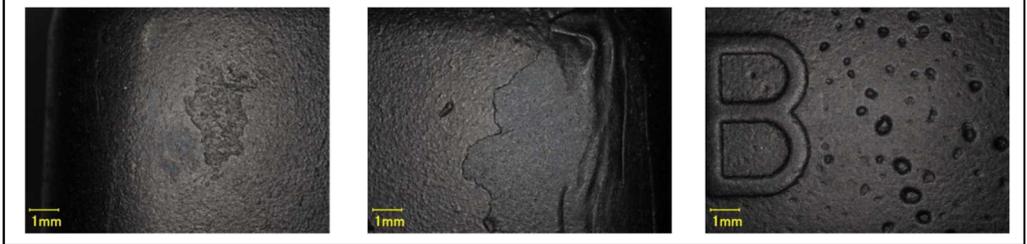
Figure 10 Uneven surfaces of foamed portion (representative portions)

Observation by magnifying the foamed portion revealed that both floats partially had unevenness. A transparent or white substance was observed to be adhered to the periphery of the upper hole of the abnormal float, part of which linearly stretched to the lower hole tracing along the surface of the foamed portion. Besides, the transparent substance was linearly stretched on the lower hole and the Liquid level bar.

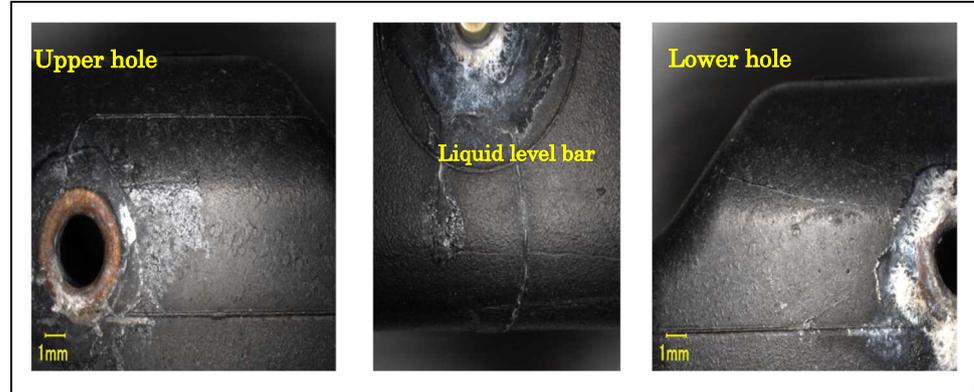
Figure 11 Adhered condition of transparent or white substance (abnormal float)

A transparent or white substance was observed in the periphery of the upper hole of the abnormal float and a white substance was observed to be adhered to the periphery of the lower hole and the Liquid level bar. Difference in color tone between both substances is presumed to be attributable to different shapes of adhering and different amounts of air contained; both substances are considered to be the same. Besides, these substances were not adhered to the inner wall of the insert.

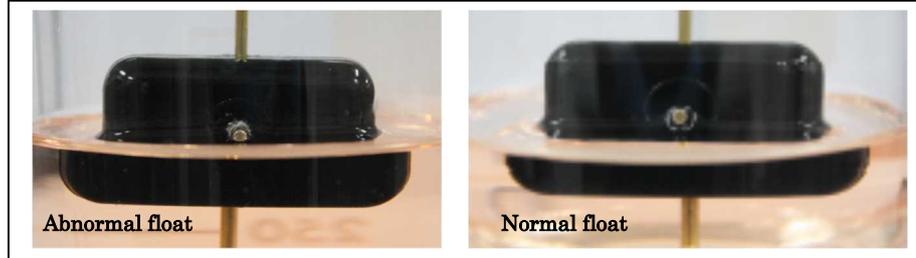
Figure 12 Float with pin passing through (no change for several hours)

An experiment to float the abnormal float and the Normal float on the fuel was conducted. From the information of a manufacturer that the pin in the float chamber had a diameter of 2.00 ± 0.04 mm, a pin with a diameter of 2 mm was alternatively used. As a result of the experiment, both the abnormal float and the Normal float floated on the fuel.

The reproduction experiment was conducted in horizontally stationary condition.

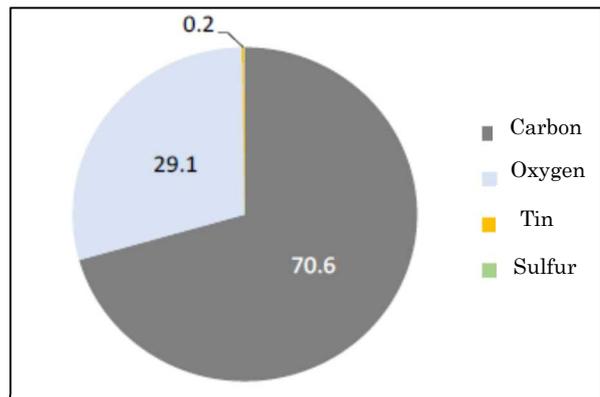
Figure 13 Elemental composition of white substance

To identify the ingredients of the white substance adhered to the periphery of the hole of the abnormal float, analysis by the methods of Elemental analysis, Fourier-transform infrared spectroscopy (FTIR) and Pyrolysis-gas chromatography-mass spectrometry (GCMS) was conducted. The white substance was adhered to the upper and lower holes and the Liquid level bar, and the one adhered to the periphery of the lower hole was used as a representative specimen. As a result, the principal ingredients of the white substance were identified as carbon and oxygen and ingredients used in an adhesive, etc. were also detected.

According to the engine manufacturer, an adhesive was not used in manufacturing processes and maintenance procedures using an adhesive were not set forth.

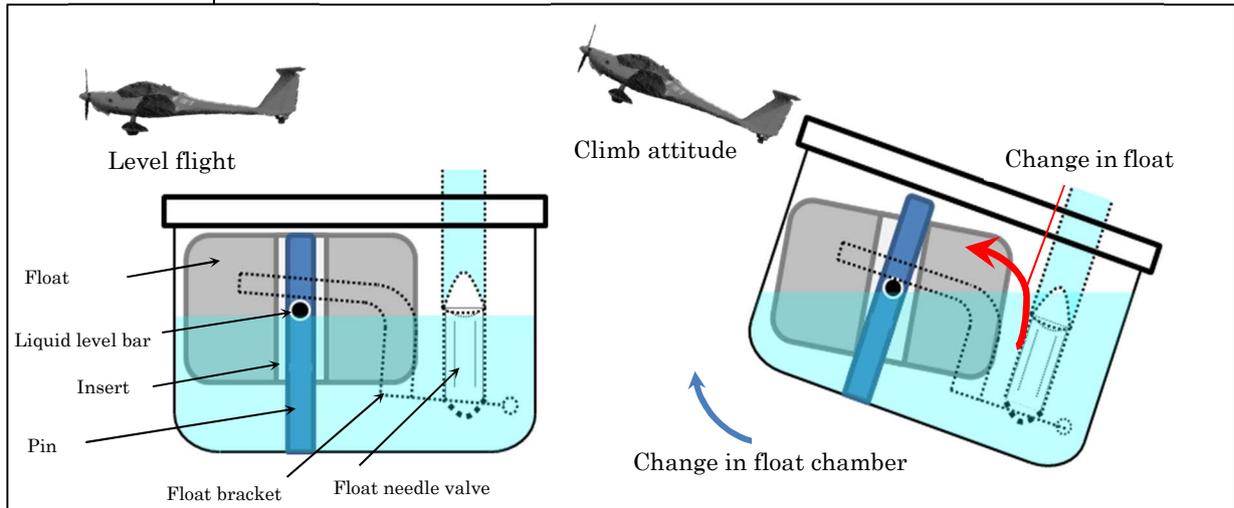
Figure 14 Motion of float chamber and float

3.1 Involvement of Weather	None
3.2 Involvement of Pilots	None
3.3 Involvement of Aircraft	Yes
3.4 Analysis of Findings	<p>(1) Factors of the engine malfunction</p> <p>Neither fuel system nor ignition system is probable to have been the factor of the engine malfunction from the findings that the test run conducted after replacing the floats of the left carburetor with new ones did not reproduce the engine malfunction, the ingredient analysis of the fuel showed no anomaly, and there did not occur such a remarkable anomaly in the electrode as faulty ignition when the spark plug was verified.</p> <p>(2) Faulty motion of the float</p> <p>The JTSA concludes that after the floats had been soaked (wholly soaked) in the fuel, mass of the abnormal float was heavier by approximately 0.26 g than the Normal float. However, the larger mass of the abnormal float is probable not to have been the factor of the faulty motion of the float (abnormal floating) that caused the engine malfunction because it was verified through the abnormal floating reproduction experiment of the floats that the abnormal float also floated on the fuel.</p> <p>In the abnormal float, it was verified that there occurred deformation and cracking in the insert and the inner diameter of the lower hole became narrow due to the white substance. Whereas the float chambers fixed to the engine incline in response to the pitch change of the aircraft attitude during takeoff climb or in some other occasions, the floats act to maintain the horizontality so does the fuel level that causes the floats to incline against the float chambers. (see Figure 14) It is probable, at this point, that a gap between the insert and the pin of the float chamber was narrowed by deformation or cracking, etc. in the insert of the float and thereby smooth vertical motion of</p>

the float was impeded.
