AA2007-4

AIRCRAFT ACCIDENT INVESTIGATION REPORT

PRIVATERY OPERATED
PIPER PA-28R-200, JA3743
FUKUSHIMA CITY, FUKUSHIMA PREFECTURE, JAPAN
OCTOBER 19, 2006, AROUND 14:32 JST

MAY 25, 2007

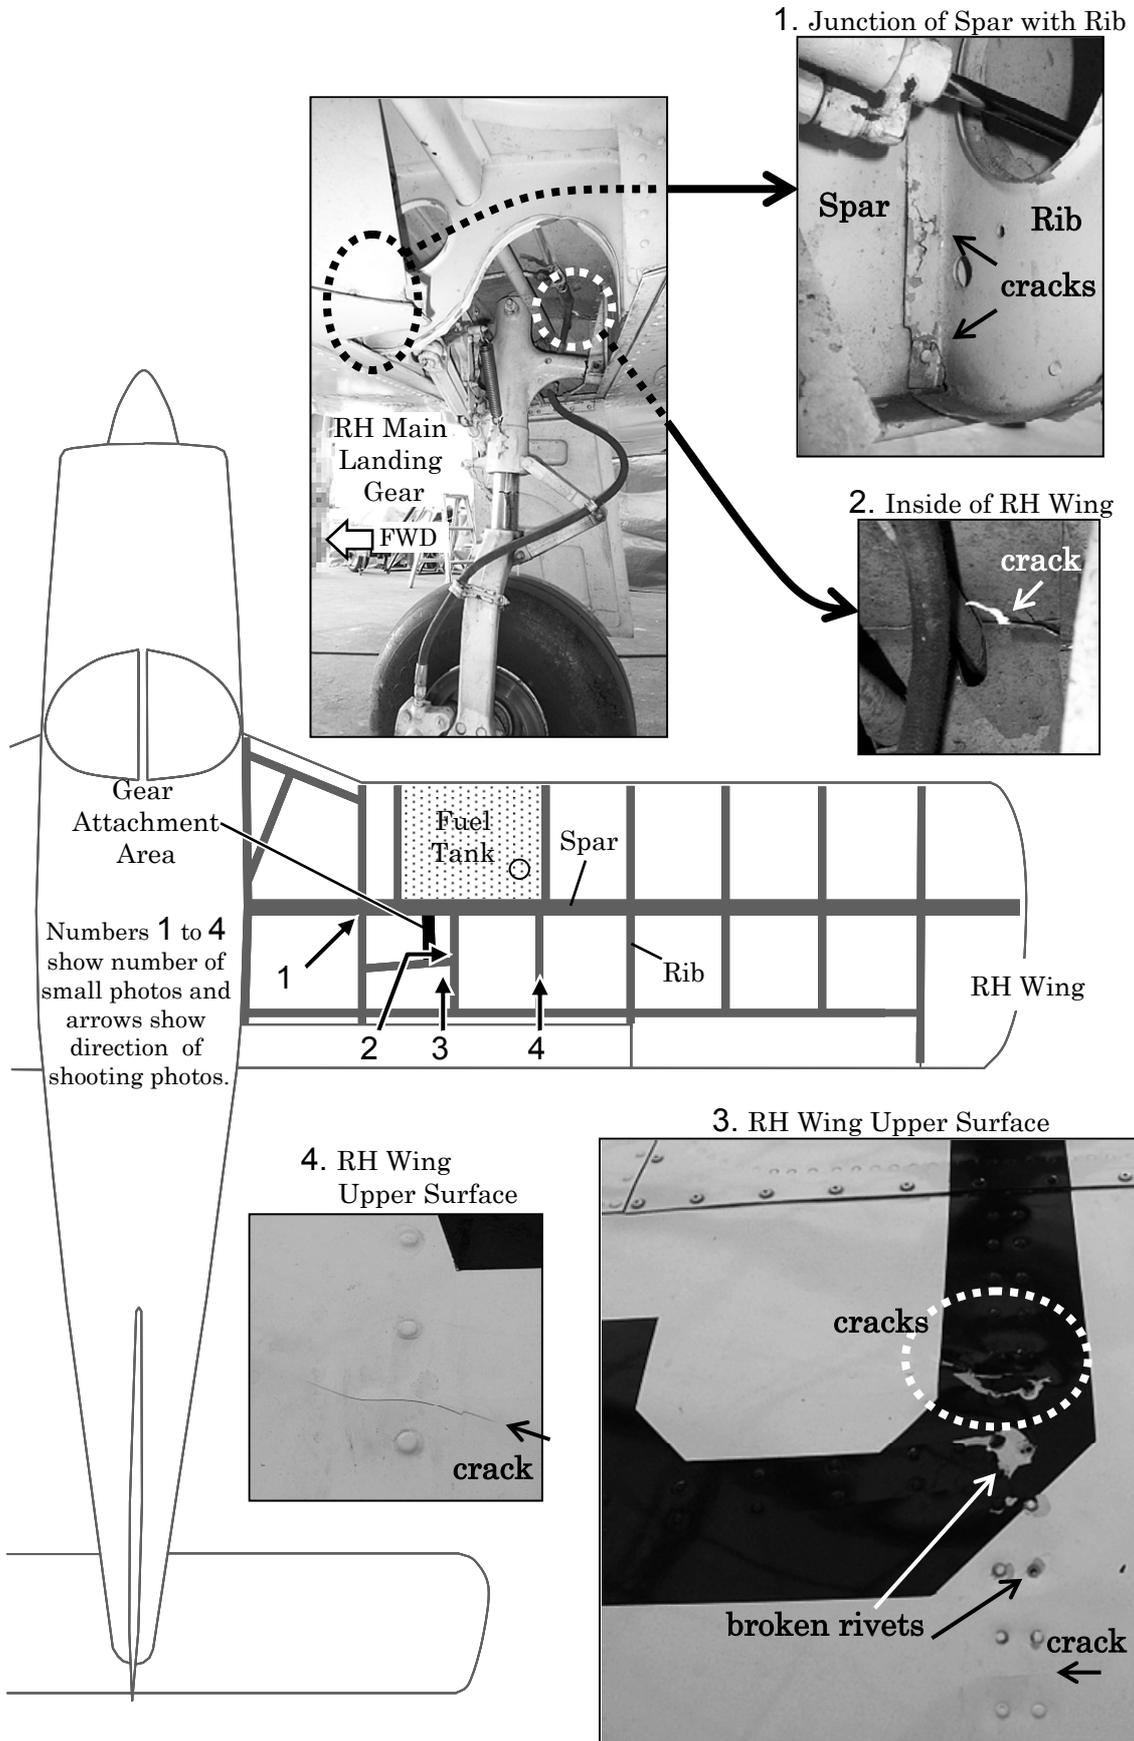
Photograph: Condition of Damages

RH wing Portions of the main structural members around the area where the RH main landing gear was fitted, sustained damage. The upper surface of the RH wing cracked and wrinkled.

All of the damages described in 2.5.2 are estimated to have been caused by the impact of the hard landing.

When the aircraft approached and landed on the runway 14 of FSP with a slightly steeper angle than normal, it is considered that the aircraft made a hard landing from slightly higher point, because the PIC would have made flare slightly too early and subsequently made speed control inappropriately. It is also considered that the aircraft was slightly banked to the right immediately before touchdown, which would have caused the RH main landing gear to touch the ground first and this in turn would have caused the RH gear fitting area of the wing to receive substantial impact load that would have caused damage to part of the structural members of the RH wing.

As to the damage sustained by part of the RH wing's main structural members while the main landing gear was intact, it is considered possible that deterioration due to aging contributed to the damage as the aircraft was manufactured over 31 years ago.
