AA2017-2

**AIRCRAFT ACCIDENT
INVESTIGATION REPORT**

**PRIVATELY OWNED
J A 3 7 8 8**

CRASH DURING GO-AROUND A PRIVATELY OWNED MOONEY M20C, JA3788 YAO AIRPORT, OSAKA PREFECTURE, JAPAN AT ABOUT 16:18 JST, MARCH 26, 2016

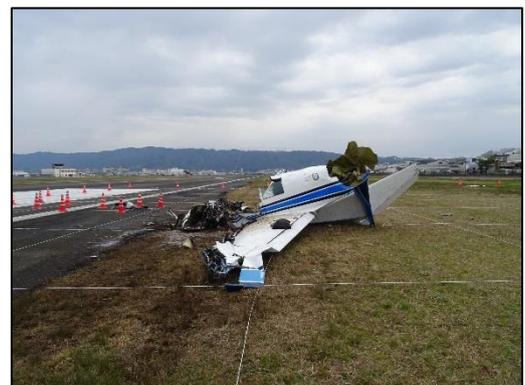
- Fuselage: Broken, partial burned
- Wings: Collapsed
- Engine: Detached from the fuselage
- Propeller: Detached from the engine, the shaft fractured, bent all of two blades
- Landing gear: Damaged the nose landing gear and the down lock mechanism of the left landing gear

Photo 1 - the aircraft

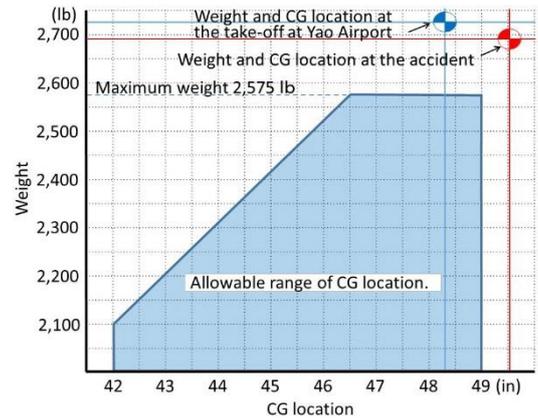
When the accident occurred, the weight and center of gravity (CG) location of the aircraft were estimated as shown in Figure 3: the weight was 2,691 lb which exceeded the maximum weight (2,575 lb) by 116 lb. The CG location was 49.53 in aft of the reference point (the centerline of the nose landing gear support bolt) and 0.53 in aft for the aft limit (49.00 in) corresponding to the maximum weight.

Besides, when the aircraft took off at Yao Airport, the weight was 2,726 lb exceeded the maximum weight by 151 lb. When the aircraft took off at Kobe Airport, the weight was 2,708 lb exceeded the maximum weight by 133 lb and the CG location was 0.52 in aft for the aft limit corresponding to the maximum weight. (See 2.10.1)

Figure 3 - weight and CG location

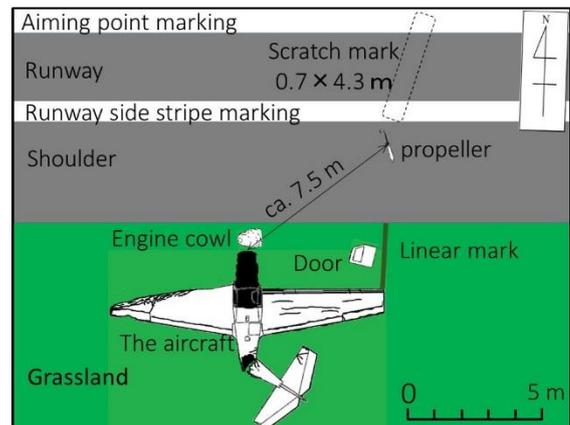
The accident site was around the south side runway shoulder at the intersection of Runway A and Taxiway A3 of Yao Airport. The aircraft was facing its nose to north, and its front tip was at about one meter south from the border of paved surface. The nose landing gear was hidden behind the engine which was detached from the fuselage, the bottom of the nose touched the grassland, the down lock mechanism of the left landing gear was damaged and bent, the right landing gear was deployed and the aircraft was tilted to left. A deformed engine cowl was detached and was at the front of the engine.

Figure 4 - accident site

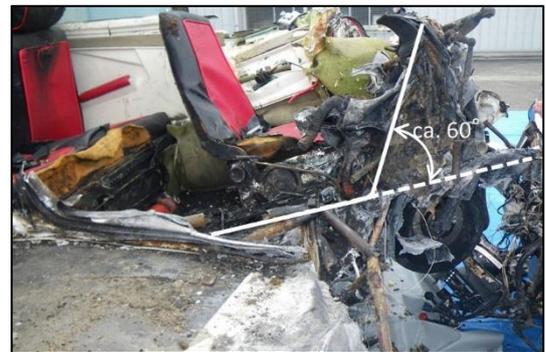
As for the fuselage, the external plate of about 70 cm to 170 cm in length to aft from the wing was broken, leaving the right side, the rear part was bent to the right, and the right side of the external plate was folded like bellows. The floor surface of the pilot seats was bent about 60 degree upward from the foot. The right side of the cabin and the fore part of the right wing base were damaged by the fire, especially the right pilot seat was severely burnt (See Photo 2).

Photo 2 - bent of the floor surface of the pilot seat

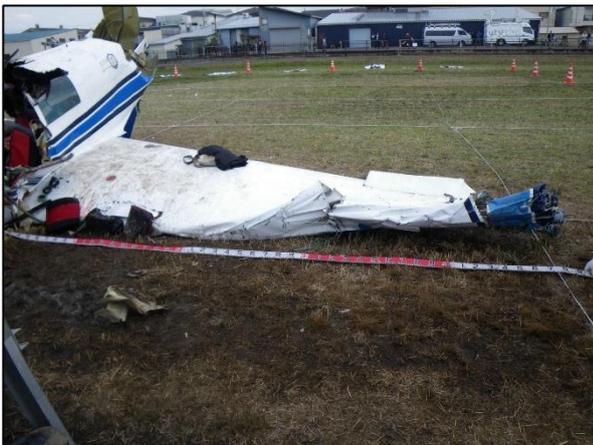
As for the left wing, the external plate from 180 cm outside of the base to the wing tip was ripped open to upward by impact from downside and folded like bellows, and the red navigation light was broken with the external plate of the wing tip. As for the right wing, the leading edge from the base to the wing tip was collapsed like bellows due to the impact from front, and the green navigation light was broken with the external plate of the wing tip. The soil got into the joint of the external plates into base from the wing tip direction (See Photos 3 and 4).

Photo 3 - left wing

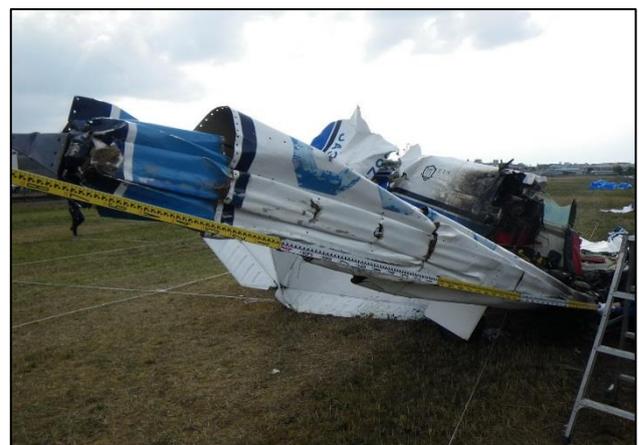
Photo 4 - right wing

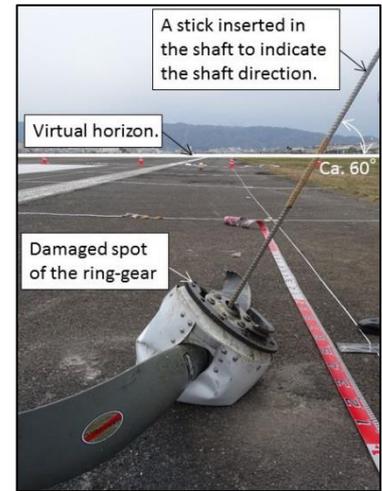
As for the propeller, the shaft was fractured and two blades were irregularly bent backward. Placing on the ground at the flattened surface of the spinner which was crashed onto ground and deformed; moreover, the angle between the shaft and the ground was approximately 60°. The alternator attached at front in lower-right of the engine had damaged the ring-gear. Based on the positional relation between the position of the damage and the alternator, the attitude of the aircraft at the time of the crash onto ground was approximately -120° in pitch angle and 30° in roll angle

Photo 5 - propeller

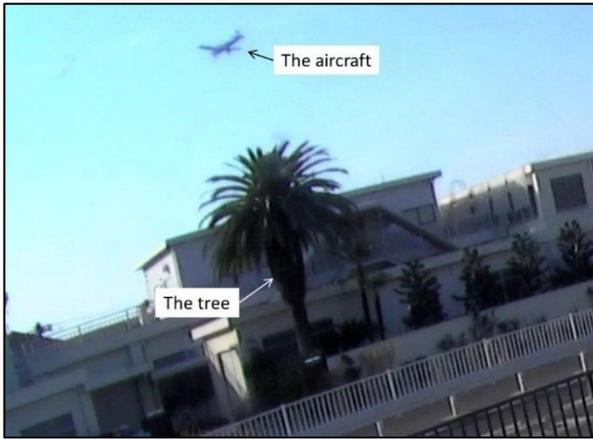
From images (Photos 6 and 7) of the aircraft at just before the accident and around 12:00 of the day shot by camera A from south side at its final approach on Runway 27 of Yao Airport, presuming that it was approaching toward the aiming point marking on the final approach course, the approach angle were about 5.3° and about 3.6°, respectively.

Photo 6 – the aircraft in the approach (at just before the accident)

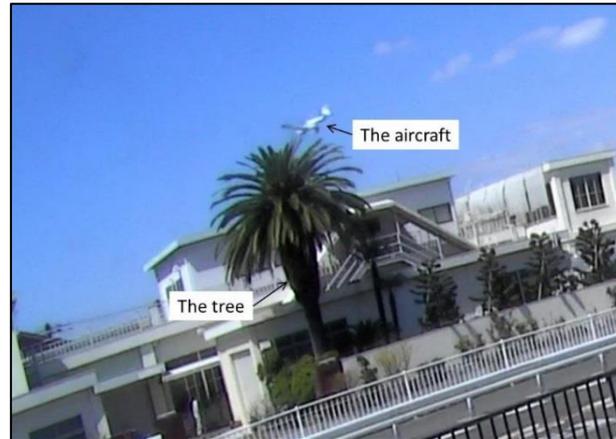
Photo 7 – the aircraft in the approach (around 12:00)

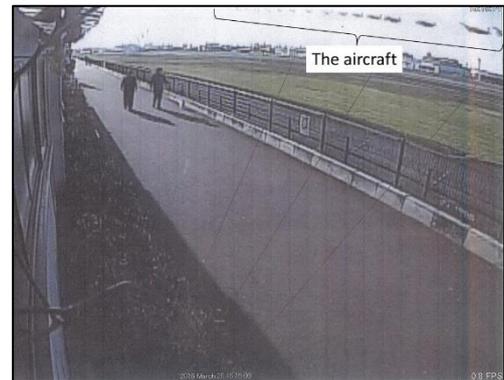
Based on the image (Photo 8) of the aircraft just after the execution of a go-around taken by the camera B from south side of Runway A, assuming that it was flying over the centerline of the runway, the estimated groundspeed just after its execution of a go-around derived from its flight distance and the time was about 58 kt.

Photo 8 - the aircraft just after the execution of go-around (sequence photographs)

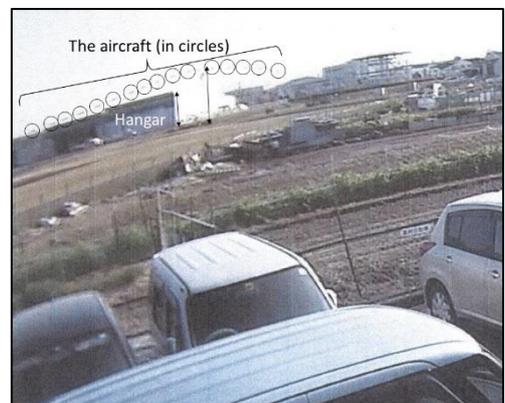
Based on the image (Photo 9) of the aircraft just before the crash taken by the camera C from the north side, its estimated the highest altitude prior to the crash was about 38 m.

Photo 9 - the Aircraft just before the crash (sequence photographs)

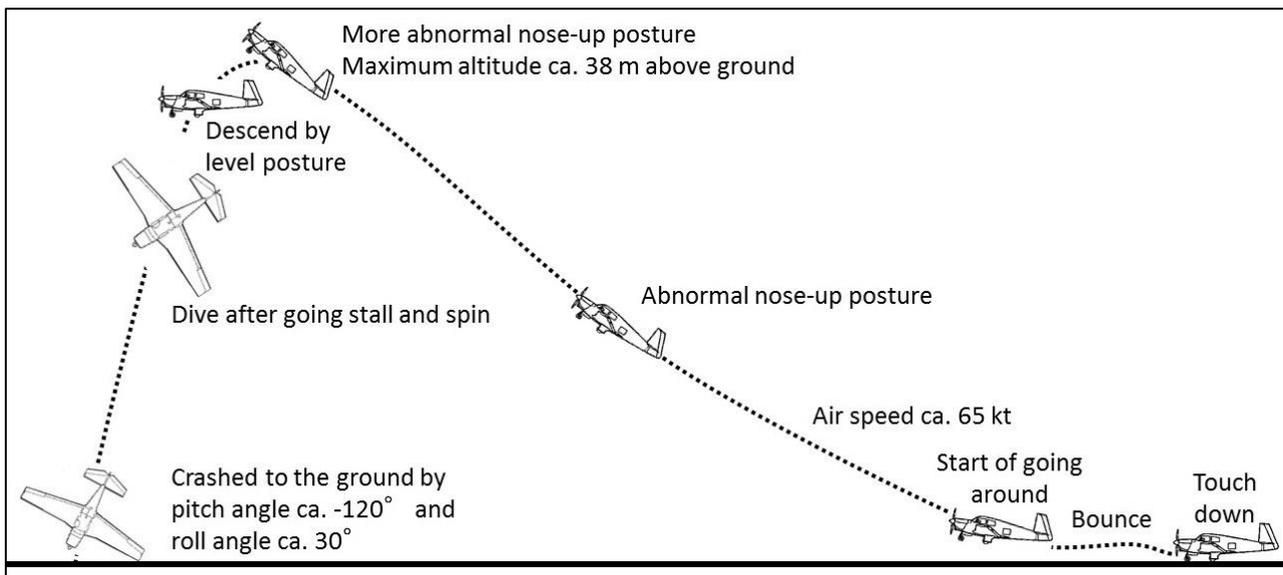
Based on the description in 2.7.1 and 2.7.2, it is highly probable that the situation when the aircraft crashed on the ground was as it was rolling to left (rotating around the longitudinal axis), the left wing tip hit the runway at first, and then, the spinner crashed onto the shoulder with an posture of approximately -120° in pitch angle (motion around left and right axes) and approximately 30° in roll angle, and the propeller shaft was fractured; accordingly, the engine part was pushed up from the bottom and the whole leading edge of the right wing was crashed onto the grassland. As described in 2.1.3 (2), since two impact sounds were generated, it is highly probable that the aircraft was bounced in reaction after the crash on the ground above mentioned, the whole airframe crashed onto the grassland again and resulted in the condition of the airframe described in 2.7.1. (See Figure 5)

Figure 5 – situation of the crash (conceptual figure)
