**AIRCRAFT SERIOUS INCIDENT
INVESTIGATION REPORT**

**PRIVATELY OWNED
J A 3 9 1 9**

RUNWAY OVERRUN
PRIVately OWNED PIPER PA-28-161, JA3919
RYUGASAKI AIRFIELD
RYUGASAKI CITY, IBARAKI PREFECTURE, JAPAN
AT 11:50 LOCAL TIME, JUNE 30, 2013

April 11, 2014

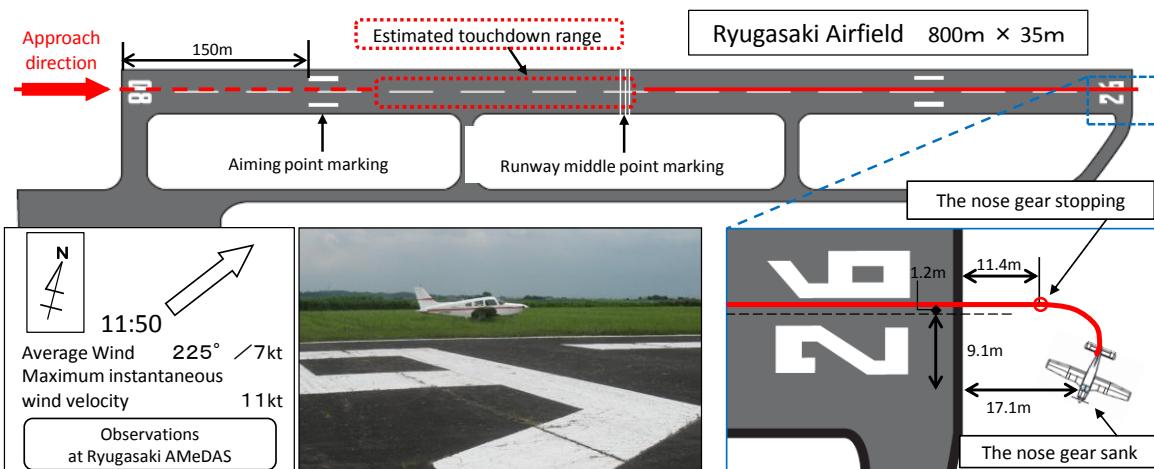
After touching down, the captain always applied the brake gradually in consideration of stopping the airplane as calmly as possible, without strongly applying the brakes from the beginning. At this time, he applied the brakes gradually as usual, but felt like the brake was working poorly and like the airplane was being pushed from behind. The captain applied the brakes as strongly as possible without locking the gears, but he was not able to stop the airplane within the runway, and released the brakes after entering the grass. The airplane stopped in a grass overrun area about 11m out of the runway.
