AIRCRAFT ACCIDENT INVESTIGATION REPORT

Kyoritsu Air Co., Ltd.

J A 3 9 5 9

NOSE GEAR DAMAGE DURING LANDING
KYORITSU AIR CO., LTD.
CESSNA TU206G, JA3959
CHOFU AIRFIELD
AT 10:08 LOCAL TIME, OCTOBER 3, 2011

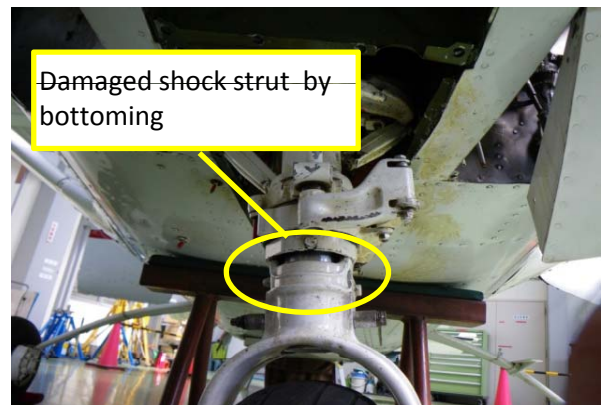
Photo 3: Nose Gear Shock Strut

The nose gear shock strut was damaged and its support fittings were partly broken.

As described above, it is highly probable that the airplane with nose-down attitude touched down from the nose gear with excessive rate of descent resulting in damage to the nose gear and its attachment structure to the fuselage.
