**AIRCRAFT ACCIDENT
INVESTIGATION REPORT**

**NEW CENTRAL AIRSERVICE CO., LTD.
J A 3 9 6 2**

April 23, 2020

Company Name	New Central Airservice Co., Ltd.
Type, Registration Mark	Cessna 172P JA3962
Accident Class	Aircraft Damage caused by Bird Strike
Date and Time of the Occurrence	December 18, 2019 at around 13:48 JST (JST: UTC+9 hours; unless otherwise stated, all times are indicated in JST in this report on a 24-hour clock)
Site of the Accident	Ryugasaki Airfield in Ryugasaki City, Ibaraki Prefecture (35° 54' 22" N, 140° 14' 29" E)

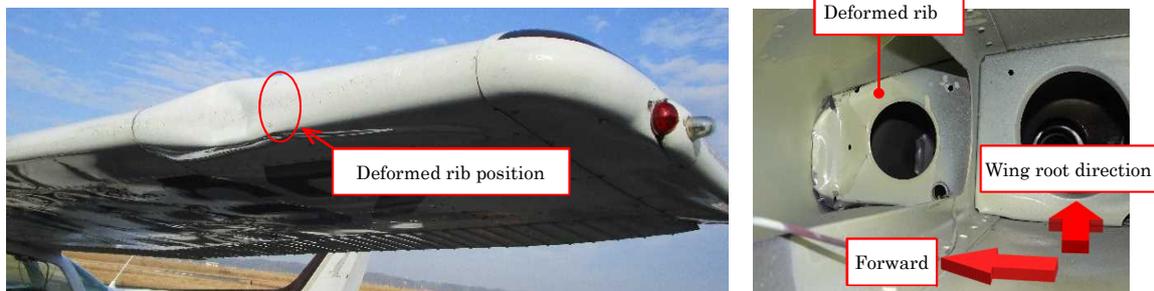
Extent of the damage: Substantial damage (equivalent to major repair)

- Deformed outer skin of the left wing leading edge (dent of about 14 cm longitudinal direction, about 50 cm width and about 4 cm depth)
- Deformed rib of the left wing leading edge (inside of the deformed outer skin)

Figure 1: Damaged position of the accident aircraft
(The right figure shows inside of the left wing taken from wing tip side)

It is certain that the Aircraft collided with the bird immediately after the take off during touch-and-go training and sustained damage to the structure.

In this accident, it is certain that the structure was damaged because the Aircraft collided with the bird immediately after the take off.
