**AIRCRAFT ACCIDENT  
INVESTIGATION REPORT**

## CRASH DUE TO STALL DURING CLIMB AFTER TAKE-OFF

CESSNA 172P, JA4005

AT ABOUT 12:42 JST, JULY 20, 2015

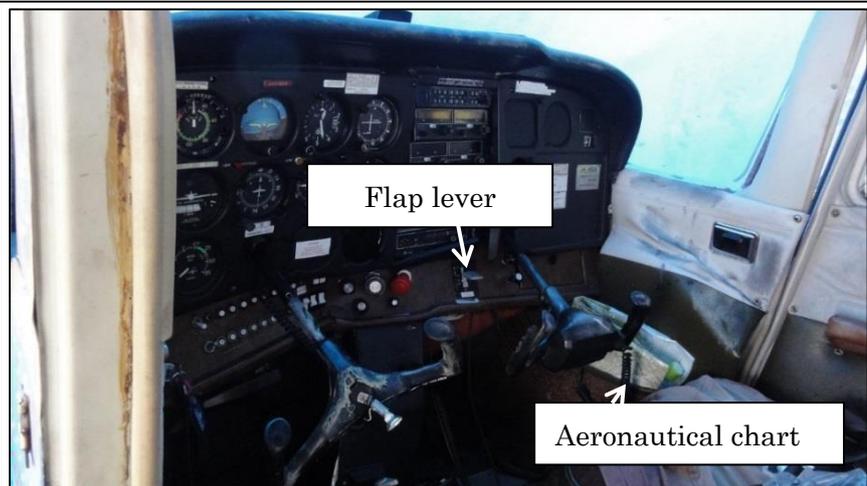
Although it was slightly difficult to watch the speed indicator while controlling in the right seat, the Pilot commenced take-off with the flaps at 10° and at maximum power, raised the nose-wheel at an airspeed of about 20-30 kt, and rolled along the Runway using the main gear only, then performed a rotation at an airspeed of about 55 kt and lifted off about 300 m before the Runway end. Although he noticed that the stall warning commenced to sound immediately after lift-off, he thought the warning sound had stopped during the climb, and then continued a climb suitable for clearing an obstacle. Thereafter, thinking that the Aircraft altitude was higher than the windbreak forest ahead of the Airfield, the Pilot fixed the engine power knob (which he had been holding with his left hand) to the maximum power position and held the control column with his left hand, then used his right hand to take out an aeronautical chart that had been placed in the right door pocket and intended to confirm the flight planned route. At that time, the edge of the chart hit the flap lever, and then the flaps went into full-up position. At the same time, the Pilot felt as if the Aircraft had suddenly stopped the climb and was in stall condition. Immediately after this, the attitude of the Aircraft became unstable, and then it crashed.

Situation of the right pilot seat

Passenger A had hardly any experience of flying an aircraft of this type, was not monitoring the flight instruments in the left pilot seat clearly during take-off. But he was mainly looking straight ahead; therefore, he knew little about the situation when the Aircraft stalled during the climb.

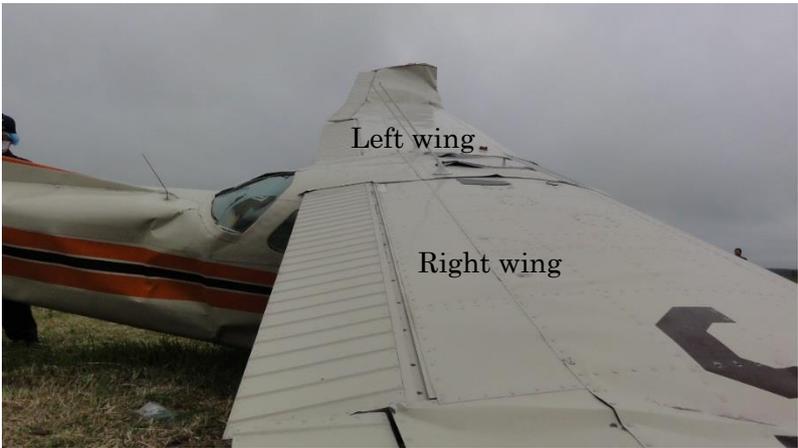
<p style="text-align: center;">Situation of flaps and others</p> <p>There was a windbreak forest with a ground height of about 15 m at a point about 400 m from the Runway 14 end in the take-off direction.</p>

Furthermore, it is also probable that the stall speed had increased to about 44 kt, because the aeronautical chart inattentively taken out by the Pilot at low altitude while climbing at low speed hit the flap lever, causing the flap position to change from 10° to full up.

It is probable that the flaps moved to full up at low altitude because the aeronautical chart taken out by the Pilot at low altitude hit the flap lever.

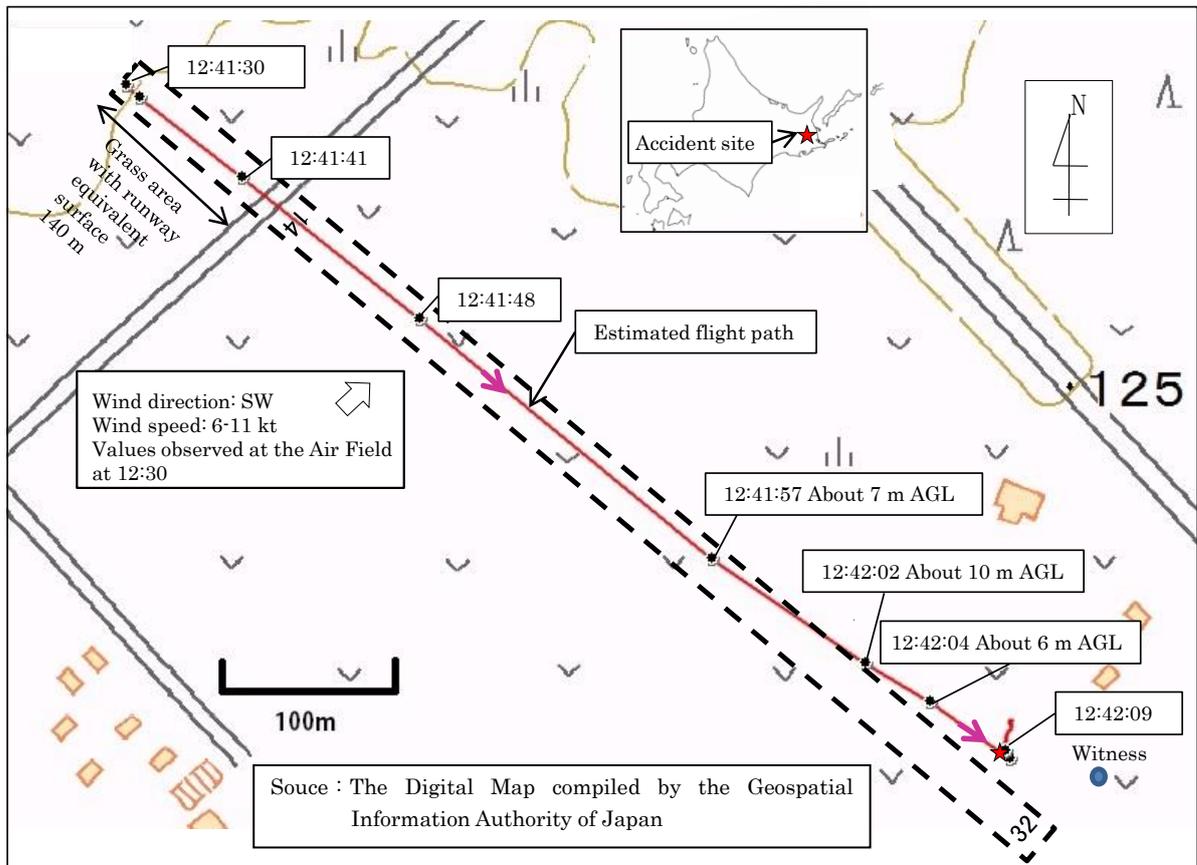
Figure: Estimated Flight Path

The witness who was the manager of the Airfield, was watching the take-off of the Aircraft from around 50 m of the left the Runway 14 end. After lifting off, the Aircraft's altitude began to fall slightly, but immediately thereafter, it became a large nose-up and changed to ascend. The Aircraft eventually approached the witness while veering to the left in an unstable condition as if it had stalled, and crashed in a meadow in a condition rolled to the left about 65 m ahead of him.

According to the GPS records, the Aircraft commenced its take-off roll at around 12:41:30, then, after climbing to about 10 m above ground level (AGL) at an estimated average ground speed of about 40 kt at around 12:42:02, it changed to a descent, and reached 0 m AGL at around 12:42:09.

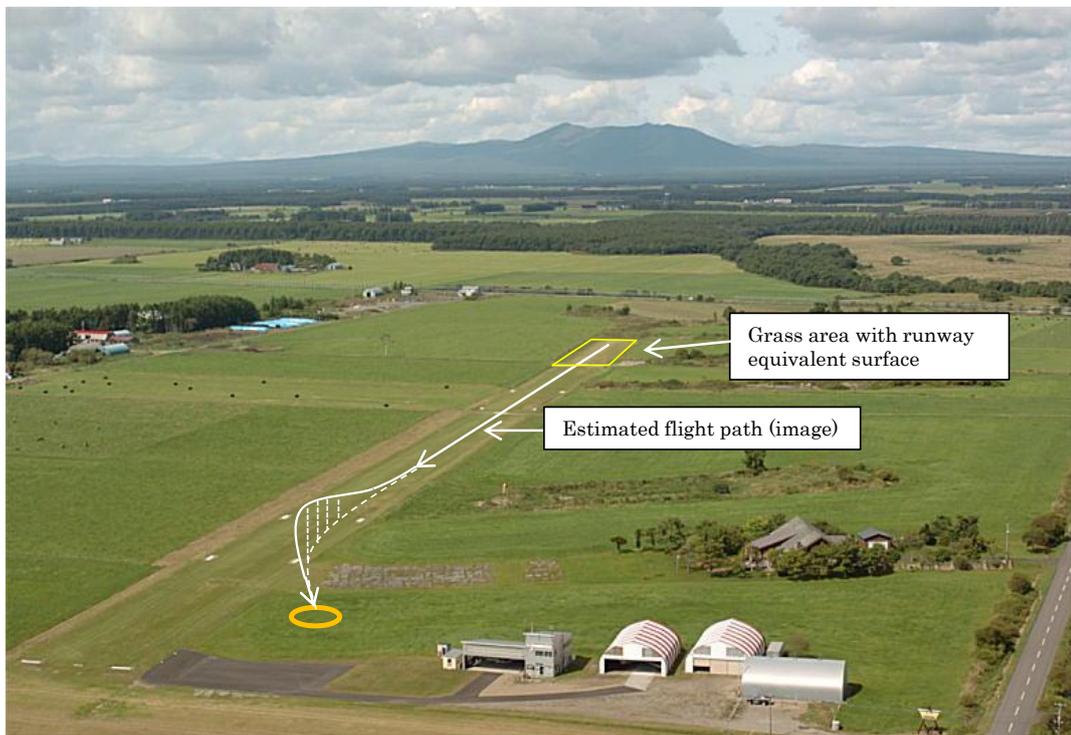
Photo: The Accident Site

Since it is probable that the Aircraft was flying at a low altitude of about 10 m when it stalled, it is highly probable that the Pilot was unable to recover from the stall and got into the difficult condition for controlling it, thus causing it to crash, whereupon the Pilot and passengers sustained injuries and the Aircraft was destroyed.

Moreover, it is also probable that the primer line of the engine was severed by the impact of the crash; accordingly, leaking fuel came into contact with the heated exhaust pipe, resulted in brake out of fire.
