**AIRCRAFT SERIOUS INCIDENT  
INVESTIGATION REPORT**

**PRIVATELY OWNED  
JA4010**

UNABLE TO MOVE ON RUNWAY  
DUE TO DAMAGES ON NOSE LANDING GEAR  
AT FUKUSHIMA AIRPORT, JAPAN  
AT AROUND 14:00 JST, JUNE 27, 2017

PRIVATELY OWNED  
PIPER PA-46-310P, JA4010

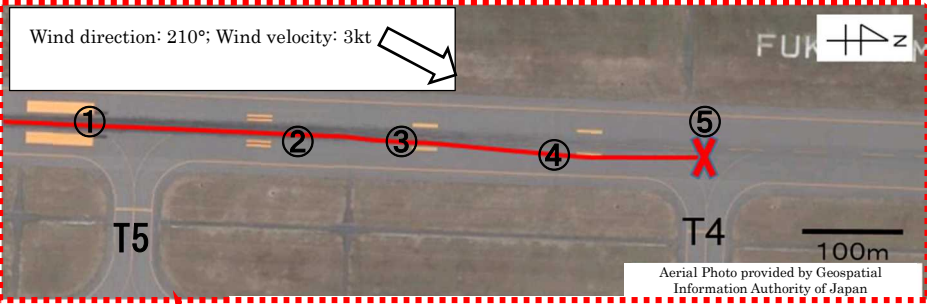
<p>Wind direction: 210°; Wind velocity: 3kt</p> <p>Photo 2: Estimated ground track on Runway by GPS Record (See Table 1)</p>

<table><tr> <th>No.</th> <th>Situation of Aircraft and Scratches on runway</th> <th>Distance from Runway Threshold (m)</th> </tr><tr> <td>①</td> <td>Touchdown point</td> <td>460</td> </tr><tr> <td>②</td> <td>Tire marks deflected to the right</td> <td>740-</td> </tr><tr> <td>③</td> <td>Scratches by propeller blades</td> <td>756-</td> </tr><tr> <td>④</td> <td>Paint marks by the nose landing gear door</td> <td>811-</td> </tr></table>

⑤	Stop position	1,088
---	---------------	-------

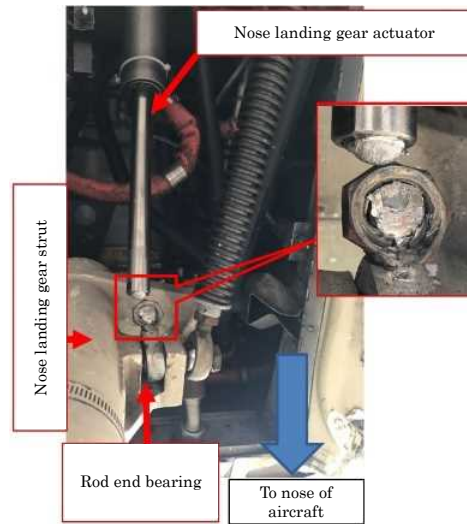
Photo 3 Damage on Nose landing gear

Both of two propeller blades of the aircraft were bent backward. The right door of the nose landing gear was opened outward wider than normal, and the scratch marks were found on the inner forward surface of the door. The scratch marks were found on the entire outer surface of the nose landing gear left door.

In addition, the scratch marks were found on the entire lower surface of the engine cowling in front of the nose landing gear well.

The rod end bearing at the tip of the actuator (nose landing gear actuator) to move the nose landing gear up and down was fractured. The landing gear was in its down position even though the piston rod was bent. The engine mount frame at around the nose landing gear actuator mounting section was cracked.

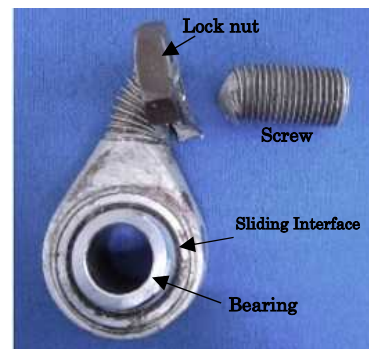
Photo 4 Rod End Bearing

The rod end bearing was bent and fractured at an angle of about 90-degree on its lock nut section. In addition, the sliding section did not move smoothly.

The Report of the National Research and Development Agency, National Institute for Materials Science, which requested the surface of the broken section, states that the breaking of the rod end bearing is not attributable to the metal fatigue, but to the ductile fracture caused by the bending load (Destruction with deformation due to excessive loading load). The process of the rod end bearing rupture is described as follows: The rod end bearing was buckled due to the compression load followed by the breaking of the bearing due to the excessive bending load. In addition, regarding that the movement on sliding section has not been smooth, the report states that it is not deniable that rust has developed in sliding interface.

Regarding that the nose landing gear was leant backward from the normal position of its extended position, it is somewhat likely that the rod end bearing was bent because the adjustment of its fully extended position had been improper or the movement of the sliding area of the rod end bearing was restricted while the piston rod was fully extended.

In this serious incident, it is highly probable that the aircraft became unable to move on the runway during the landing roll because the rod end bearing of the nose landing gear actuator was ruptured and consequently the nose landing gear was retracted.

Regarding that the rod end bearing ruptured, it is somewhat likely that the compression load was applied to the actuator along its longitudinal direction because the nose landing gear strut leant backward from its normal fully extended position.

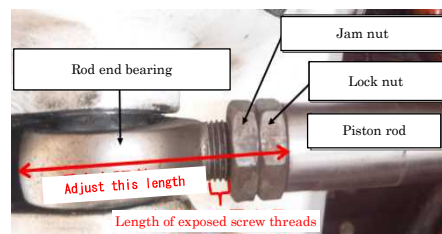
Photo 5 Length of Rod End Bearing (Other aircraft)

The position of each landing gear in its up and down position is set by adjusting the length of the rod end bearing on the actuator. (See Photo 5.)

Two nuts (Lock nut and Jam nut) are utilized when attaching a rod end bearing on a piston rod. In the Maintenance Manual of the same type of the aircraft, when the nose landing gear cannot be accommodated with the proper retracted position, it is allowable to use one nut (remove the jam nut) but the maximum length of the exposed threads shall be 0.28 in (approximately seven mm).

Only the lock nut was utilized and it is highly probable that the exposed length was close to the maximum allowable exposure length based on the numbers of threads of the exposed part.
