**AIRCRAFT SERIOUS INCIDENT  
INVESTIGATION REPORT**

**NON-PROFIT ORGANIZATION AERO SPORTS KITAMI  
JA 4027 & JA 2288**

JA4027 (Aircraft A) and JA2288 (Aircraft B)

<b>Company</b>	Non-Profit Organization Aero Sports KITAMI
<b>Type, Registration</b>	Aircraft A: Avions Pierre Robin DR400/180R, registered JA4027 Aircraft B: Alexander Schleicher ASK21, registered JA2288
<b>Incident Class</b>	Case of Unintended Drop of Tow Rope Article 166-4 (xv) of Ordinance for Enforcement of the Civil Aeronautics Act of Japan
<b>Date and Time of the Occurrence</b>	Around 13:45 JST (JST: UTC+9 hours; unless otherwise noted, all times are indicated in JST in this report on a 24-hour clock), on July 7, 2019.
<b>Site of the Incident</b>	Kitami City, Hokkaido Prefecture (43°46' N, 143° 46' E)

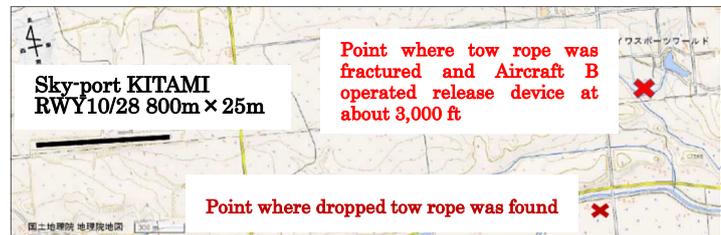
Figure 1: points where Aircraft B released tow rope and it was found

The dropped tow rope (about 49 m long and about 1.5 kg) was found in the field about 1 km south of the point Aircraft B operated the release lever.

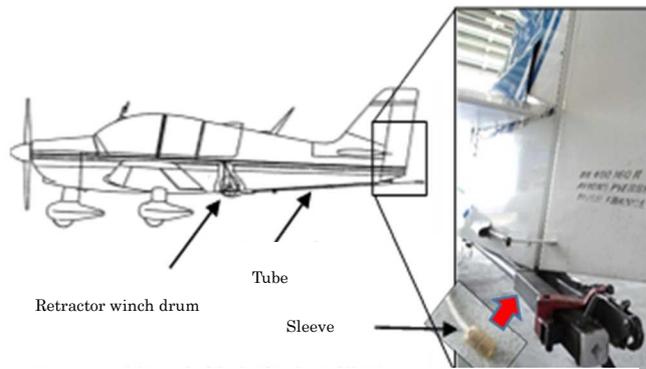
Figure 3: Tow rope retractor winch of Aircraft A

Non-Profit Organization Aero Sports KITAMI replaced tow rope every 1,000 launches in accordance with the flight manual and the serious incident was 428<sup>th</sup> launch since the last replacement. The tow rope was fractured in a knot in the sleeve (see Figure 4) of tow rope retractor winch of Aircraft A (see Figure 3).

The tow rope was knotted in the sleeve and had a mechanism that the sleeve moved backward in the tube and was blocked by stopper so that the tow rope could not be pulled out further from the aft end of Aircraft A. By this mechanism, pulling force imposed on the tow rope was not directly propagated to retractor winch drum in the lower part of Aircraft A (see Figure 3).

1. To disassemble a sleeve of tow rope retractor winch for checking its attached condition and the condition of a knot at daily checking.
2. To provide and reconfirm with members of the organization the acquaintance with the Skyport KITAMI including characteristics of conditions of the site and meteorological conditions, points to note when towing aircraft, and dealing measures with troubles.
3. To make it public that pilots of towing aircraft strive to grasp the flight experience and competence of individual members through communicating to their best with the members and take it into consideration for towing.

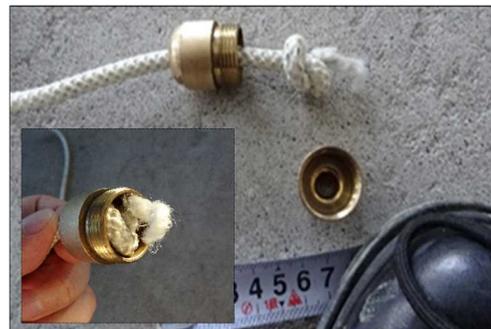
Figure 4: Fractured at a knot in the sleeve

It is highly probable that the tow rope was rapidly stretched by a widened distance between Aircraft A and B from the widely slack condition, and was fractured at the knot in the sleeve by a strong tensile force exceeding pulling strength of the tow rope instantaneously applied after the sleeve had been blocked by the stopper.
