AA2016-9

**AIRCRAFT ACCIDENT
INVESTIGATION REPORT**

GENERAL INCORPORATED ASSOCIATION SHIZUOKA
PREFECTURE AERONAUTICAL ASSOCIATION
PIPER PA-18-150, JA4048
AIRFRAME DAMAGE DUE TO RUNWAY EXCURSION
DURING LANDING
FUJIKAWA GLIDING FIELD, SHIZUOKA CITY,
SHIZUOKA PREFECTURE

AT ABOUT 12:06 JST, DECEMBER 20, 2015

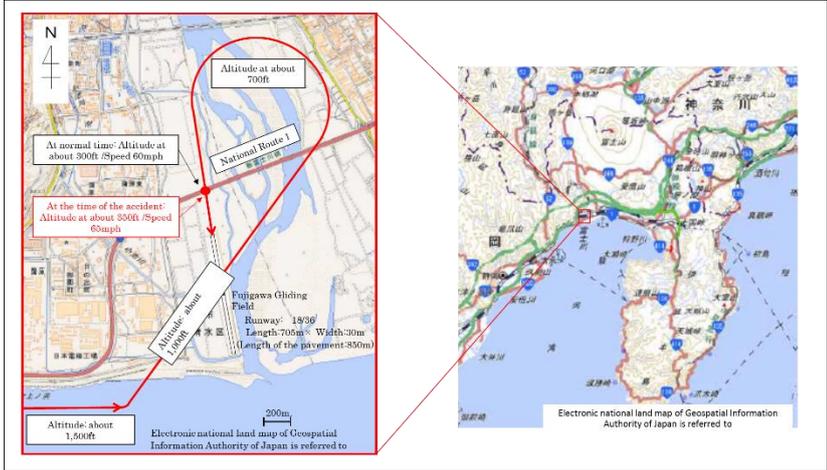
Thereafter, when the aircraft flew to the north, the captain after checking the speeds, turn onto the final approach course on runway 18 for landing, by down the flap by one-step and turning left in front of the Tokaido Shinkansen Bullet Train Fujikawa railroad bridge. Usually the aircraft used to pass through over of the National Route No.1 at altitude 300 ft and airspeed 60 mph; however, at that time the aircraft was at altitude 350 ft and airspeed 65 mph; therefore, the approach path angle had to become higher. The captain thought that the reason why the aircraft did not become the normal altitude and speed at this point, was because of the influence of the tail wind. (See Fig 1)

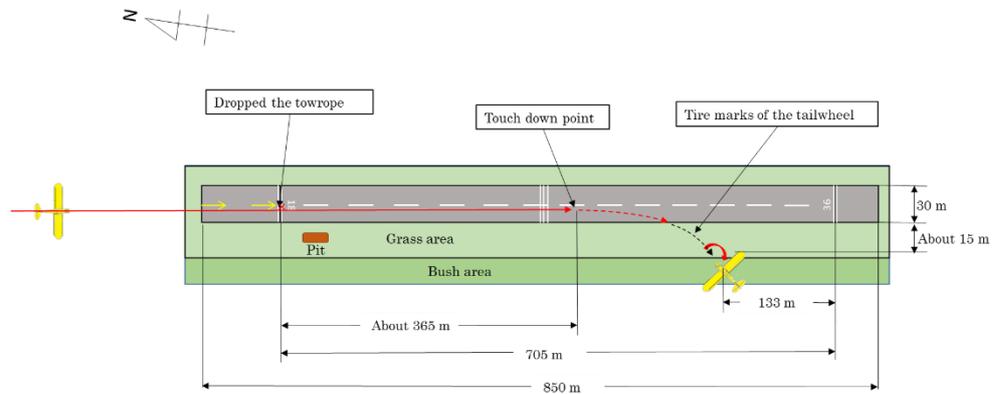
Fig. 2 Details for the Fields

The accident site was the bush area located 133 m north to the terminal end of runway 18 and approximately 15 m to the west from the runway long side. The aircraft was overturned on top of the bush. The height of the bush was about 2 m. (See Fig. 2)

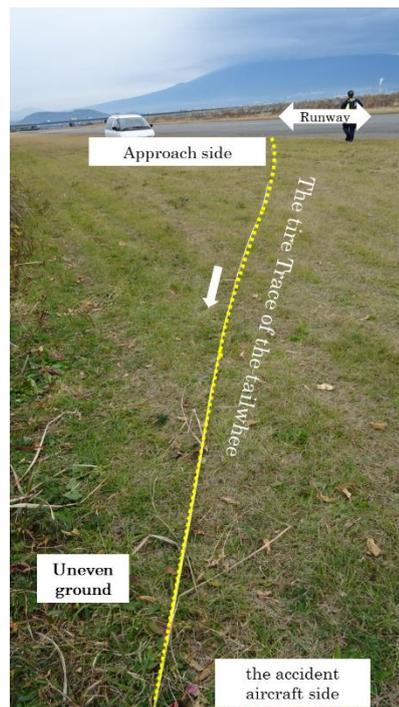
Fig. 3 The tire Trace of the tailwheel

It was not able to confirm the trace of the aircraft on the runway, but the tire marks of the tailwheel were remained for as long as 30 m on the grass area of the runway side. Incidentally, the tire marks initially gently draw a curve to the right, and then it was almost straight ahead. (See Fig. 3)

The captain tried the direction control by the rudder till the aircraft deviation from a runway and operated brakes; besides, the tire marks of the tailwheel which remained in grass area was initially gently drawing a curve to the right, and then almost straight ahead. It has a tendency to swing the nose during the turn by the characteristics of the tailwheel type landing gear; it is probable that it was not possible to adequately correct the deflection in the right direction in the rudder operation.
