AA2017-4

**AIRCRAFT ACCIDENT
INVESTIGATION REPORT**

**CRASH AFTER TAKEOFF
PRIVATELY OWNED
PIPER PA-46-350P, JA4060
CHOFU CITY, TOKYO METROPOLITAN, JAPAN
AT AROUND 10:58 JST, JULY 26, 2015**

July 7, 2017

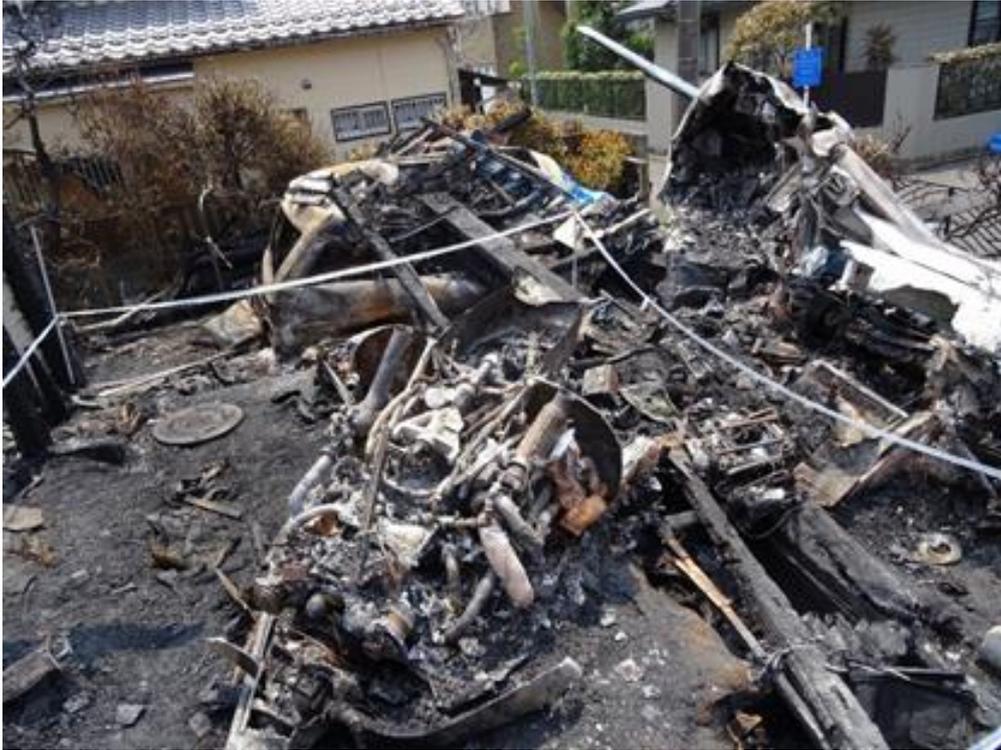
Photo 2.4.1-1 Accident Site and the Aircraft (part 1)

House E was partially burned due to the fire caused from the Aircraft. Other houses next to House D suffered damage due to the fire spread or radiant heat. Excluding the empennage, the fuselage of the Aircraft was almost all burned up without any original shapes. The right horizontal stabilizer was sticking out on the public road. A part of the burned main wings was found on the public road in front of House D and near the west-side wall of House D left unburned.

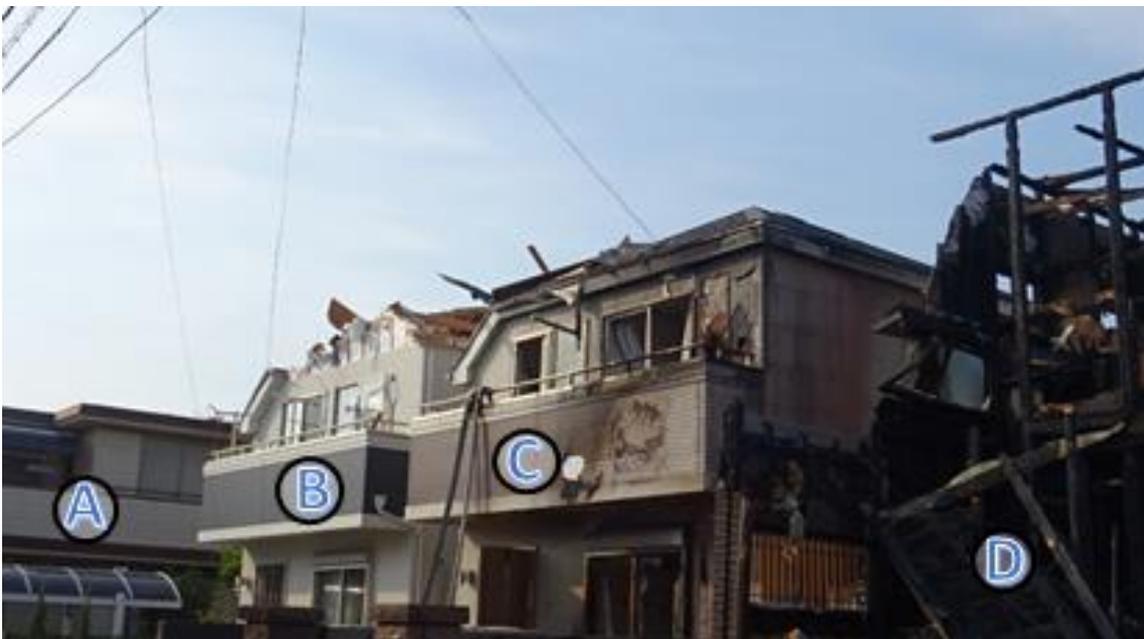
Photo 2.4.2-1 House A to House D

House D facing a public road at the south-side was a two-story house, but the south-side of the house was burned down almost completely, leaving only the west-side wall. For the other parts of the house, the roofs were lost to fire and only charred columns were standing. A vehicle and a motorcycle which had been parked in the garden of House D were consumed by the fire, being under the Aircraft. Houses C and E adjacent to House D, which was burned down completely, caught fire or suffered damage due to radiant heat with the level of damage varying.

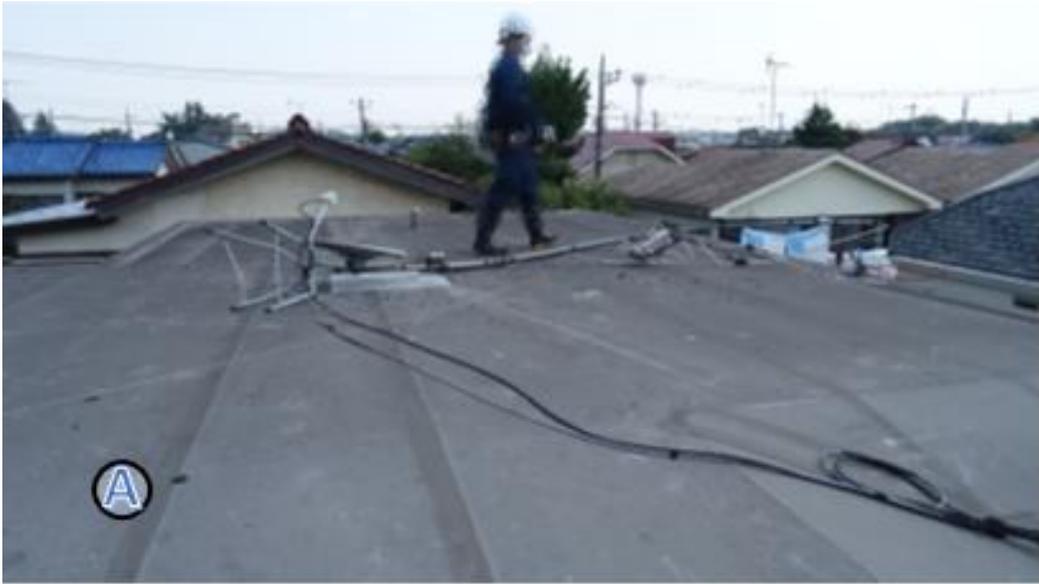
Photo 2.4.2-2 Collapsed TV Antenna of House A

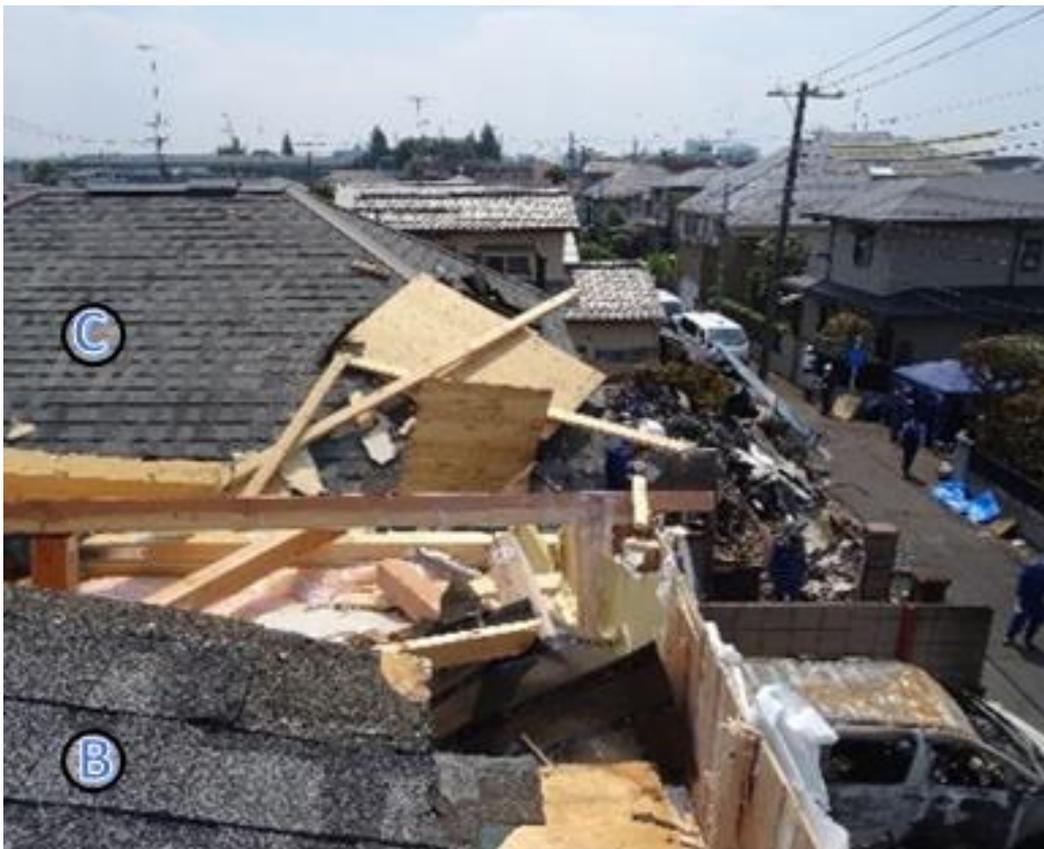
Photo 2.4.2-3 Damaged Roof of House B and Roofing Materials Scattered on House C

There were the roofing materials from damaged House B scattered over the rooftop of House C, but there is no trace of contact with the Aircraft. Besides, the windows at the south east side of the first and second floors were broken and traces of burning were confirmed on the south side exterior wall. A vehicle and a bicycle parked in the garden were burned. House E had a closet on the first floor and the exterior wall and roof of the second floor damaged by the fire.

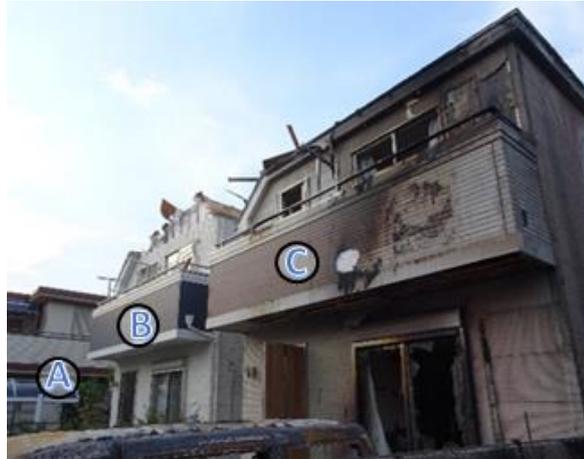
Photo 2.4.2-4 Fire Damage of House C

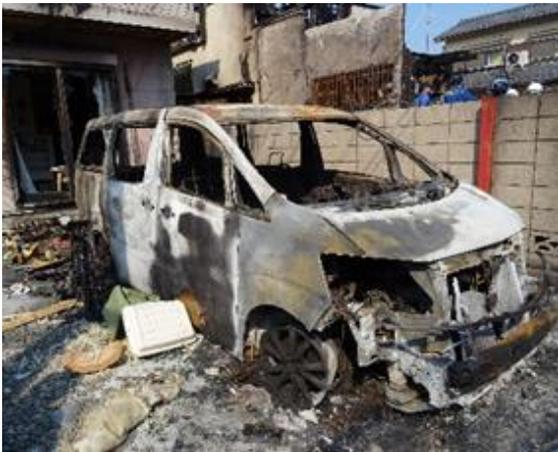
Photo 2.4.2-5 Fire Damaged Vehicle of House C

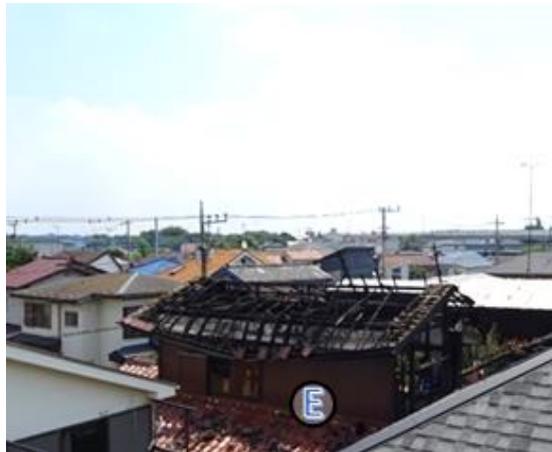
Photo 2.4.2-6 Fire Damage of House E

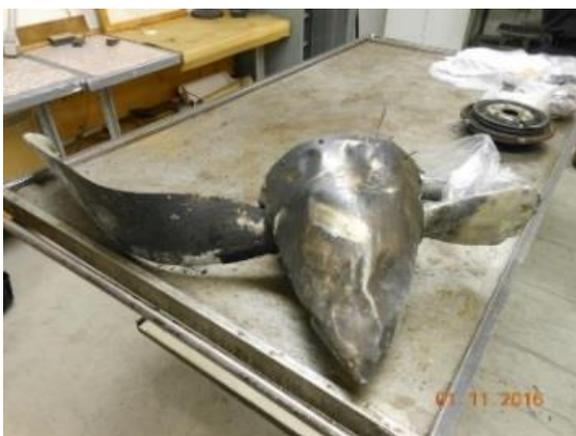
Photo#1: Propeller (before teardown)

The propeller was attached to the engine when shipped to Lycoming. The propeller had been removed from the engine by Lycoming personnel prior to my arrival. Photos #1 and #2 show the condition of the propeller prior to the examination. The majority of one blade had been consumed by the post-crash fire. The other blade showed bending in the aft direction and twisting leading edge down (toward low pitch). The spinner dome and bulkhead remained attached to the propeller but approximately 30% was consumed by the post-crash fire.

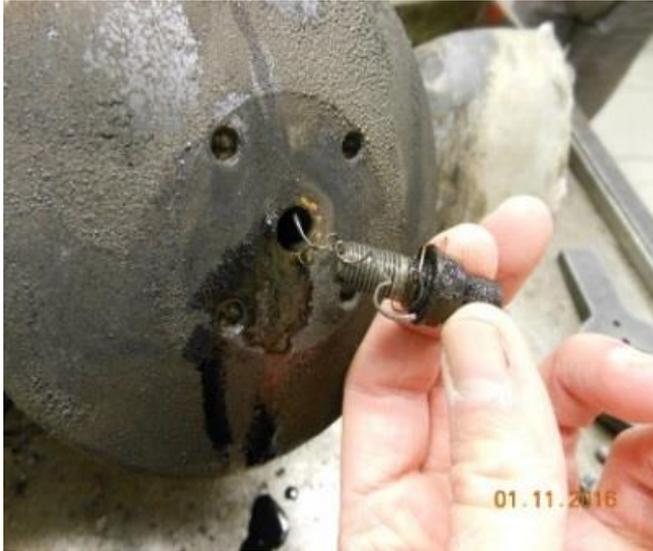
Photo#3: Low Pitch Stop

The cylinder was intact but showed signs of heat distress on the exterior surface (charring, bubbling, etc.). The low pitch stop screw had been forced forward, stripping mounting threads in the cylinder but remained in the cylinder and required further unthreading to remove (see Photo # 3).

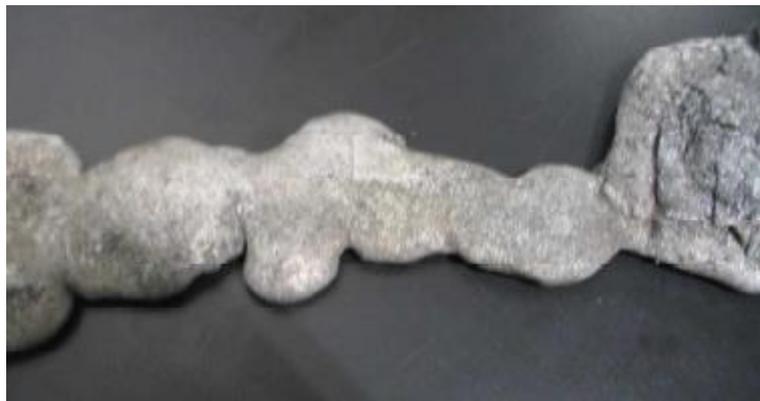
Photo – Melted Propeller Blade

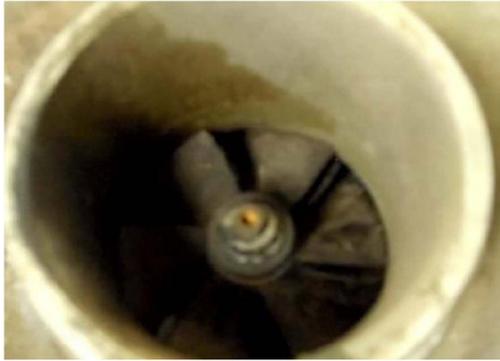
The turbine wheel appeared undamaged. BackPlate: Intact

Photo #2 - Remains of compressor wheel

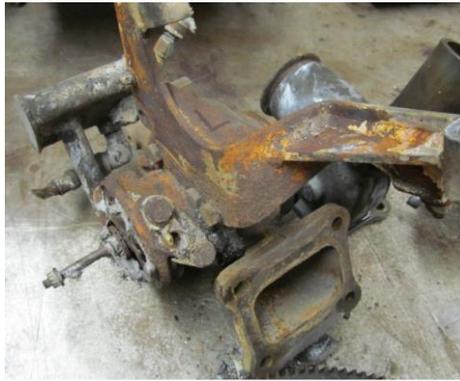
- Existence of Residual Oil. Dry and extreme corrosion present.*

Photo #4 – As-Received Condition 1

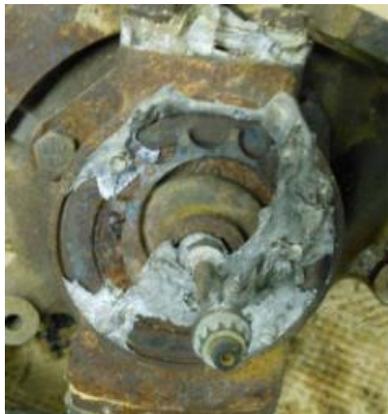
Photo #5 Remains of compressor wheel

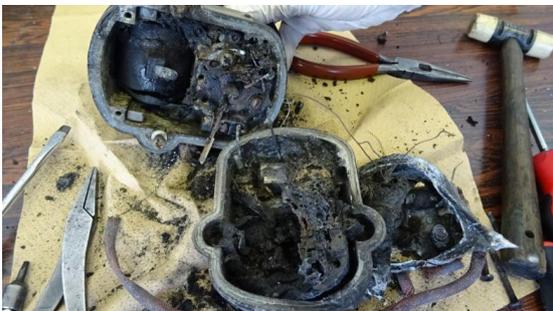
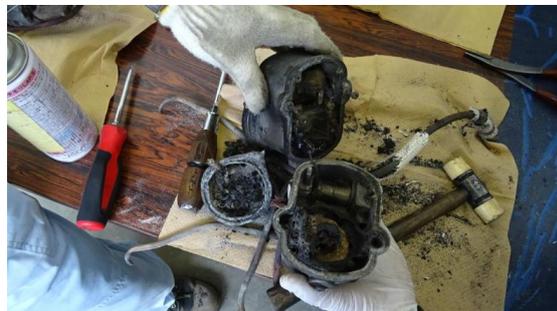
- (1) The ignition harness was mostly consumed;
- (2) The distributor block was damaged by fire;
- (3) The distributor rotor was melted;
- (4) The coil assembly was damaged by fire;
- (5) The field through capacitor was consumed;
- (6) Although the breaker point was damaged by fire, there was no major damage at the contact point which could be inspected;
- (7) The primary lead wire connecting the field through capacitor and the coil assembly was not broken.
- (8) The rotating magnet could be rotated freely by hand.

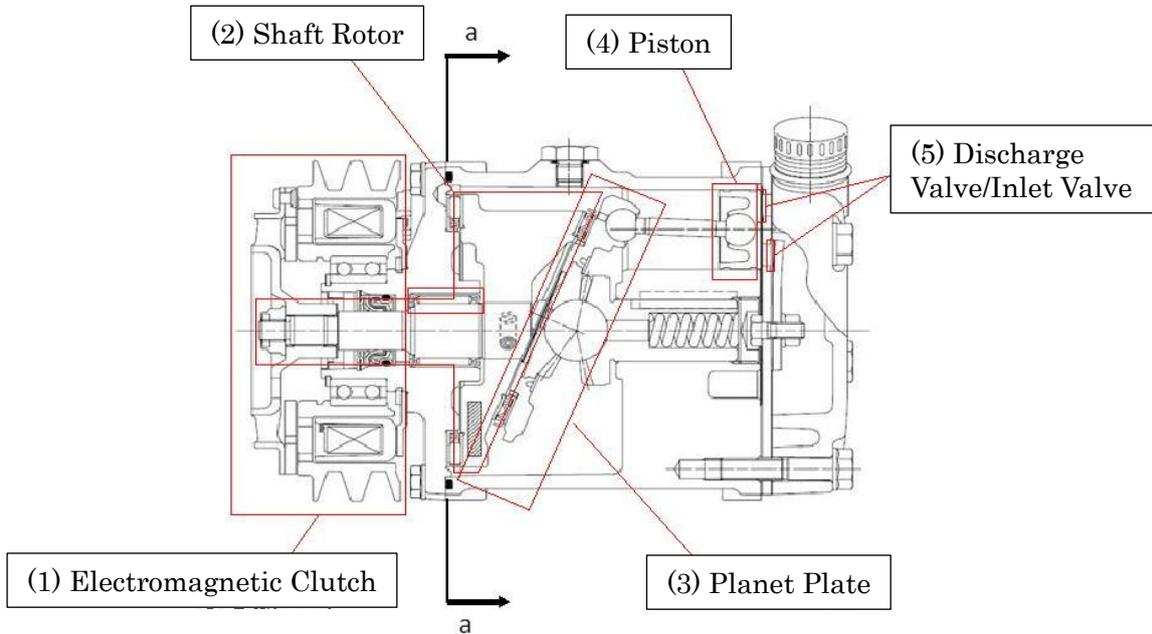
Figure. Attachment 6 3.2 (2) Compressor (cross-section)

A black substance was found attached to the lower inner surface of the crank chamber after the accident. No substance was found on the upper side.
