**AIRCRAFT ACCIDENT
INVESTIGATION REPORT**

**NEW JAPAN AVIATION CO., LTD.
J A 4 0 6 2**

July 30, 2020

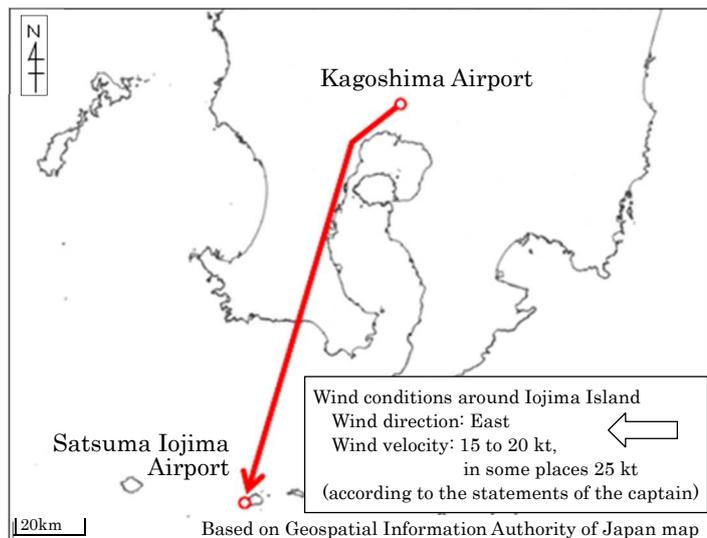
Figure1: Estimated flight route

Due to topographic effects from Mt. Iogatake (2309 ft), when an easterly wind blows, the southerly tail wind blows on the approach end on the side of Runway 36, the northerly tail wind blows on the approach end on the side of Runway 18, but no wind around the center of the Runway, thus generating unique weather conditions.
