**AIRCRAFT SERIOUS INCIDENT
INVESTIGATION REPORT**

**PRIVATELY OWNED
JA 4083**

April 28, 2022

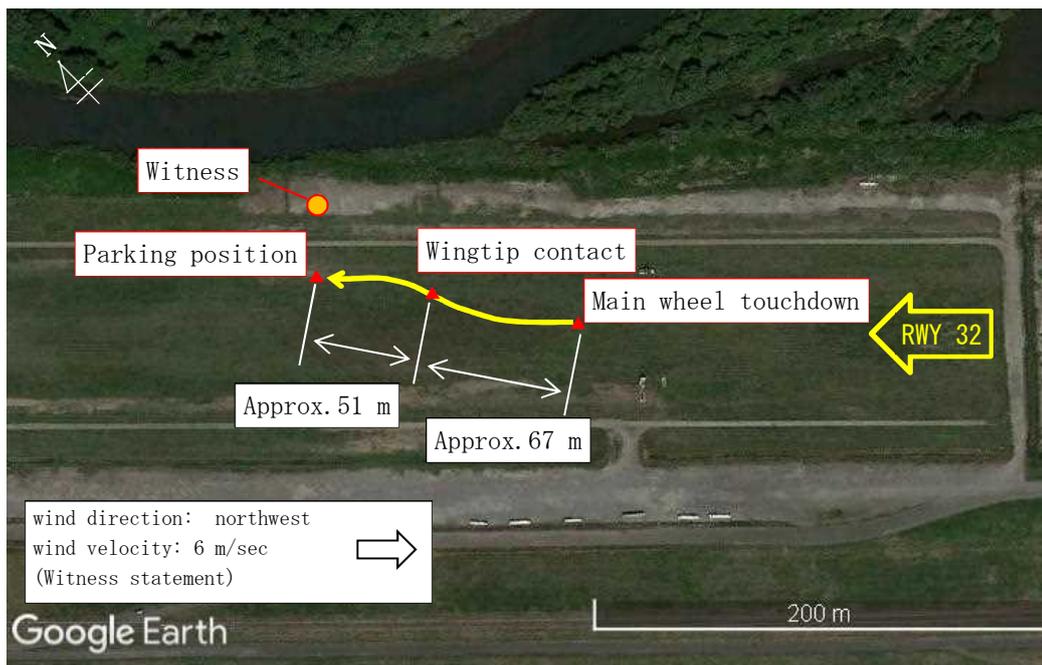
Figure 1 Estimated rolling route

The aircraft took off from the Menuma Gliding Field towing a glider, and landed back at the gliding field after detaching the glider in the air. The aircraft touched down from the main wheel at the speed of approximately 50 mph using 30° flaps with engine outputs idle, and the tailwheel touched down as the aircraft decelerated. During landing roll, the pilot pointed the heading to the right to move to the parking position where a tow plane waits for the next operation, and continued rolling by inertia keeping the engine outputs idle without applying the brake. When the aircraft decelerated close to taxiing speed during rolling toward the parking position, the right wing suddenly floated, and the airframe leaned to the left and returned to a level attitude immediately thereafter. As the aircraft was in a landing configuration with the flaps downward at this time and the pilot recognized that the wind was an almost headwind, the aileron was held in neutral position. As the pilot did not recognize that the wingtip contacted with the ground surface when the airframe leaned, the pilot continued rolling and halted the aircraft at the parking position. After parking the aircraft, the pilot was informed by a witness that the left wingtip contacted with the ground surface.

The JTSA concludes that it is likely that the aircraft was shaken by the gusty wind from the right direction during landing roll that caused the right wing to float and the aircraft to lean to the left, and the left wingtip contacted with the ground surface.
