AIRCRAFT ACCIDENT INVESTIGATION REPORT

J A 4 1 2 3

**PRIVATELY OWNED
SOCATA TB21, JA4123
DAMAGE OF LEFT WING DURING TAXIING (GROUND CONTACT)
ON AN APRON AT TAJIMA AIRFIELD
ABOUT 15:27 JST, JULY 24, 2011**

December 7, 2012

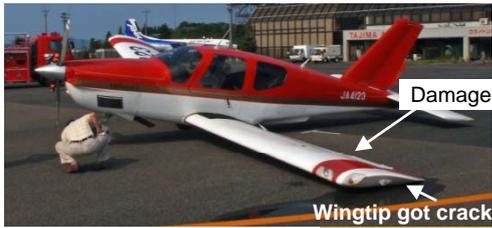
The accident aircraft

The owner stopped the engine and turned off the main switch, then got out of the Aircraft. The left wing tip cover had been broken and areas around the flap fitting structure had been deformed.

The Aircraft came to a halt at a place about 51 meters northwest of Spot 11 on the apron at Tajima Airfield with its L/H MLG retracted and the tip of the left wing contacted with the ground surface and with its nose directed to the west-northwest.

Scratch marks caused by the tip of the left wing and a flap hinge, each with a length of about four meters, had been left on the apron.

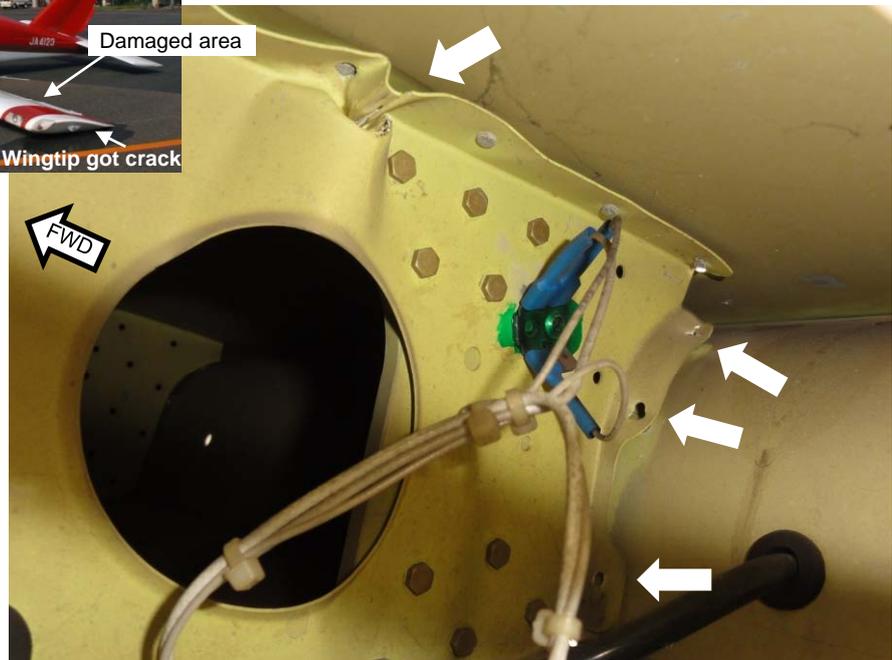
(2) Left Wing

There were cracks in the wing tip cover made by the plastic.

Scratch marks were found on the lower surface of the wing tip and the lower surface of the aileron.

There were scratch marks on the lower end of the outer flap hinge.

The wing structure in the area with the outer flap hinge installed had been deformed.

The damages and deform of the LH wing-structure around the fitting of outboard flap hinge.

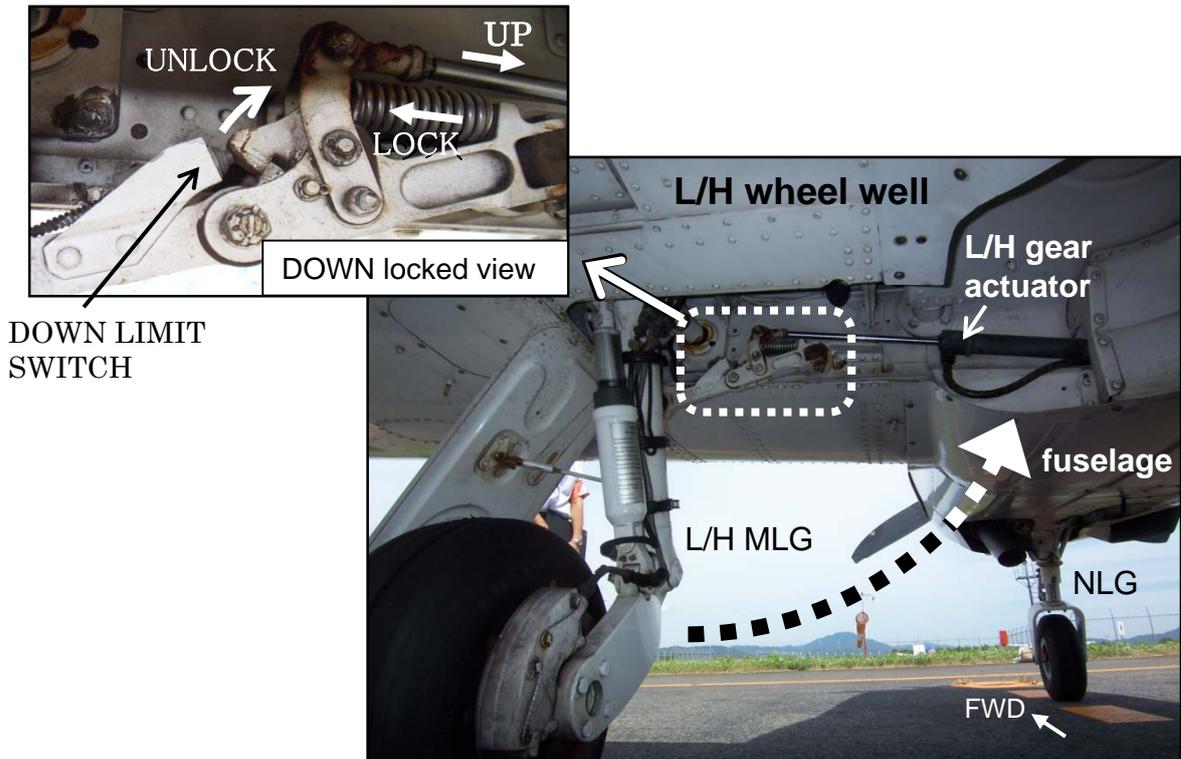
Photo2 The Gear Retract Mechanism of L/H MLG

Based on these findings, it is considered highly probable that when the Aircraft started taxiing, the actuators for all the three landing gears had stopped at the place to the UP side where the down locked mode was released and the hydraulic circuit on the UP side had been closed. At that time, it is considered highly probable that all landing gear actuators had stopped in the middle of the up and down positions and in a situation where they weres able to be moved in either direction. It is considered highly probable that the Aircraft had started taxiing in this situation and the landing gears were about to move to the down lock position with the power of the springs. But, because the hydraulic circuit on the UP side had been closed, it is considered highly probable that the actuators for the three landing gears connected to the hydraulic circuits could not move simultaneously in the same direction; as a result, the mutual loads for the landing gear actuators became unbalanced when the Aircraft was taxiing, causing only the L/H MLG to move in the UP direction. As a result, it is considered highly probable that the Aircraft leaned to the left with the L/H MLG retracted and the left wing contacted with the ground surface and sustained damage.

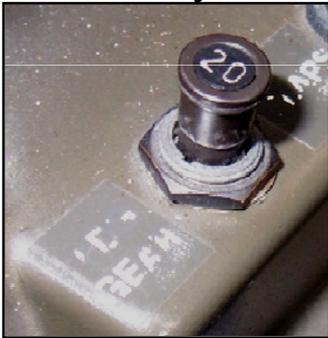
Aircraft arrived at Tajima Airfield at about 13:30. But when an operation to extend the landing gears for landing was performed, the owner found that the circuit breaker for the landing gear system (hereinafter referred to as “the Gear CB”) had been popped up. He tried to reset it several times, but it popped up each time. He could not extend the landing gears with a normal procedure; therefore, lowered them using the emergency landing gear knob. After that, they confirmed that the three green indicating lights for the down locked mode (the 3 Greens) had been illuminated, and the Aircraft landed on the airfield.

Landing Gear CB (popped up)

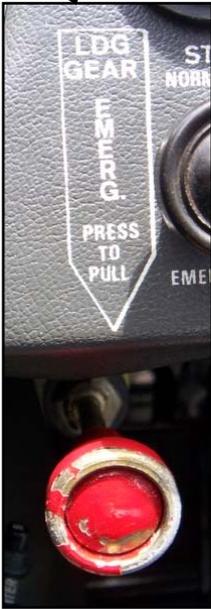
According to the captain and the owner, as described in 2.1 (1) and (2), when the Aircraft started taxiing, the emergency landing gear knob remained to be reset and the 3 Greens had been off, while the popped up Gear CB was unable to be reset. The Aircraft started taxiing, the owner checked its break system and running straight again and after turning to the left, the Aircraft began leaning to the left.

Emergency gear knob (pulled)

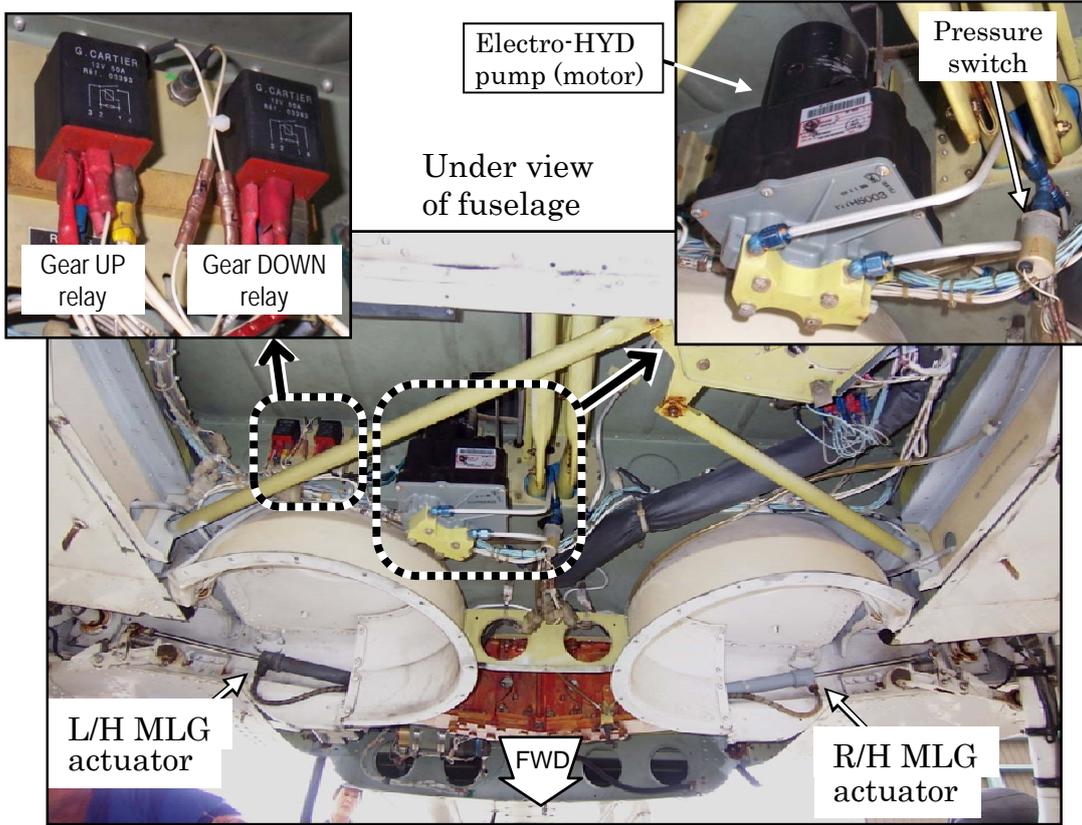
Photo 4 Gear Relays and HYD Pump

As described in 2.8.2 and 2.10.2, the Aircraft had been installed the landing gear UP and DOWN relays with the mark “12V 50A Ref. 03393”, but their specification had been mentioned as “03395 – 24V 50A” on the component list in the flight manual. In addition, the Aircraft had a 28V power supply system, as described in 2.10.1.

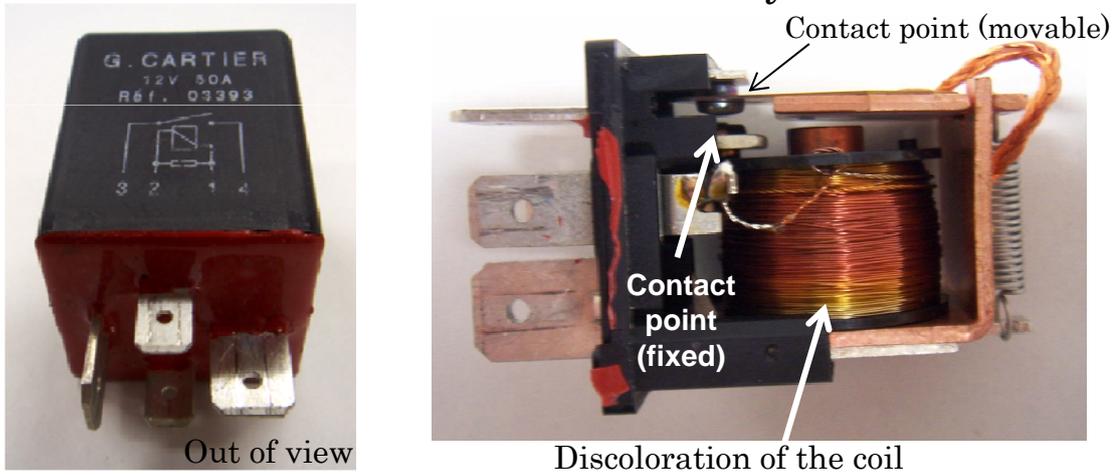
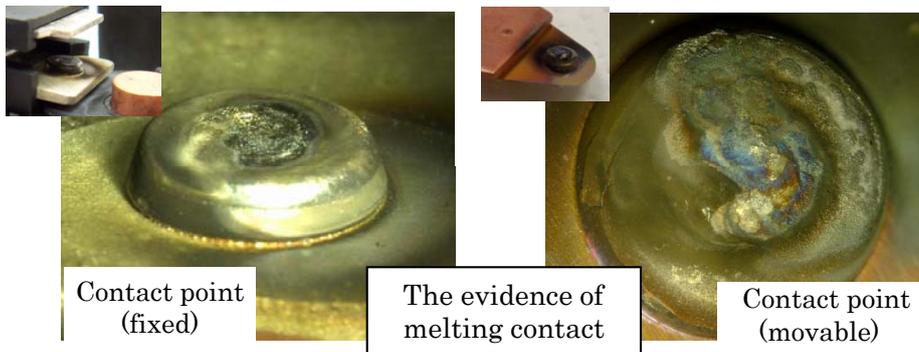
Photo 5 Gear UP Relay

- (1) The mark “12V 50A Ref. 03393” was found on the side of the relay, while the stamp mark “2459” was seen on the topside.
 - (2) The surface of the contact points both on the fixed and movable sides had been degraded (with compounds accumulated) and there were traces of partial melting and adhesion.
 - (3) The surface of the wires for the coils inside had been partially discolored.
- (See Photo 5 Gear UP Relay)

As to the condition of the landing gear system at that time, because the contact points of the landing gear UP relay had become partially melted and adhesive at the CLOSE position due to degradation, as described in 2.8, it is considered highly probable that the system had been in a situation where the electrical power was supplied to the UP side of the electro-hydraulic pump. Regarding the fact that the Gear CB had popped up and, when it was reset, immediately popped up again, it is considered highly probable that the phenomenon had occurred due to an overcurrent because electrical supply could not be stopped even after the pressure switch was activated, as the landing gears were in the UP position.

This means that electrical power with 28V for the power supply system had been supplied as against the voltage rating of 12V and the current rating of 50A for the installed landing gear relays. In this situation, an electric current which is more than double the current rating flows to the coils. Therefore, it is considered highly probable that the coils had got overheated and the temperature increased, causing heat that discolored the coating of the coils.

As to the fact that the contact points of the landing gear UP relay had been deteriorated and become partially melted and adhesive, as described in 2.10.3, it is considered somewhat likely that the relay which was not confirmed to the specification of the Aircraft was installed, and was using with the overload condition for it, then the determination of the contact point of it had become faster. Not only weight of the landing gears but also the power of the springs works to the landing gear mechanism for the Aircraft in the downward direction. Therefore, the load for the electro-hydraulic pump is larger in the upward direction than in the downward direction. Further, the landing gears are retracted and extended one time each on every flight, in addition, the landing gear system operates in the upward direction also when the pressure switch is activated. So that, the landing gear UP relay works more frequently than the landing gear DOWN relay; as a result, it is considered highly probable that the contact points of the UP relay had become deteriorated more
