AA2015-5

**AIRCRAFT ACCIDENT
INVESTIGATION REPORT**

**PRIVATELY OWNED
J A 4 1 5 2**

CRASH DUE TO A STALL PRIVATELY OWNED BEECHCRAFT A36, JA4152 INTO THE GRASS ON THE SOUTH SIDE OF AMI AIRFIELD AMI TOWN, INASHIKI GUN, IBARAKI PREFECTURE, JAPAN AROUND 13:55 JST, AUGUST 18, 2013

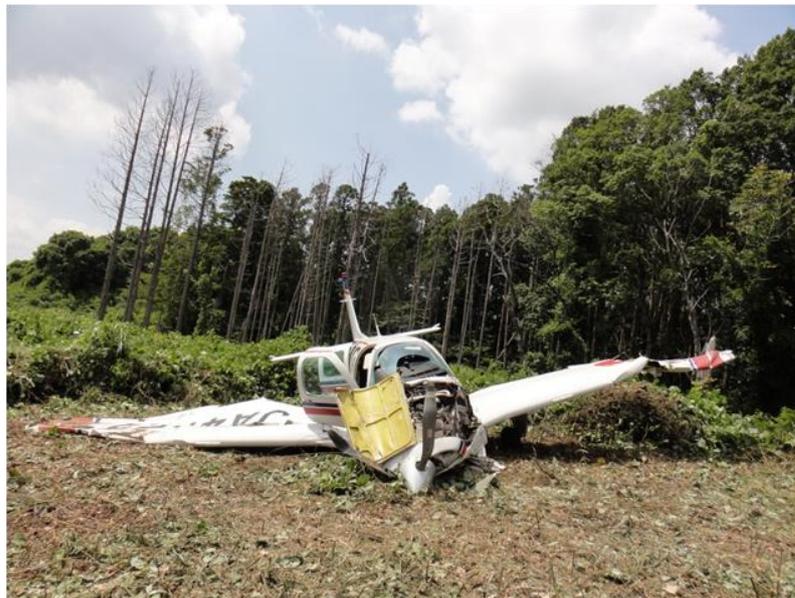
Photo: Accident Aircraft

- (1) Fuselage: Damage to the front lower section
- (2) Wings: Damage to the right wing, damage to the leading edge at the end of the left wing
- (3) Engine: Damage. Especially major damage to the right lower section
- (4) Propeller: Damage to all three blades
- (5) Landing gears: Breakage to the right main landing gear and the nose landing gear

The front lower section was damaged, but there was no damage to the rear fuselage.

The right wing suffered buckling damage, and the left wing suffered major damage to the leading edge near the wing tip. The flaps were in the down (full down position within 3 levels) position.

Structural parts in the lower engine part suffered major damage, and the damage around the right side cylinders was especially great. The engine mount was broken.

All of the three blades were bent backwards and damaged.

Nose landing gear was broken back toward the left, and the right main landing gear was broken inward. However, no major damage was found in the left main landing gear, and it was locked in the down position.

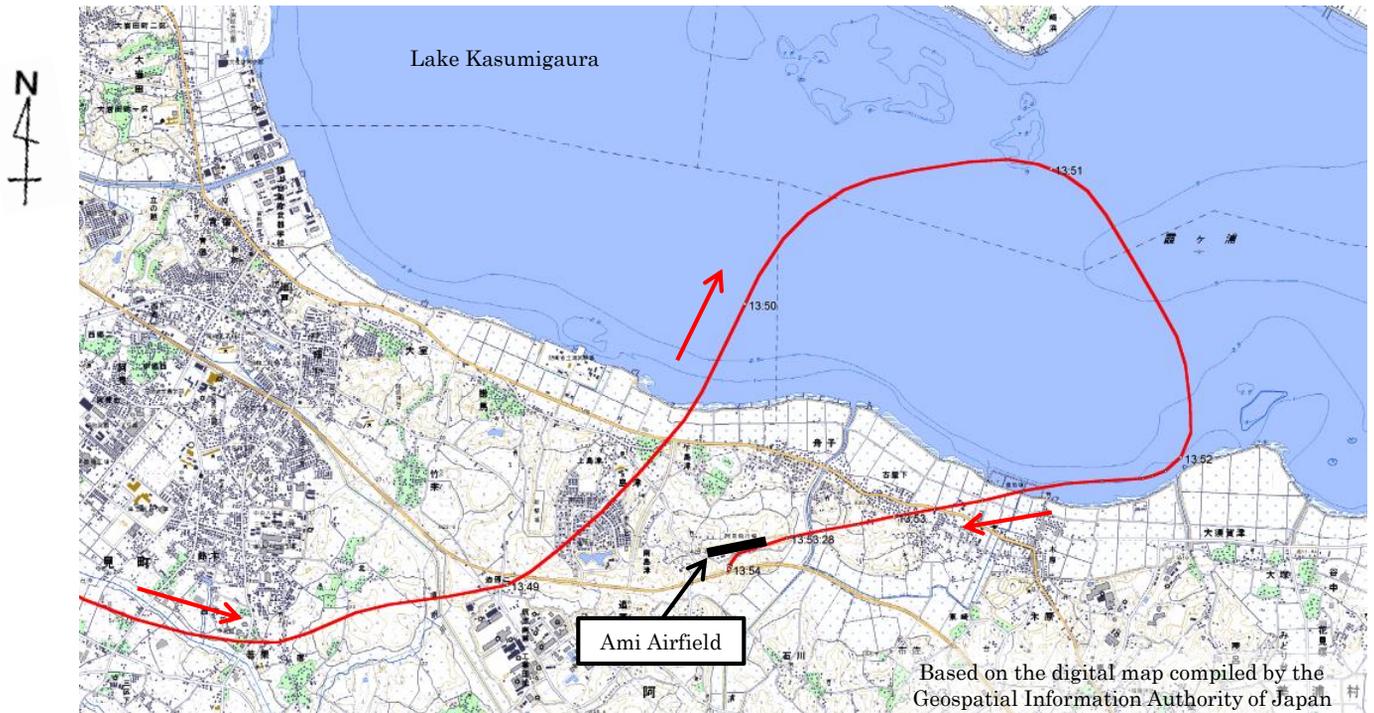
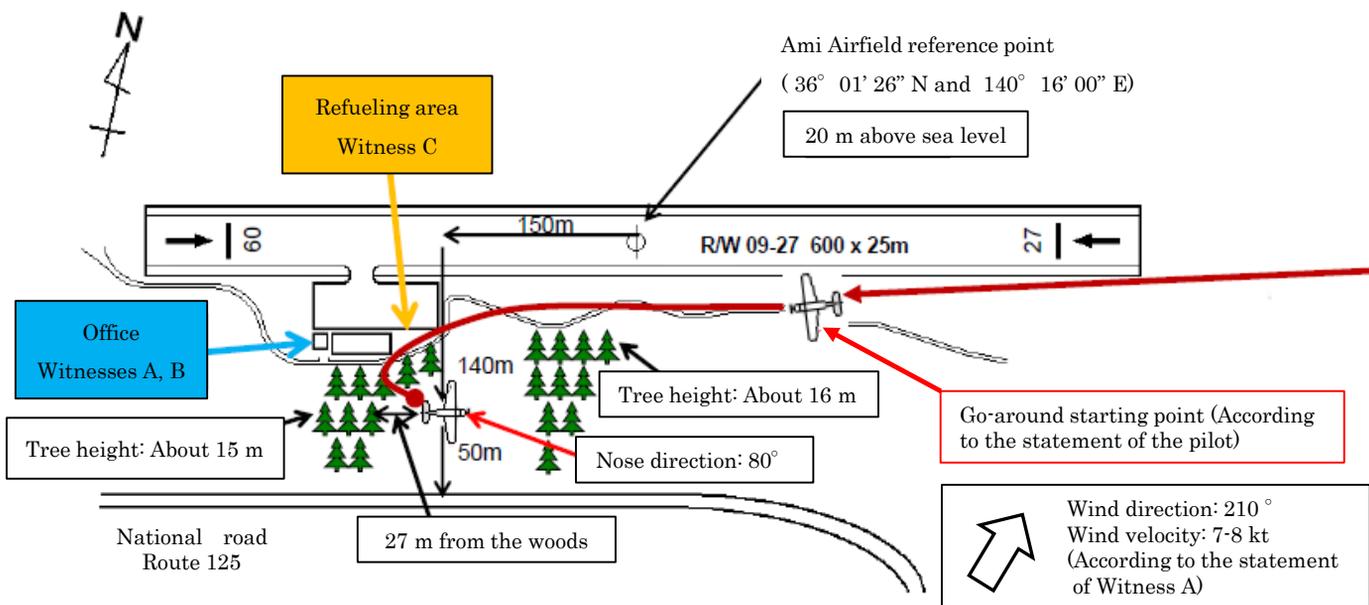
Figure 1 Estimated Flight Route and Accident Site Layout

This accident occurred into the grass about 140m south of the Airfield (36°01' 20" N and 140°15' 55" E) and the time of this accident was around 13:55 on August 18, 2013.

The accident site is located about 12 m above sea level and was a soft grassy area surrounded by woods on about 140m the south side of the Airfield.

The Aircraft halted with the nose facing east (about 80° in the magnetic bearing), which was the opposite direction from the approach direction.

The handheld GPS device installed in the Aircraft recorded the flight route, altitude, and time information leading to the accident regarding the Aircraft's flight on the day of the accident. (See Figure 1 "Estimated Flight Route and Accident Site Layout")
