AA2012-5

**AIRCRAFT ACCIDENT
INVESTIGATION REPORT**

J A 4 1 6 7

CIVIL AVIATION COLLEGE
BEEHCRAFT A36, JA4167
IMMOBILE ON THE RUNWAY
ON RUNWAY AT MIYAZAKI AIRPORT, JAPAN
AT ABOUT 13:49 JST, NOVEMBER 5, 2010

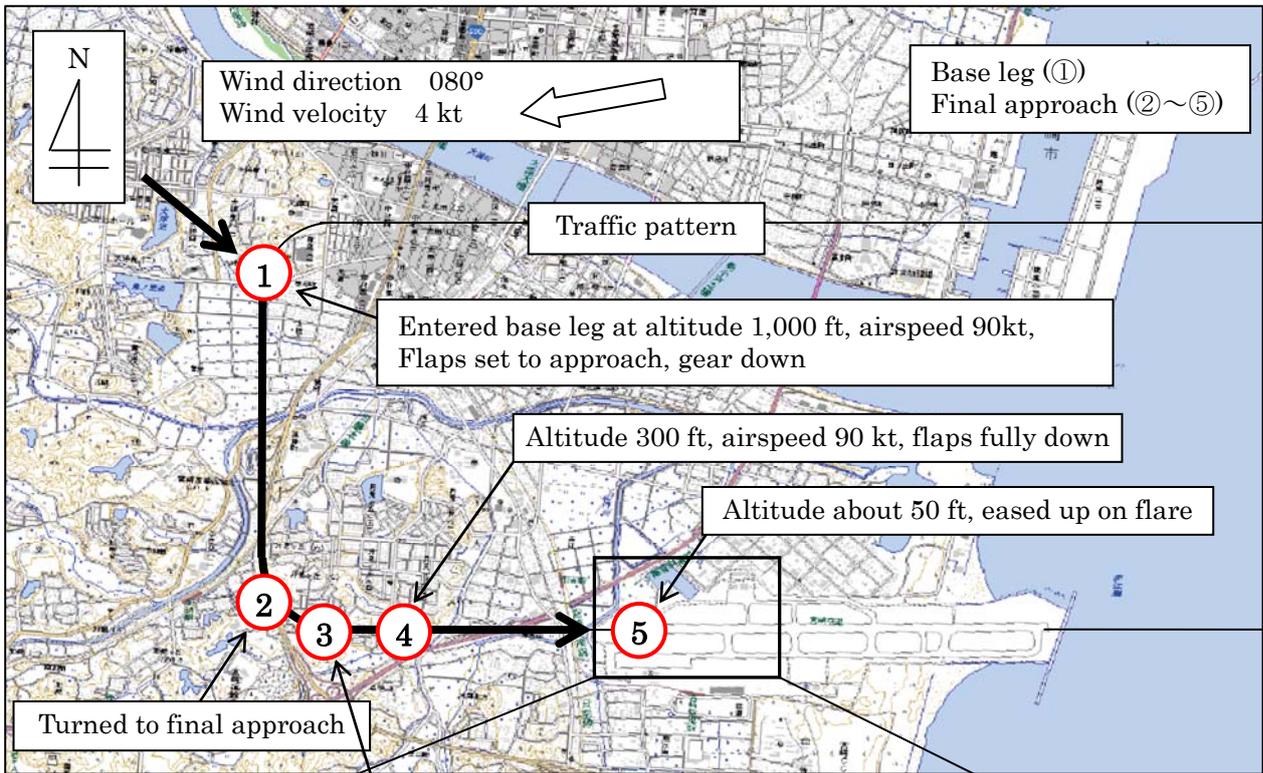
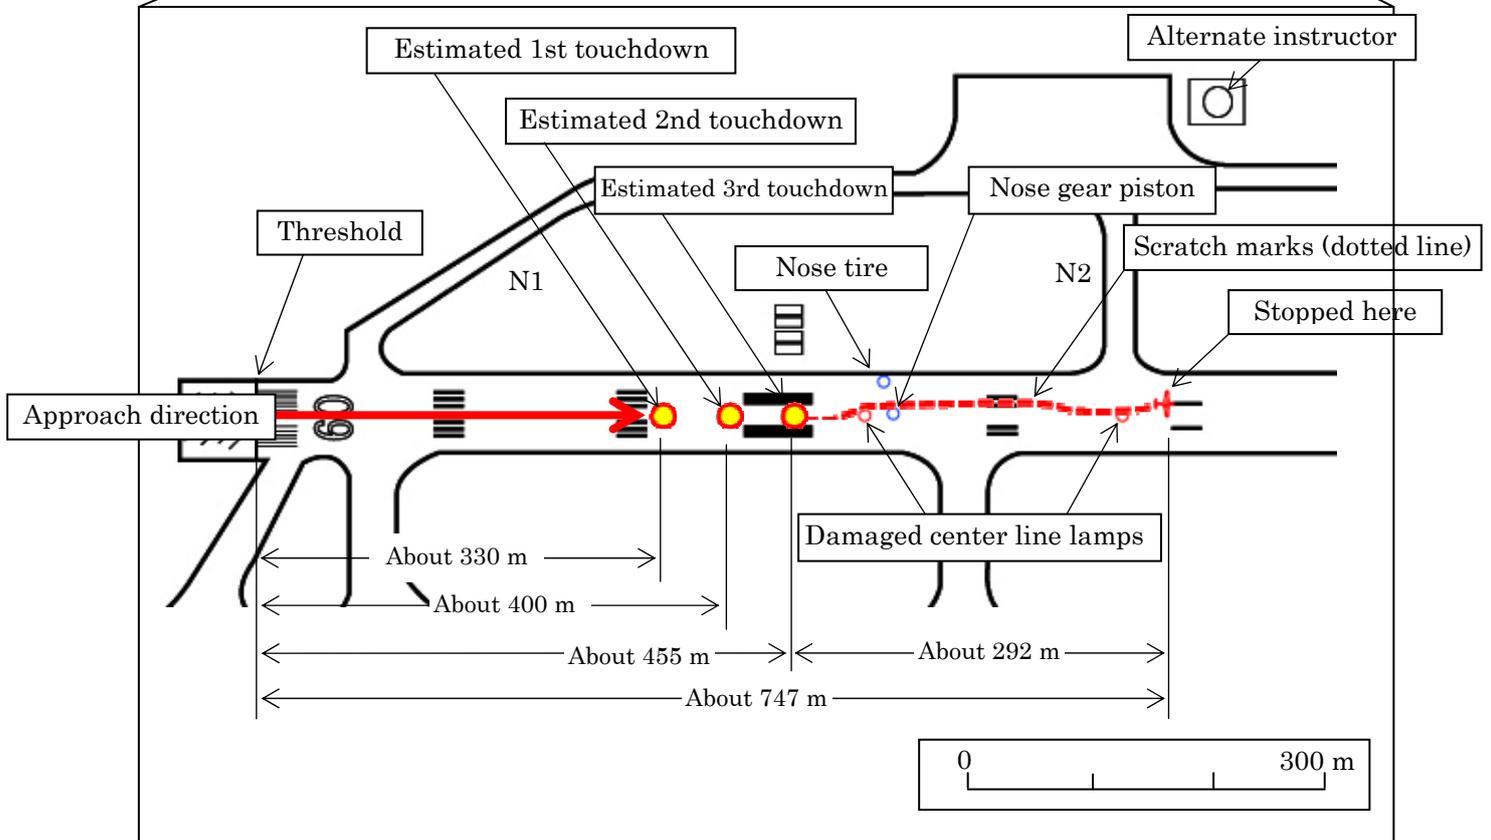
Figure 1 Estimated Flight Path

The runway of Miyazaki Airport is 2,500 meters long, 45 meters wide with its direction of 09/27. The Aircraft was found immobile on the runway, with the nose pointing to the east, about 747 meters beyond the Runway Threshold and about 3.4 meters on the left from the runway center line.

Scratch marks were found stretching eastward over a distance of about 292 meters on the runway, starting from a point about 455 meters beyond the Runway Threshold. Two of the runway center line lights within the 292 meters range were broken.

In addition, the nose gear piston and tire were found on the runway, separated from the Aircraft.

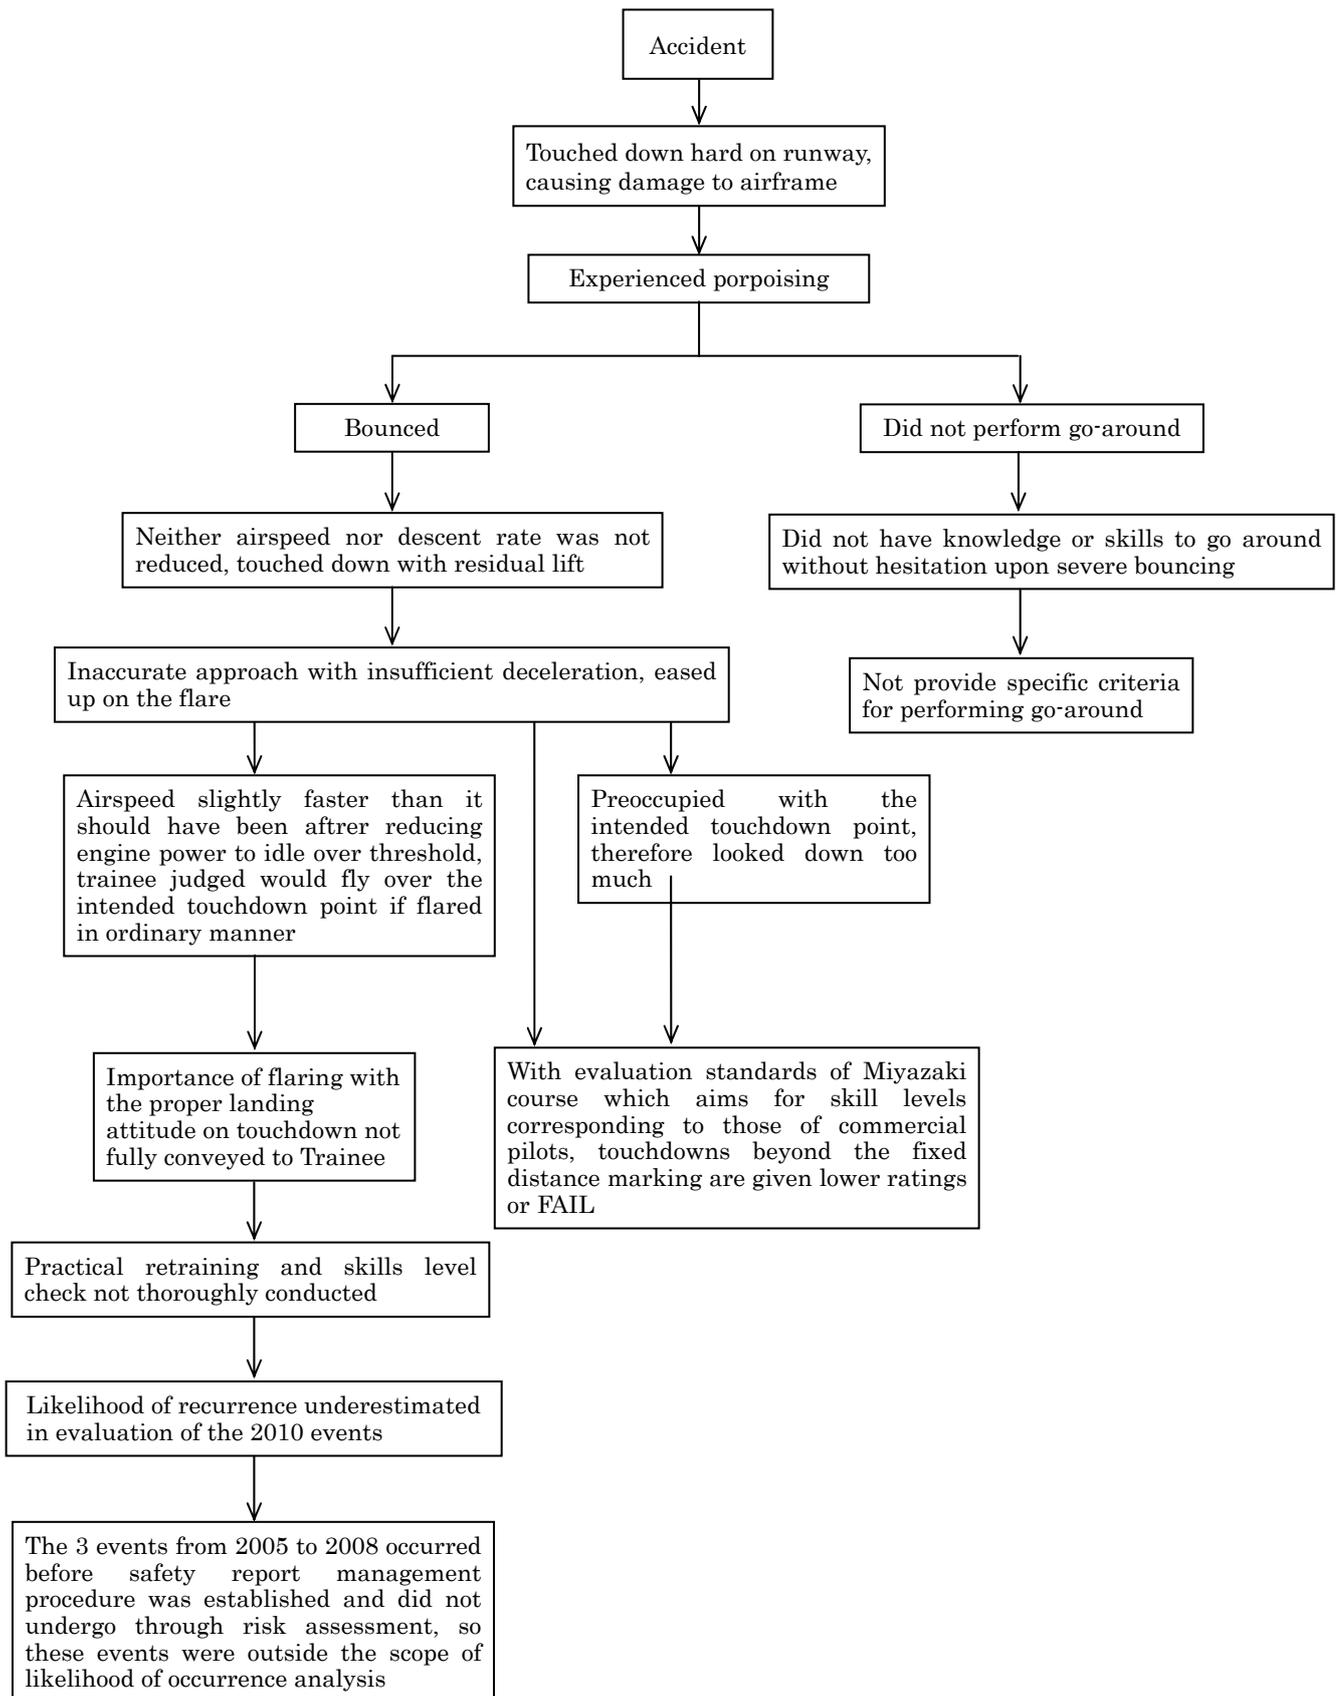
Figure 5 Cause Analysis

It is highly probable that the accident occurred as follows: the Aircraft bounced at touchdown, and subsequently fell into a state of porpoising without performing a go-around, eventually touched down with the nose gear severely hitting the runway first, sustained damage to the airframe and then became immobile on the runway.

Regarding the reason why the Aircraft bounced at touchdown, it is probable that, with the airspeed still slightly faster than it should have been after reducing the engine power to idle on passing the Runway Threshold, the Trainee judged that performing a flare in an ordinary manner under the circumstances would cause the aircraft to fly over the intended touchdown point and therefore he eased up on the flare. As a result, it is probable that neither airspeed nor rate of descent was reduced and the aircraft touched down with residual lift, which resulted in bouncing at touchdown due to the impact of the landing gear as it hit the runway.

- (1) As part of the safety education for the students and instructors, the College lectured the outline of the accident, the conditions under which a go-around must be performed, examples of an unsuccessful final approach and the need to check the airspeed on passing the runway threshold.

- (6) Review was made on the risk assessment time period (five years) and the risk assessment method relating to the probability of occurrence (frequency).

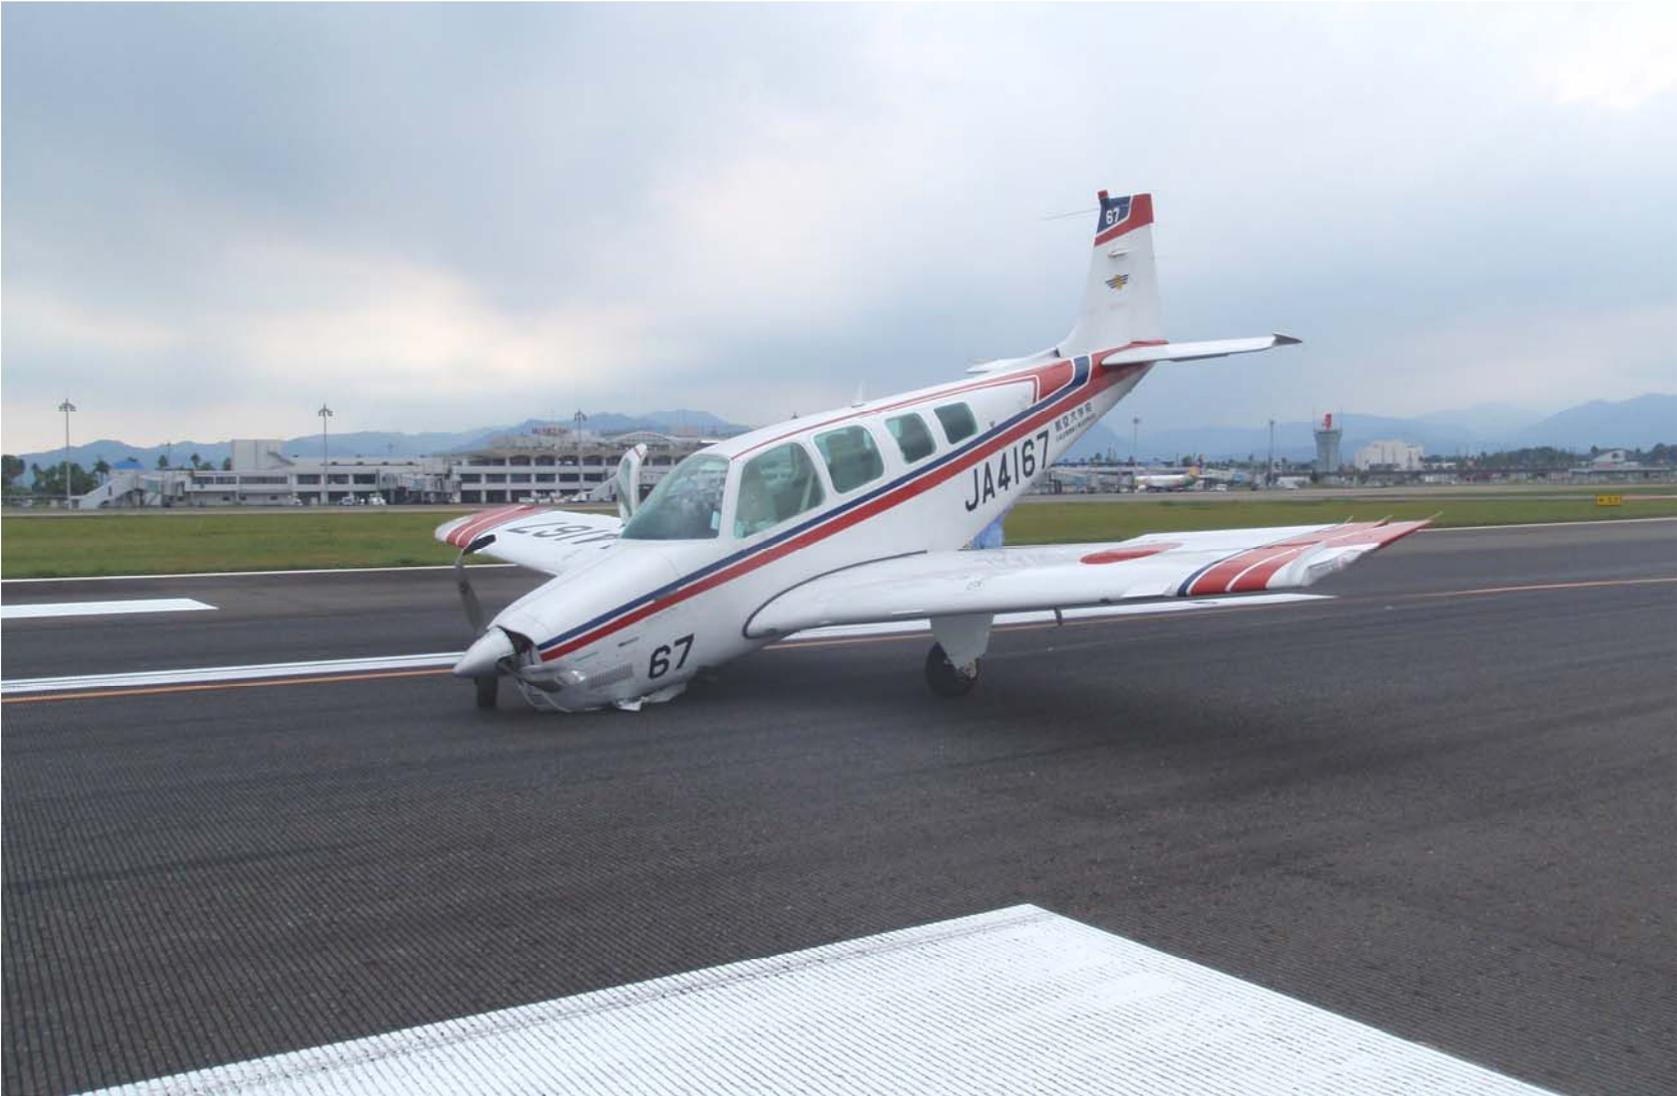
Photo 1 Accident Aircraft

The accident occurred around 13:49 on the runway at Miyazaki Airport (Latitude 31°52'36"N, Longitude 131°26'35"E).

According to the statements in 2.1.2 (1), (2) and (3), the descriptions of the accident site in 2.8.1 and the details of damage to the Aircraft in 2.8.2, it is probable that the Aircraft touched down with the main gear first and then the nose gear at a point about 330 m beyond the Runway Threshold. It is probable that, after touchdown, the Aircraft bounced in a near level attitude and touched down again on the nose gear first at a point about 400 m beyond the Runway Threshold, followed immediately by the main gear, and that, with the impact of the second touchdown, the Aircraft bounced again in porpoising with the nose up steeply. It is probable that the Aircraft touched down again on the nose gear first in the steep nose down attitude at a point about 455 m beyond the Runway Threshold, that the nose gear sustained damage from that impact, and that the Aircraft then skidded about 292 m on the runway with the nose pushed against the runway surface before becoming immobile. As for the reason that the VHF antenna on the bottom of the aft fuselage was bent rearward around the middle and had black scratch marks on the antenna support, it is probable that the tire came into contact with the antenna support when the nose gear fork was broken, judging from the color of the scratch marks and the way the marks were left

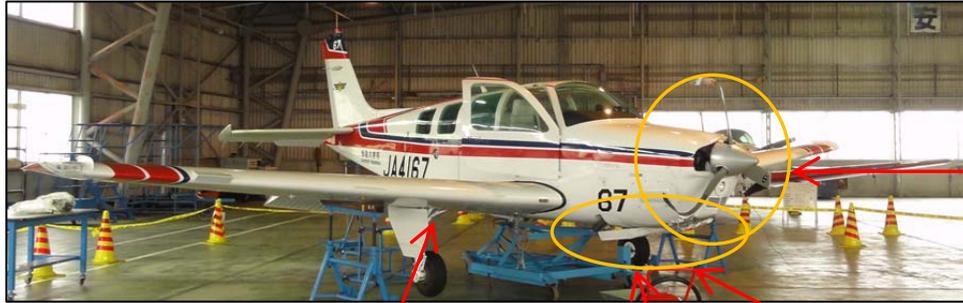
Photo 2 Damages of the Aircraft

| (2) Propeller: | All three blades were bent rearward. |

Bent propeller blades rearward

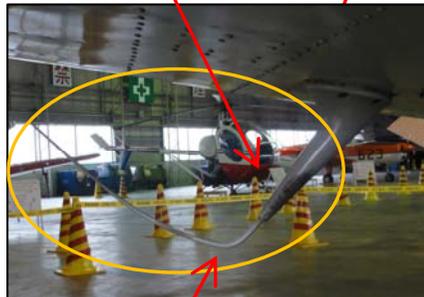
| (1) Fuselage: | At the bottom area of the nose, the nose gear door was deformed and the keel was also worn. In addition, the VHF antenna at the bottom of the aft portion of the fuselage was bent rearward at around the middle and the antenna support had black scratch marks. |

Bent VHF antenna

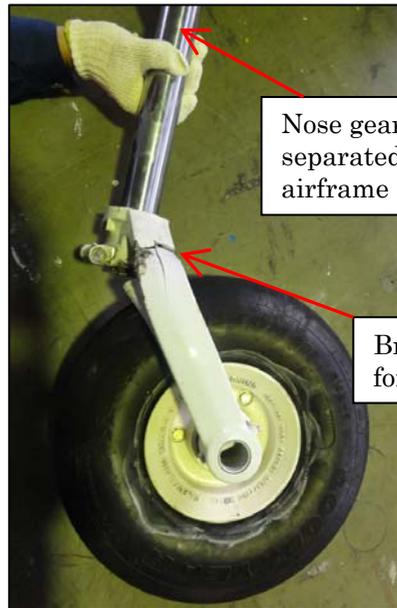
| (3) Landing gear: | The nose gear piston was separated from the Aircraft and the fork was broken. |

Nose gear piston separated from the airframe

Broken nose gear fork

Worn keel

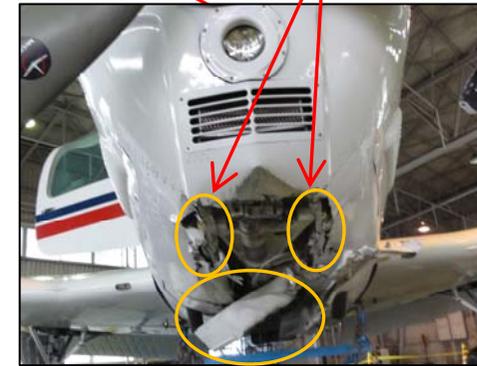
Deformation damaged nose gear door
