**AIRCRAFT SERIOUS INCIDENT  
INVESTIGATION REPORT**

**PRIVATELY OWNED  
J A 4 1 7 8  
JAPAN AIR COMMUTER CO., LTD.  
J A 8 4 7 C**

April 26, 2013

CESSNA 172RG, JA4178

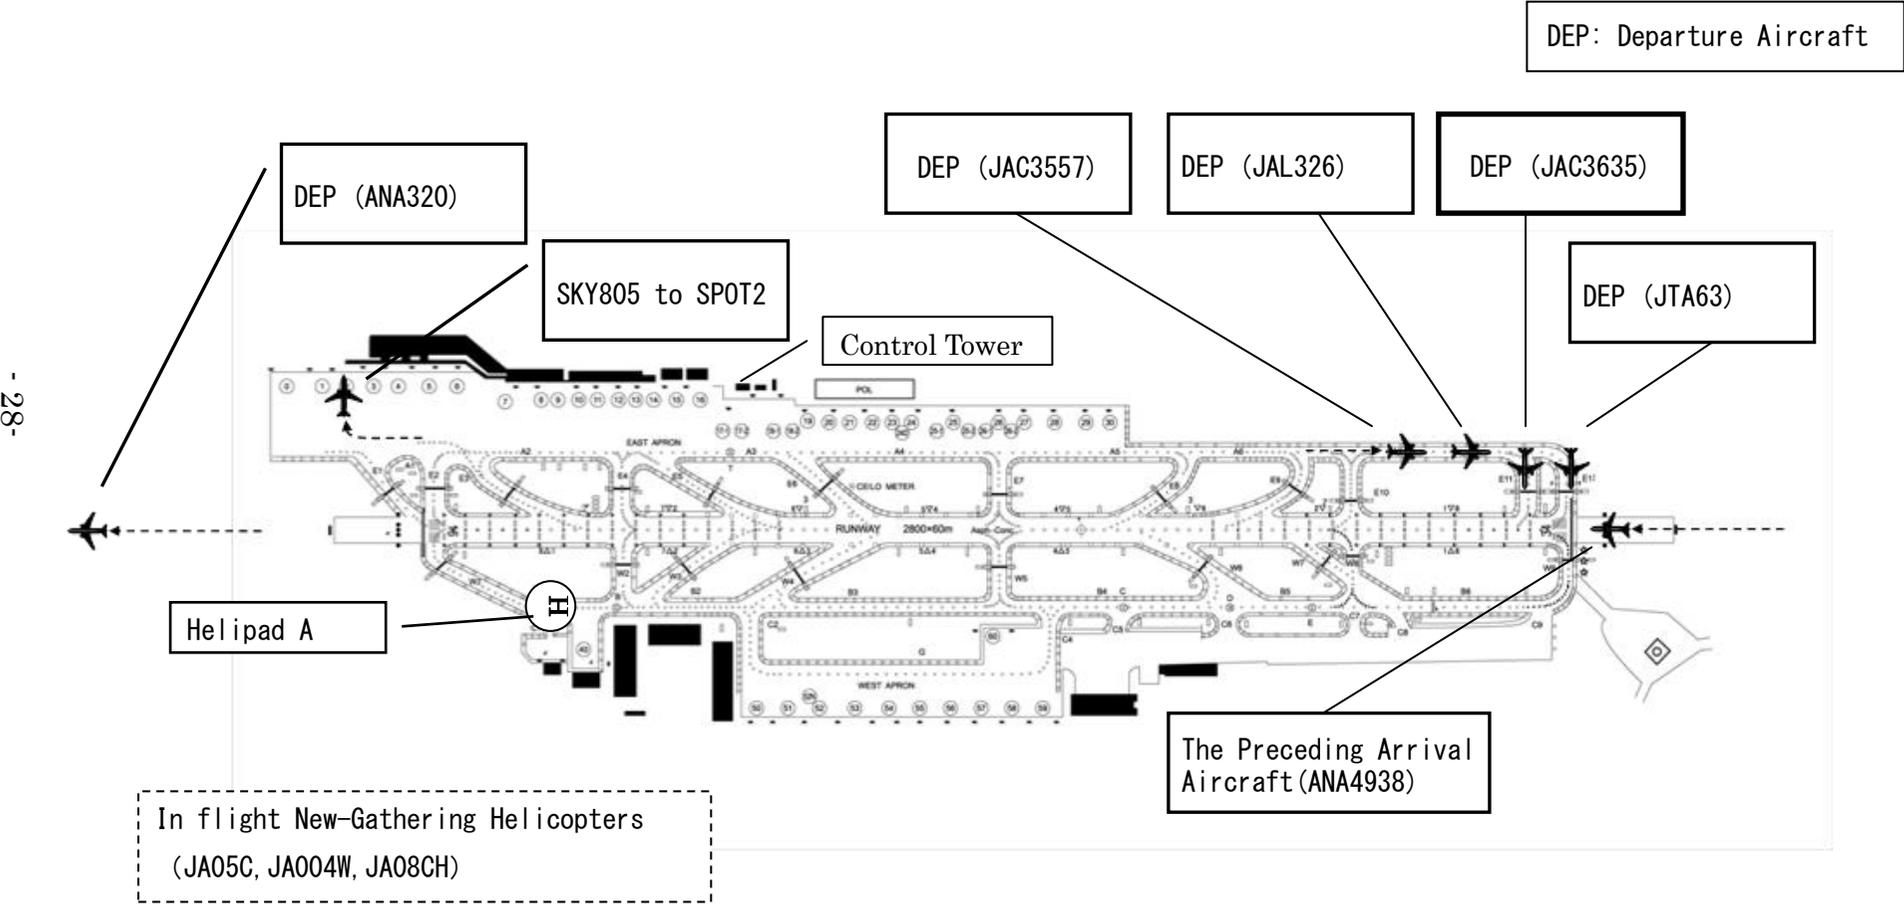
Figure 2 Estimated Traffic Conditions Just Before the Occurrence of Serious Incident

By the time when the aircraft arriving ahead of Aircraft A passed the approach end of Runway 34, the Tower had forgotten the existence of Aircraft A, and therefore, the Tower instructed Aircraft B, which had already waited at E11, to wait on the runway.

Usually, since arrival aircraft approach Runway 34 using the left traffic pattern, they are visually confirmed when they fly from the turning base leg to the final approach course, but the Tower failed to confirm Aircraft A in the final approach course. Small aircraft can easily be recognized when they are circling around, but are difficult to spot if they are in other positions. Nor could Aircraft A be confirmed on the screen of the Tower Display Subsystem (TDS). Furthermore, the strip bay<sup>\*4</sup> was also confirmed.

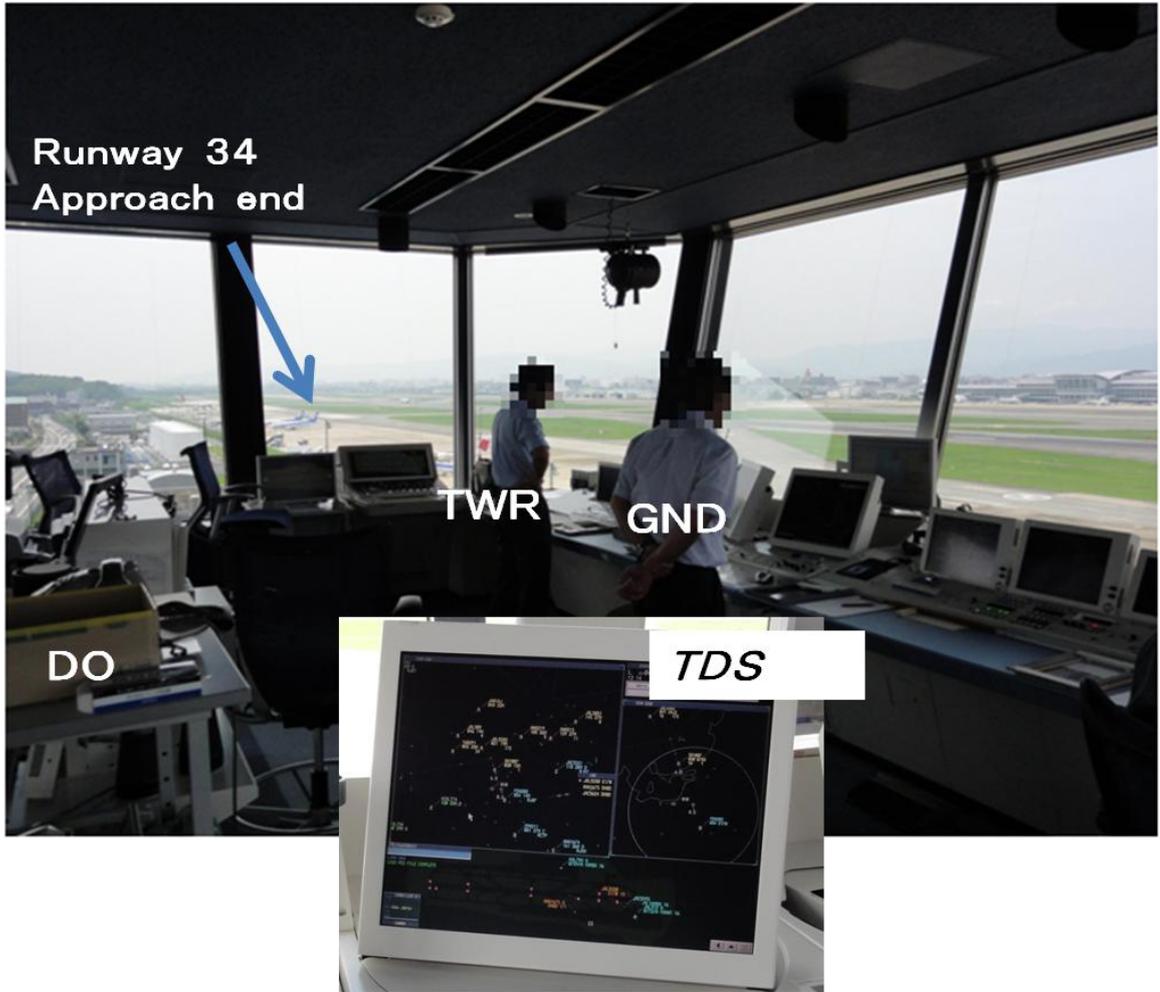
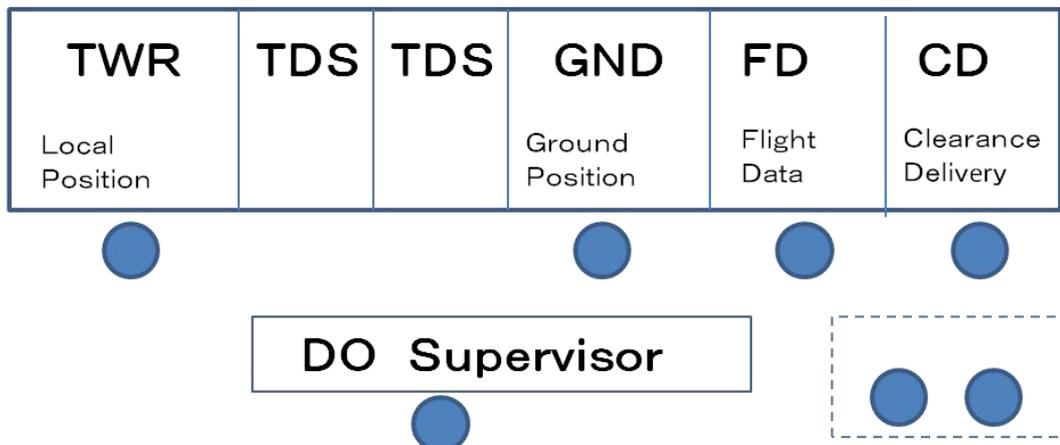
Figure 3 Layout of the Control Tower and View of the Runway

On the day of the incident, eight controllers were on duty at the Control Tower. Two of them (one of whom was a trainee) took the ATC Clearance Delivery seat with four others each in the Flight Data, Ground, Tower, and DO position. The remaining two were on standby.
