AI2016-1

**AIRCRAFT SERIOUS INCIDENT
INVESTIGATION REPORT**

NEW CENTRAL AIRSERVICE CO., LTD. CESSNA 172P, JA4184 ATTEMPTED LANDING ON A CLOSED RUNWAY HYAKURI AIRFIELD, IBARAKI PREFECTURE, JAPAN AT AROUND 10:05 JST, SEPTEMBER 20, 2014

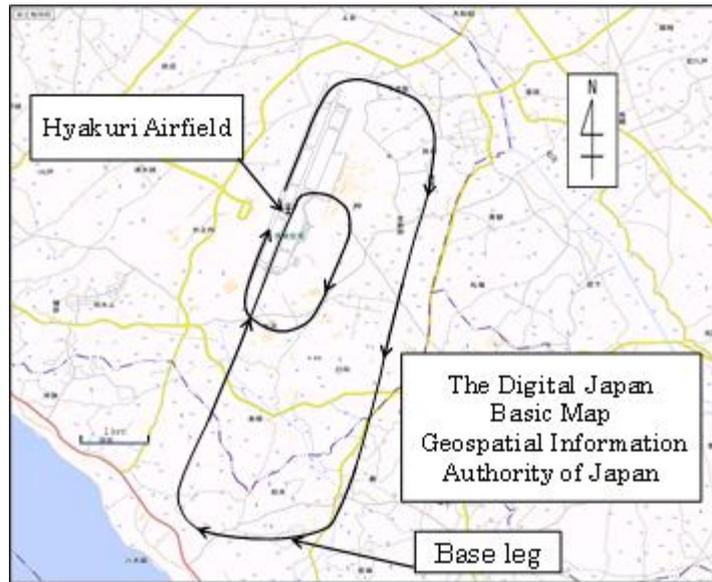
Figure 1 Estimated flight path

After taking off, the Aircraft turned right and entered the east side traffic pattern wider than usual. The Aircraft was given a landing clearance for 03L on the base-leg and the captain read it back.

The captain understood the Aircraft should land on 03L. However, 03L paved with asphalt was melt into the brackish background and unclear. On the other side, the runway 03R (hereinafter referred to as “03R”) was clearly looked white.

Therefore, the captain thought it was 03L and the taxiway seen in the front was 03R, because 03R attracted the captain’s attention and the captain could not see any runway in the back.

It was planned that the Aircraft evacuated from the runway at the taxiway W and taxied towards the apron after landing. Therefore, the captain was approaching aiming at the touchdown zone marking that was the third from the threshold allowing the Aircraft to enter the apron without braking, thinking to perform the activities in an efficient way.

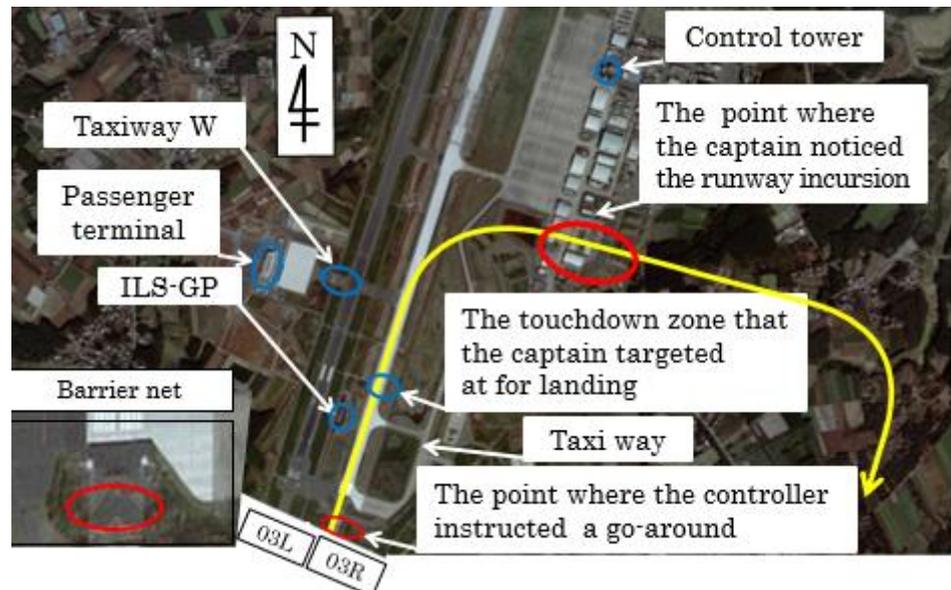
Figure 2 Situation of go-around

The controller who controlled the Aircraft noticed that the Aircraft entered 03R when it approached the runway in the final approach and gave an instruction to the captain to make a go-around at around 10:05.

Receiving this instruction of a go-around, the captain made a go-around. At this time, the Aircraft was flying at approximately altitude of 200 ft around the area where the nearest touchdown zone was not visible.

The captain received the instruction of a go-around and was told that he was going to land on 03R from the controller. However, he did not understand what it meant.

After the go around, the captain made a right turn at altitude of 500 ft. He looked back and noticed that the runway he tried to land was 03R for the first time.
