AA2015-4

**AIRCRAFT ACCIDENT
INVESTIGATION REPORT**

**ANA WINGS CO., LTD.
J A 4 6 2 A**

**DAMAGE CAUSED BY LIGHTNING STRIKE
DURING LANDING APPROACH
ANA WINGS CO., LTD.
BOMBARDIER DHC-8-402, JA462A
AT AN ALTITUDE OF APPROX. 5,300 FT, APPROX. 20 KM
TO THE NORTHEAST OF FUKUE AIRPORT
AT AROUND 09:30 JST, NOVEMBER 29, 2013**

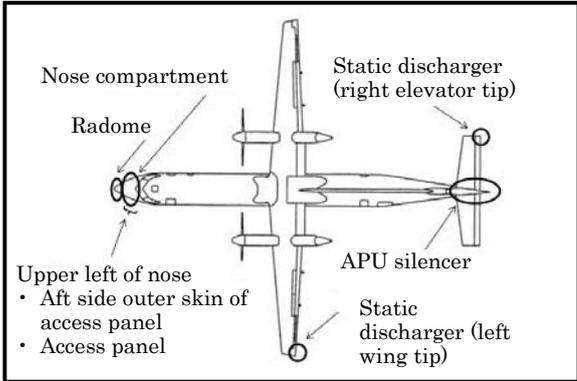
2.2 Injuries to Persons	None
2.3 Damage to Aircraft	<p>Extent of damage: Substantially damaged</p> <ul style="list-style-type: none"> • Radome: Paint was flaked off approximately 1 mm diameter each in scattered areas. • Nose: Rivet heads (six) on the upper left access panel were

<p>burned. Latches of the upper left and upper right access panels (three locations) were burned. Dents occurred in five locations on the aft side outer skin of the upper left access panel. (The depth of each dent was approximately one to three mm, and each dent was deformed toward the center of the dented surface. No other damage aside from deformation was revealed on the surfaces of the outer skin where the dents occurred.) Portions of the materials of the internal structure supporting the aft side outer skin where the dents occurred, of the upper left access panel, were deformed. (See Photo 2: Damage on Left Side of Nose)</p> <ul style="list-style-type: none"> • Main wing: A static discharger was burned (left wing tip). • Elevator: A static discharger was burned (right hand elevator tip). • APU: Part of the silencer was burned.

<p style="text-align: center;">Major damaged areas of the aircraft</p>

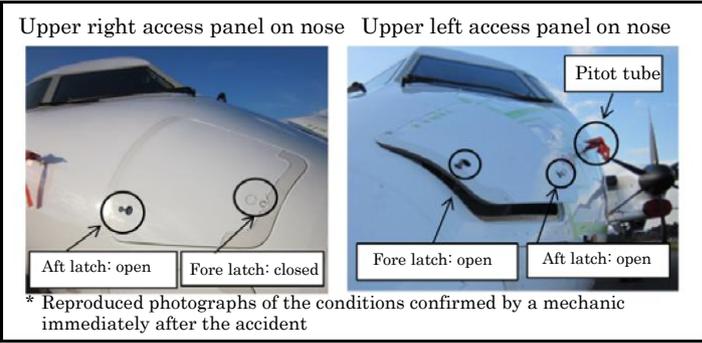
<p>2.7 Additional Information</p>	<p>The fore and aft latches of the upper left access panel on the nose, and the aft latch of the upper right access panel on the nose, were opened. Even if the fore and aft latches of the upper left and upper right access panels on the nose are opened, their structure is such that other mechanisms will prevent those panels from becoming fully released. Although there is a pitot tube each located to the aft of the upper left and upper right access panels on the nose for detection of speed and other factors, there were no abnormalities identified with any data indicated by flight instruments, according to the DFDR records and the statements of the PIC and the FO.</p>

<p style="text-align: center;">Condition of upper left and upper right access panels on the nose after the accident</p>
--	--

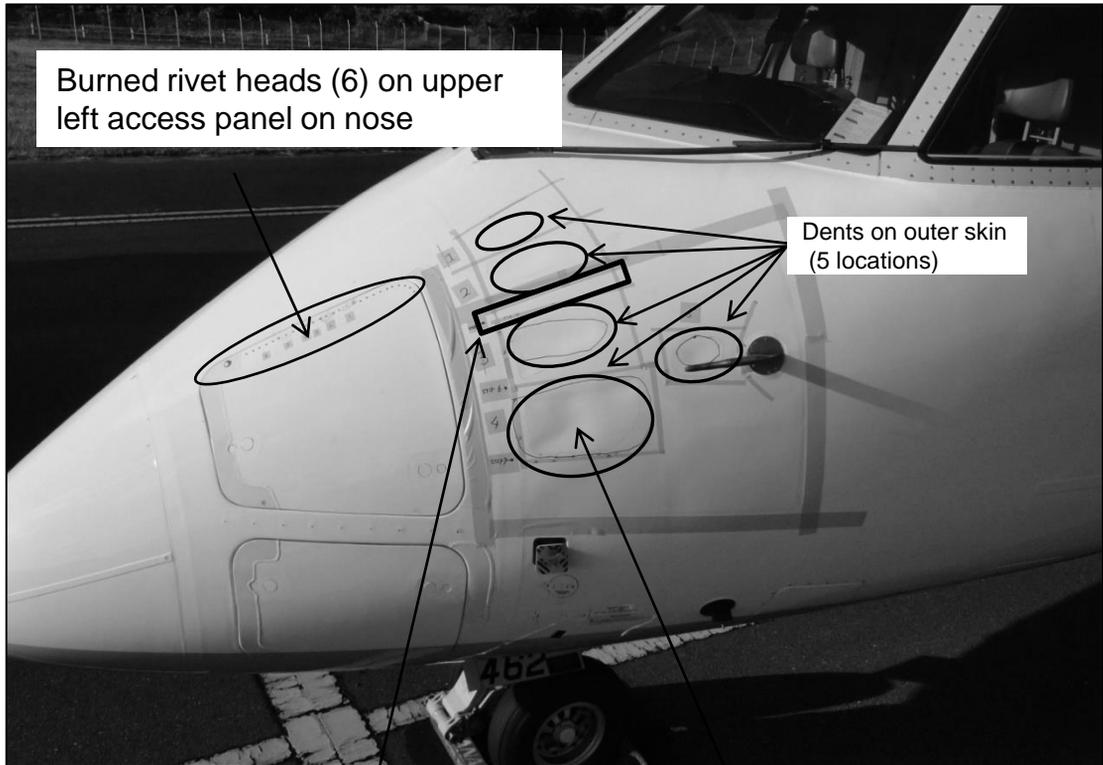
Photo 2: Damage on Left Side of Nose

- Five dents occurred on the aft side outer skin of the upper left access panel on the nose,
- Six rivet heads on the upper left access panel on the nose were burned, and
- The aft latch of the upper right access panel on the nose, as well as the fore and aft latches of the upper left access panel on the nose were opened.

In the accident, it is somewhat likely that the aircraft sustained damage on the aft side outer skin of the upper left access panel on the nose and on the portions of the internal structure supporting the outer skin because it was subjected to a powerful shockwave generated by the discharge of lightning while making a landing approach.

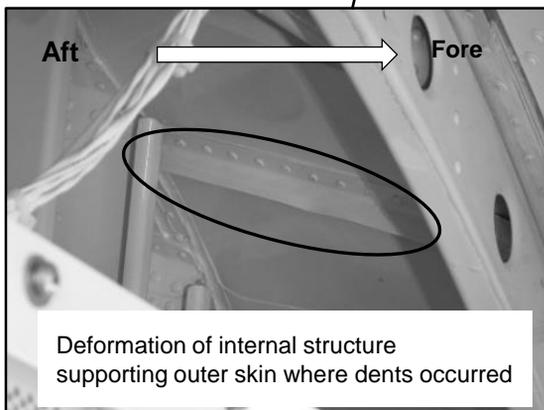
The Company inspected the details of the damage of the aircraft, and confirmed that deformations had also occurred on the internal structure supporting the rear side outer skin of the upper left access panel on the nose.

Enlarged Photo
(taken from the interior of the aircraft)
