**AIRCRAFT SERIOUS INCIDENT  
INVESTIGATION REPORT**

**TOHO AIR SERVICE CO., LTD.  
J A 5 0 4 D**

July 29, 2021

<b>Company</b>	Toho Air Service Co., Ltd.
<b>Type, Registration Mark</b>	Airbus Helicopters AS350B3 (Rotorcraft) JA504D
<b>Incident Class</b>	Dropping of Object during External Cargo Sling Operation Item 16, Article 166-4 of the Ordinance for Enforcement of Civil Aeronautics Act of Japan
<b>Date and Time of the Occurrence</b>	At about 10:55 JST (JST: UTC+9 hours, unless otherwise noted, all times are indicated in JST in this report on a 24-hour clock), December 4, 2020
<b>Site of the Serious Incident</b>	Higashi-Matsushima City, Miyagi Prefecture (38° 20'18" N, 141° 08'04" E)

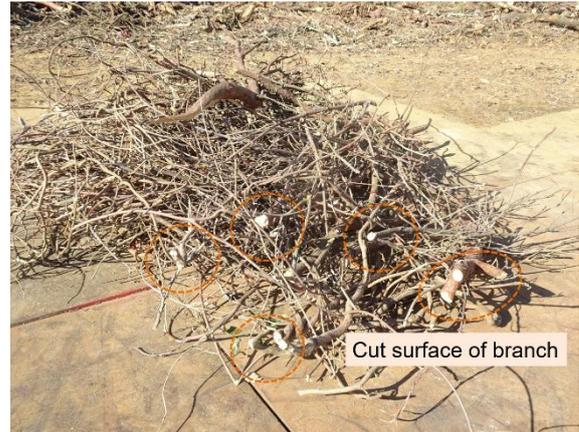
According to the statements of the signal person, he cut off wisteria vines, which got entangled with the dead pine trees, as much as he could with a chain saw before carrying out the dead pine trees and judged that the lifting was practicable. When the dead trees were lifted with the sling, the signal person visually recognized that the mass of the dead branches of the pine trees was entangled with the vines, and reported to the captain by radio saying, “There is something unstable.”

Figure 3 Dropped dead branches

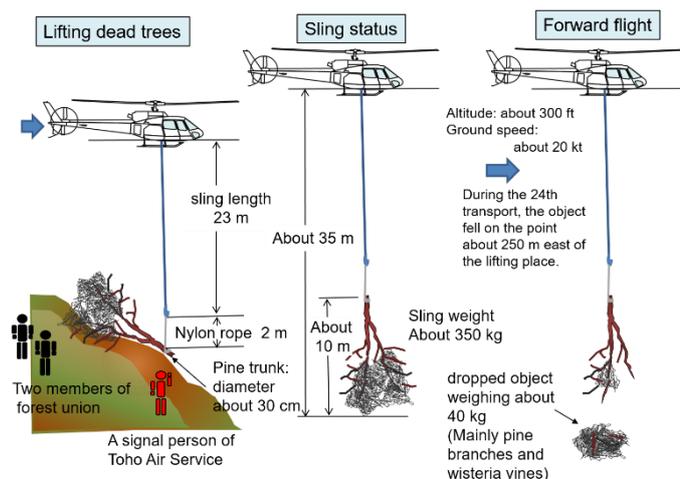
Figure 4 Transition status from lifting to dropping of some of dead trees in forward flight

From the event occurred and the relevant information, transition from lifting the dead trees to dropping of some of the dead trees in the forward flight is as shown in Figure 4.

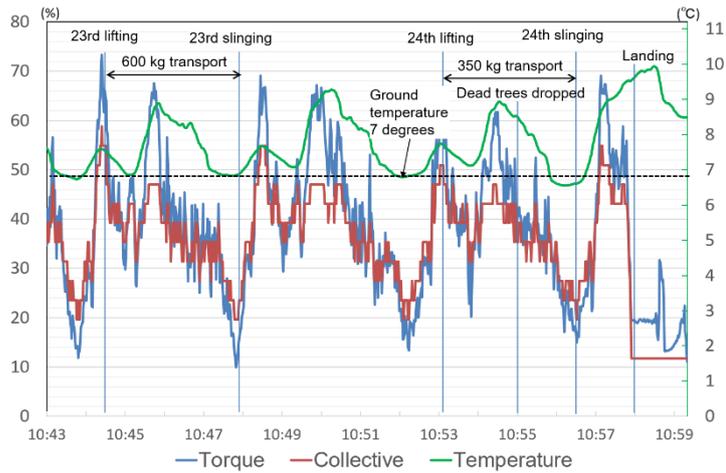
Figure 5 Changes of outside temperatures and engine outputs

From the ECU record and confirmation record of the goods transport, the changing tendency of the downwash\*<sup>1</sup> was estimated from the varying values of the outside temperature, torque and collective pitch lever.

When the downwash is passing through near the fuselage, the outside temperature sensor attached to a lower part of the fuselage is influenced by heat emissions from the engine, and thereby the outside temperature rises higher than the actual value.

From the fact that the outside temperature rose at around 10:55 when the helicopter was flying at a low speed after the 24<sup>th</sup> lifting, it is probable that the downwash moved just under the airframe.

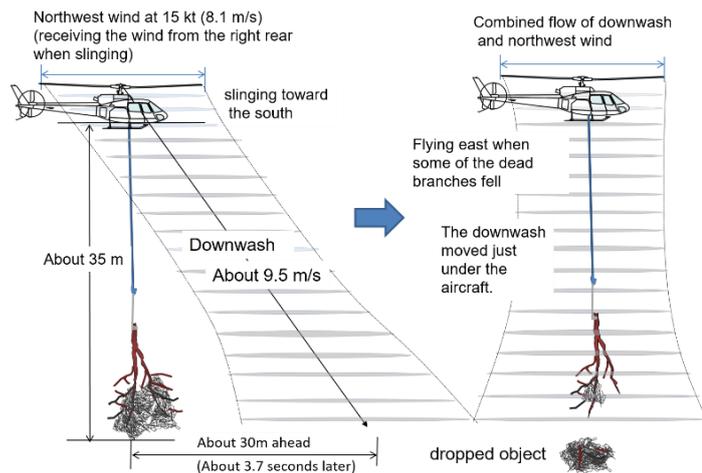
Figure 6 Influence by downwash

The weight of the helicopter lifting the dead trees indicates that the induction current generated from the main rotor is more likely to have been about 9.5 m/s. When the helicopter was slowly approaching from the northwest, it is more likely that the downwash was blowing in the vicinity of the sling place before the helicopter arrived just over the sling place influenced by the northwest wind at about 15 kt.

When the dead trees were completely slung, it is likely that the signal person judged that the influence of the downwash was limited as the center of the downwash was on the leeward of about 30 m ahead.

From the outside temperature rise as shown in Figure 5, it is probable that the wind combining the downwash and northwest wind increased the wind pressure on the dead trees while the helicopter was flying at a low speed toward the east after lifting since the center position of the downwash moved just under the airframe. (Refer to figure 6)

Packaging methods for carrying out dead or damaged trees were taking place customarily without being clarified in the company. In this serious incident, part of the slung goods, which were not bound tight enough, is most likely to have dropped due to the influence of the downwash. Similarly, when measures to prevent slung goods from dropping are not taken

In this serious incident, during the flight at low speed, it is highly probable that some of the dead trees dropped on the fallow field due to the wind pressure including downwash because the measures to prevent the slung dead trees from dropping were not sufficient.
