**AIRCRAFT ACCIDENT
INVESTIGATION REPORT**

**CENTRAL JAPAN AERONAUTIC ASSOCIATION, GIFU DIVISION
J A 5 0 5 G**

AIRCRAFT DAMAGE DURING FORCED LANDING CENTRAL JAPAN AERONAUTIC ASSOCIATION, GIFU DIVISION Glaser-Dirks DG-500 ELAN ORION (GLIDER, TWO-SEATER), JA505G MATSUMOTO CITY, NAGANO PREFECTURE AT AROUND 12:17 JST, MAY 2, 2019

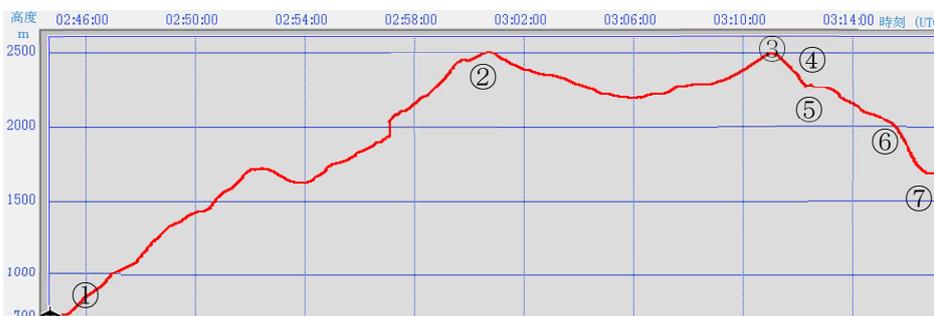
Figure 3: Cross section of the estimated flight route

When the Glider reached altitude of about 2,500 m (③) near Mt. Jukkoku, the captain intended to fly further north towards Mt. Yakedake, but as the altitude was low, he tried to fly close to the mountain slope to

<p>gain altitude with the ridge lift. As the captain was concentrating too much on maintaining distance from the slope, he looked away from Mt. Yakedake. While flying along the slope, the Glider encountered strong downdraft. The captain assumed that it was the downdraft from the valley of Aboutoge Pass and it would turn into updrafts after passing over the valley, so he kept on flying. The Glider reached the point where the downdraft became weaker, but had lost considerable altitude, so the captain turned back to return to the original updraft place. At this time, unexpectedly the captain visually recognized Mt. Yakedake to the right, therefore, he thought he had passed Mt. Yakedake to the north without even noticing, turned back and flying southward. The Glider entered the downdraft again, the height from the ground has decreased, and the mountain slope came close.</p> <p>According to records on GPS, the Glider turned southeast at Mt. Jukkoku instead of north towards Mt. Yakedake, and continued to fly over saddle located between Mt. Jukkoku and Mt. Abou and crossed the ridge of Mt. Norikura from its upwind side to its lee side (④). As the Glider rapidly lost altitude since there was the strong downdraft at about -3 m/s on the lee side of the ridge, the captain flew through the downdraft at an altitude of about 2,300 m and made a turn to return (⑤), but the Glider entered into the downdraft again and lost more height.</p> <p>At an altitude of about 1,800 m, the captain felt that the ground height decreased and he thought that he had no choice but to make a forced landing, but there was no suitable open space for the landing, therefore, he found a forest with thin trees on gentle slopes and decided to make a forced landing by making contact with those trees to decrease the speed (⑥). Upon force landing, the Glider contacted trees, breaking fuselage and right wing, and came to rest with the nose down and hanging from trees. (1,680m Elevation ⑦)</p> <p>It was not until the captain was rescued and told the place where he was found was not in Gifu Prefecture but in Nagano Prefecture that he realized he had gone over the ridge and drifted into the downdraft area on the lee side of the ridge. Until then, captain believed that the forced landing site was on the west slope of Mt. Yakedake.</p> <p>This accident occurred at around 12:17 on May 2, 2019, on the south slope of Mt. Yakedake, Azumino Kamikochi in Matsumoto City, Nagano Prefecture (Latitude 36°12' 28" N, Longitude 137°35' 17" E).</p>

When crossing the ridge of Mt. Norikura, the Glider was flying at an altitude of about 2,500m, which is almost same altitude as Mt. Jukkoku nearby with an elevation of 2,525m. In light of the fact that there was the strong downdraft zone on the lee side of the ridge as described in 2.7 (1), it is probable that the height above ground was too low. As the captain intended to fly further north when he reached Mt. Yotsudake, the target of

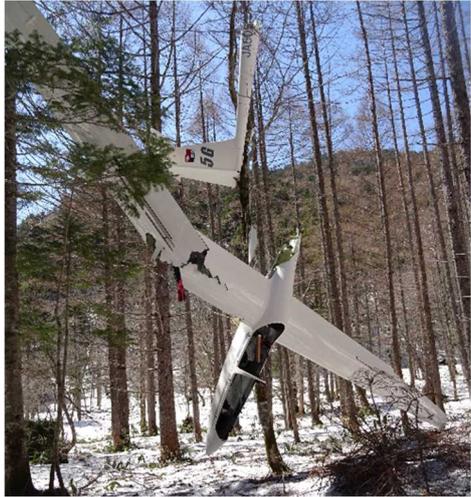
<p style="text-align: center;">Figure 4: Accident site</p>

2.3 Damage to the Glider	<p>Extent of damage: Destroyed</p> <ul style="list-style-type: none"> - Main wings: Right main wing broken - Fuselage: Tail broken

As the captain missed to keep target in sight and flew along the slope, he lost the position and wandered into the downdraft zone on the east side of Mt. Norikura ridge. As he lost altitude, it is highly probable that he gave up flying and made the decision to make a forced landing to the forest. It is highly probable that the Glider collided with trees, causing serious damage.

This accident occurred while flying ridge soaring, the Glider wandered into the downdraft zone on the lee side of the ridge and lost altitude. As the captain tried to make a forced landing to the forest, it is highly probable that the Glider collided with trees, causing damage.

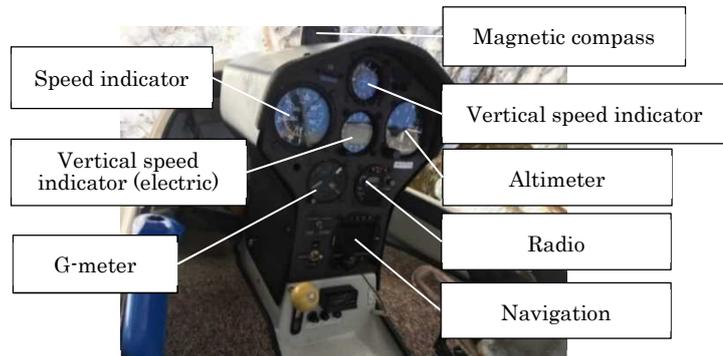
Figure 7: Instruments panel of the Glider

The navigation utilizes GPS signal and displays heading and area map. The captain was not used to use navigation nor compass, so he did not confirm the position and heading by these instruments at the time of the accident.

The Glider was equipped with a magnetic compass and a navigation with a map display. The captain was able to confirm the position and heading of the Glider with these instruments. As he was not used to check navigation instruments such as magnetic compass, it is probable that he was not able to notice his mistake on the heading.

The education shall be given to the Club members in order to ensure that they can understand the importance of the use of instruments like a magnetic compass and use those instruments positively during cross-country flight.

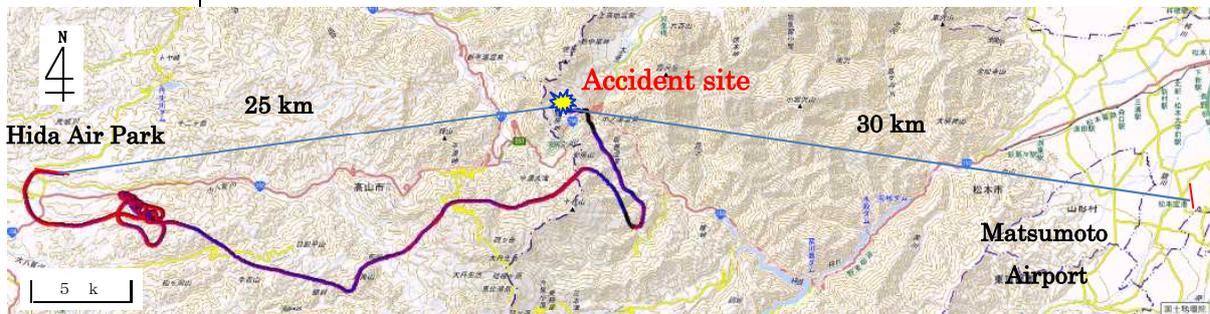
Figure 8: Relative position of the Hida Air Park,

The flight operations procedure of the Club described the radio frequency of Matsumoto Airport but did not specifically state it as alternate landing site. As there were no event in the past that an Glider was unable to return to the Hida Air Park due to altitude loss on the lee side of a ridge, the captain and the Club members was not prepared to use Matsumoto Airport located far side of the ridge as an alternate landing site.

The captain had lost position and heading of the Glider, however if he had acknowledged them correctly, from the Glider glide ratio, wind direction and velocity, it is most likely that he may have reached and land safely to Matsumoto Airport. Glider pilots always needs to fly considering whether he have suitable landing site within his glide range. The captain should have prepared the radio frequency and the landing method of Matsumoto Airport, considering that he might mistakenly fly to downdraft zone on the lee side of the ridge.

It was set out in the flight operations procedure that Matsumoto Airport shall be considered as an alternate landing site.

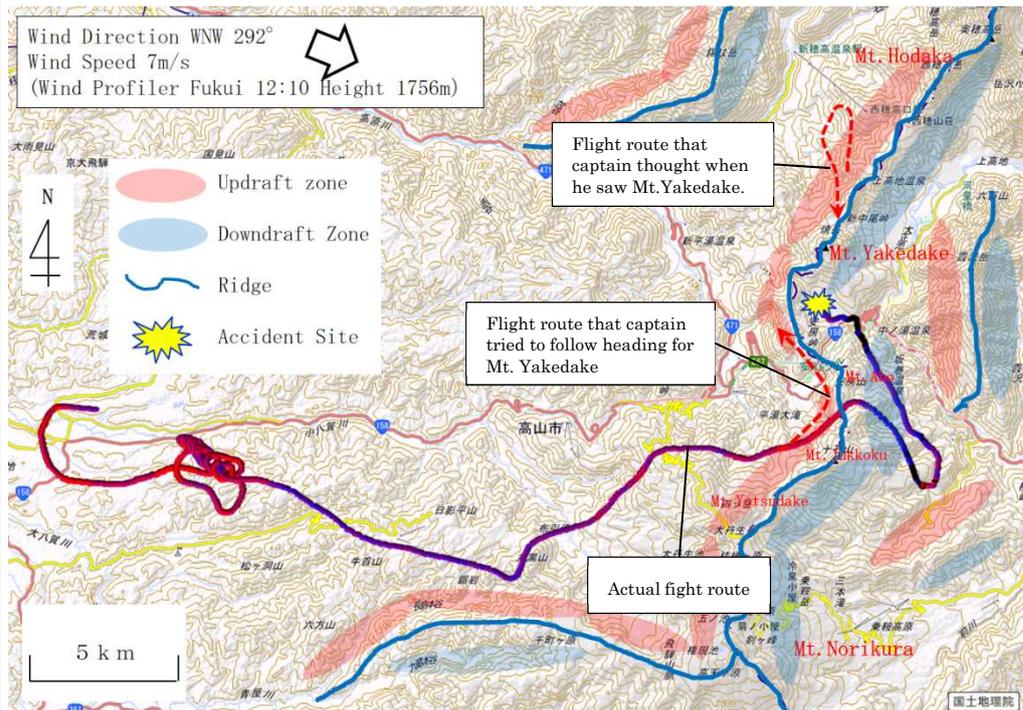
Figure 9: Slope lifts estimated from the landscape and wind conditions around the accident site

3.1 Involvement of Weather	None
3.2 Involvement of Pilots	Yes
3.3 Involvement of Aircraft	None
3.4 Analysis of Findings	<p>(1) Meteorological conditions</p> <p>(a) Wind on the day of the accident</p> <p>As shown in Figure 5, it is probable that the areas around Japan were in a weak west-high and east-low pressure system, and there were light northwesterly winds (about 7 m/s) at around the accident site.</p> <p>(b) Slope lifts in the area</p> <p>As shown in Figure 6, on the upwind side of the slope, there are ridge lifts created by wind flowing to the slope. From the landscape and wind conditions around the time of the accident, estimated updraft zone (red color) and downdraft zone (blue color) are as shown in Figure 9. It is highly probable that the Glider was in the updraft zone when flying west of Mt. Norikura. It is also highly probable that the Glider entered the downdraft zone and lost altitude as it crossed the ridge to the lee side near Mt. Jukkoku.</p> <p>While flying ridge soaring, it is important for the pilot to recognize updraft and downdraft zones expected from the relative position of the ridge and the wind direction, and always stay in the updraft zone.</p> <p>(2) Flight of the Glider</p> <p>(a) Flying to the downdraft zone</p> <p>When the captain was at Mt.Jukkoku intending to head north towards Mt.Yakedake, as he was concentrating too much on maintaining distance</p>

from the slope, and looked away from his visual target Mt. Yakedake, and did not check his heading with the instruments such as magnetic compass, it is probable that he did not notice that he had changed heading to the southeast. When the Glider entered the downdraft zone, it is probable that the captain erroneously thought that it was the downdraft affected by valley of Aboutoge Pass, and thus he kept flying without getting back right away. As the captain visually recognized Mt. Yakedake to the right when making a turn to return to the original place, he mistakenly thought he have already passed Mt. Yakedake to the north and going southward. The red arrow in Figure 9 shows what captain has stated how he believed the flight route. It is highly probable that the captain lost position and crossed the ridge of Mt. Norikura to the lee side, and entered the downdraft zone.
