**AIRCRAFT SERIOUS INCIDENT  
INVESTIGATION REPORT**

**AIR NIPPON CO., LTD.**

**J A 5 5 A N**

**AIR NIPPON CO., LTD.  
BOEING 737-800, JA55AN  
AT AN ALTITUDE OF ABOUT 6,800 FT, AT ABOUT 30 KM EAST OF  
ASAHIKAWA CITY, HOKKAIDO PREFECTURE  
AROUND 13:38 JST, OCTOBER 26, 2010**

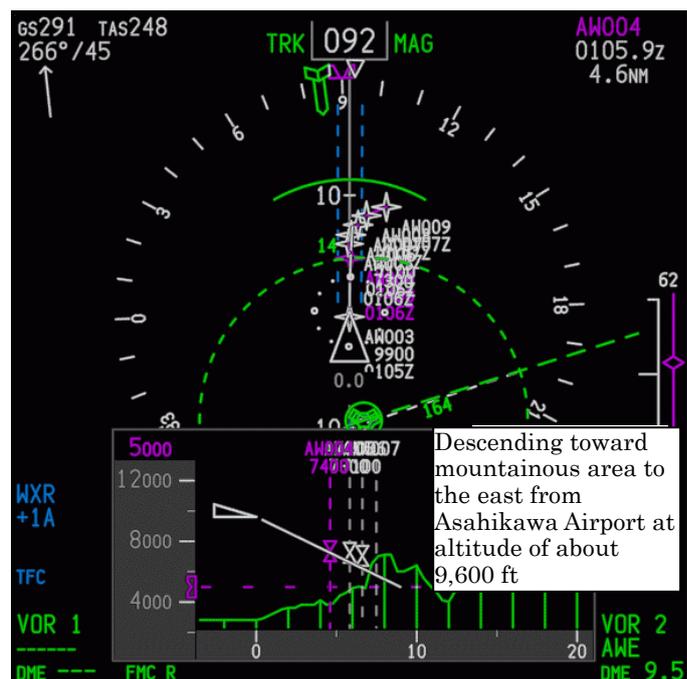
Figure A ND-1 on the FO side

- (1) While descending toward a mountainous area to the east from over Asahikawa Airport, the ND on the FO's side showed a geographical feature (a mountain ahead) on the VSD with a 20 nm range selected even at about 10,800 ft at around a point 6.3 nm from AWE. (See Figure A)

At about 8,100 ft at around a point 12.7 nm from AWE, the peak of the geographical feature shown on the VSD with a 10 nm range began to change to yellow. At this moment, the ND remained on the WXR mode.

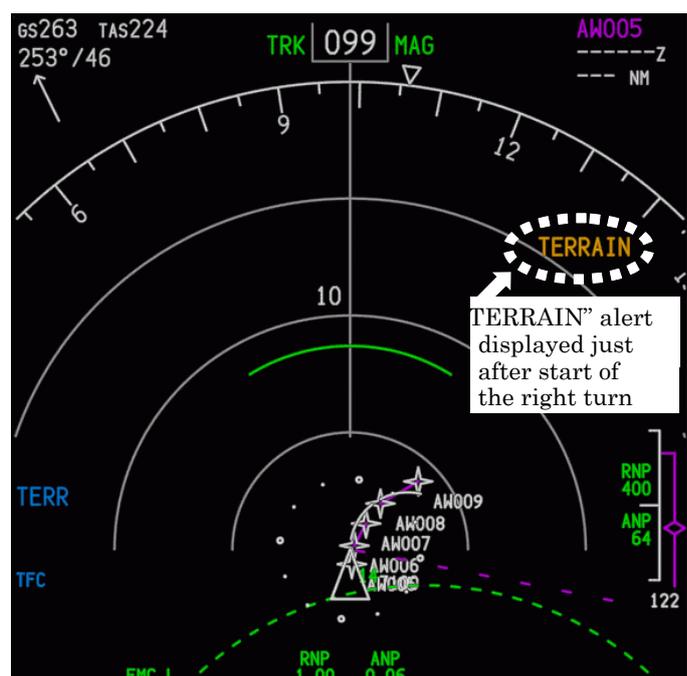
Figure B ND-1 on the PIC's side

- (2) The ND on the PIC's side showed the "Caution Terrain" heads-up message of the TERRAIN" (EGPWS) in yellow around heading 099° just after the start of a right turn from heading 090°. At the same time, the WXR mode was switched to the terrain mode. (See Figure B)

About five seconds later, a geographical feature shown in yellow began to appear on the ND from around heading 109°.

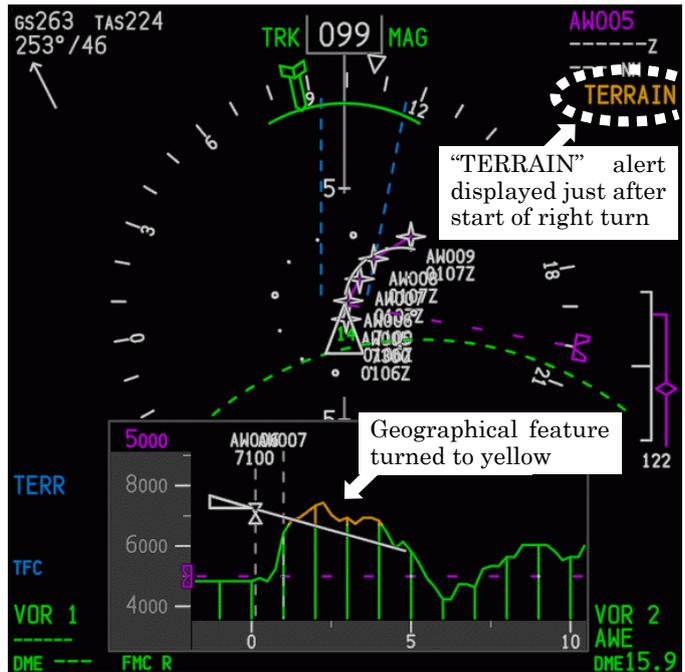
Figure C ND-2 on the FO side

- (3) Around the same time as the phenomena mentioned in (2), the ND on the FO's side showed the "TERRAIN" in yellow around heading 099°, 15.9 nm from AWE at about 7,200 ft just after the start of a right turn. Simultaneously, the WXR mode was switched to the terrain mode. The geographical feature shown in yellow on the VSD was within a range of 2 nm. (See Figure C)

The geographical feature shown in yellow began to appear on the ND from around heading 109°, 16.3 nm from AWE.

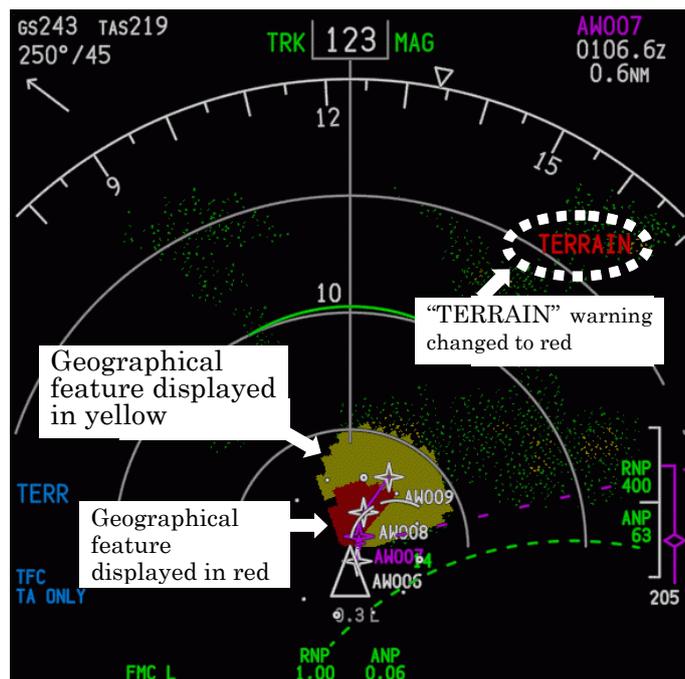
FigureD ND-2 on the PIC's side

- (4) On the PIC's ND, the color of the "TERRAIN" indication (the "Terrain" warning by EGPWS) changed to red from around heading 118°. The geographical feature began to be shown in red from around heading 121°. (See Figure D)

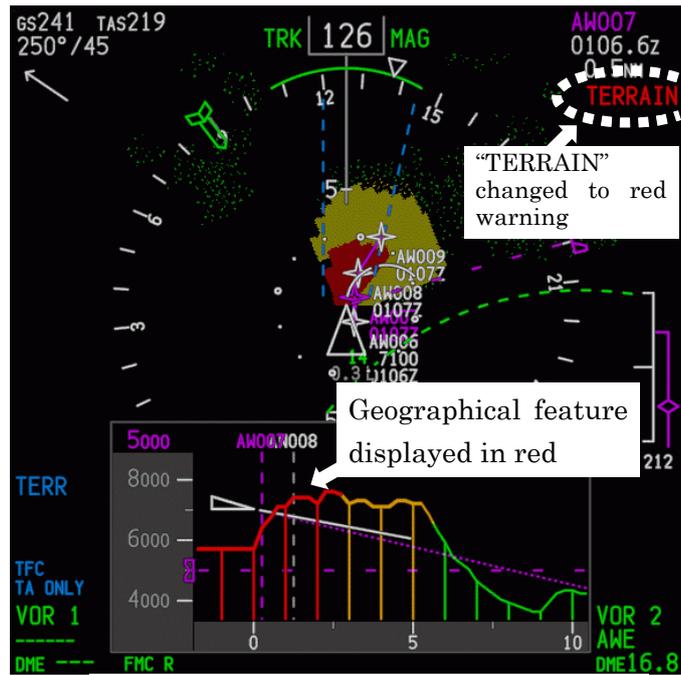
FigureE ND-3 on the FOside

- (5) Around the same time as the phenomena mentioned in (4), the color of the “TERRAIN” message on the ND on the FO’s side changed to red from around heading 119° , 16.6 nm from AWE. The geographical feature on the VSD began to be shown in red around heading 126, 16.8 nm from AWE. (See Figure E)

A collision evasive maneuver was performed and ten-odd seconds later, the “TERRAIN” indication and the red geographical features disappeared from the ND.

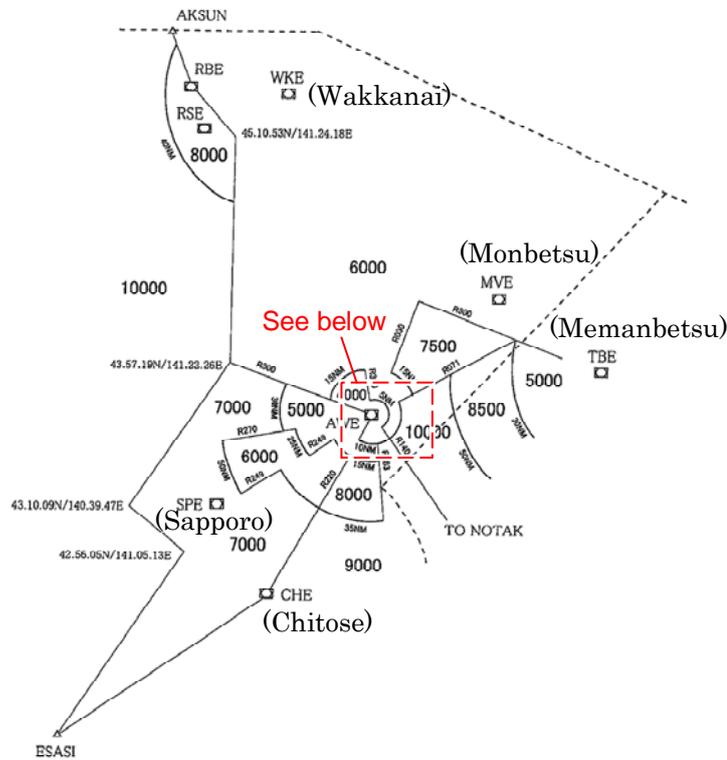
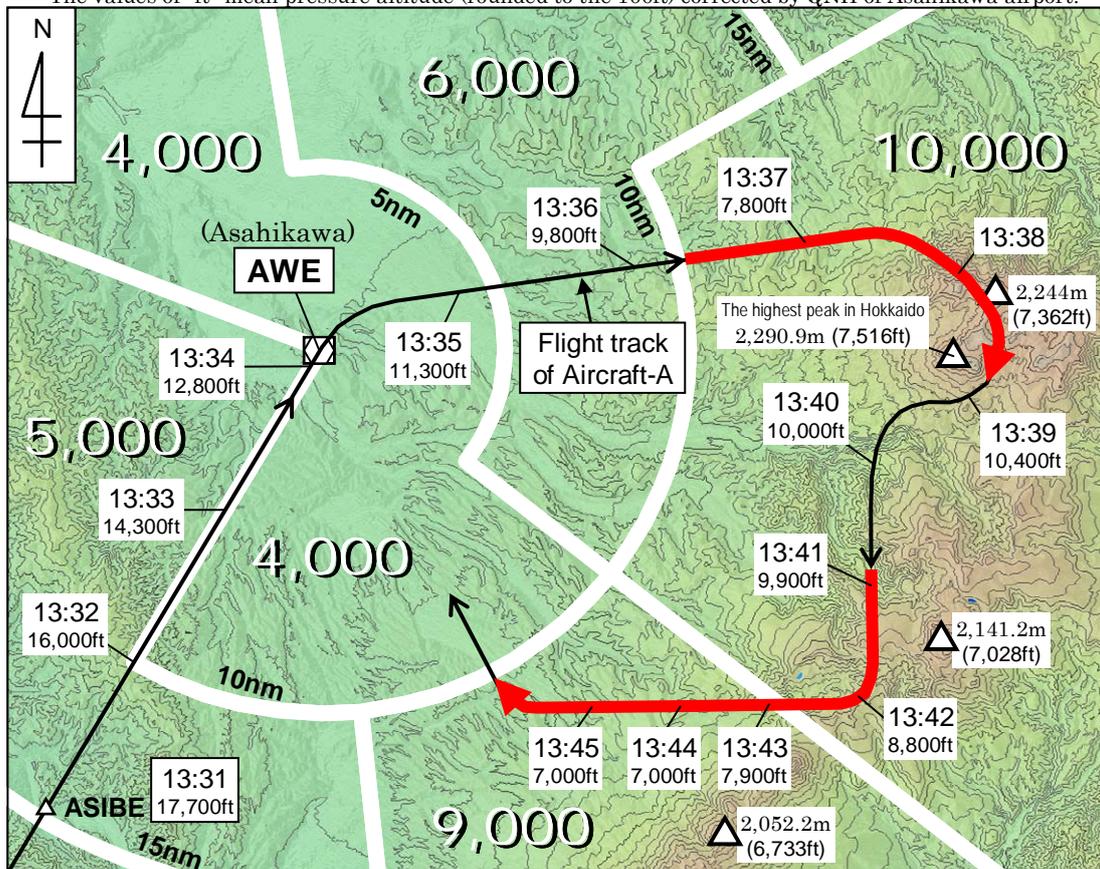
Figure 6 Minimum Vectoring Altitude (MVA) in the vicinity of the serious incident site

Bold and shadowed numbers show MVA (ft)

: below MVA
