**AIRCRAFT ACCIDENT  
INVESTIGATION REPORT**

**TOKYO SKYDIVING CLUB**

**J A 5 5 D Z**

**AIRCRAFT TYPE : CESSNA 208B**

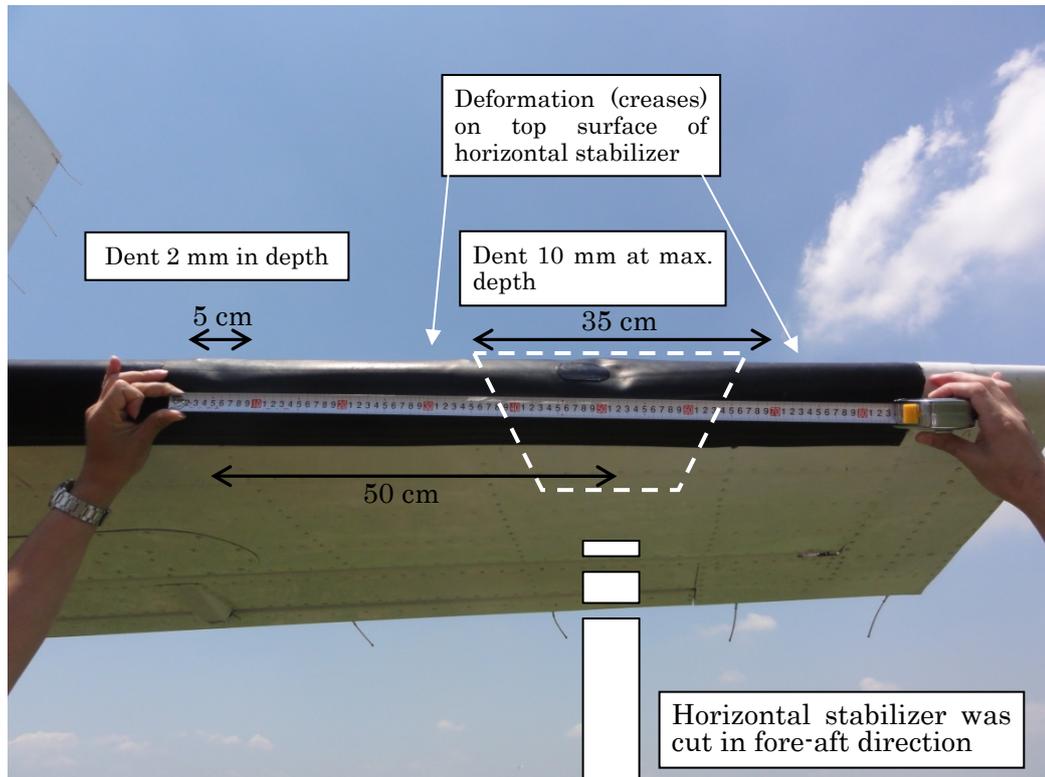
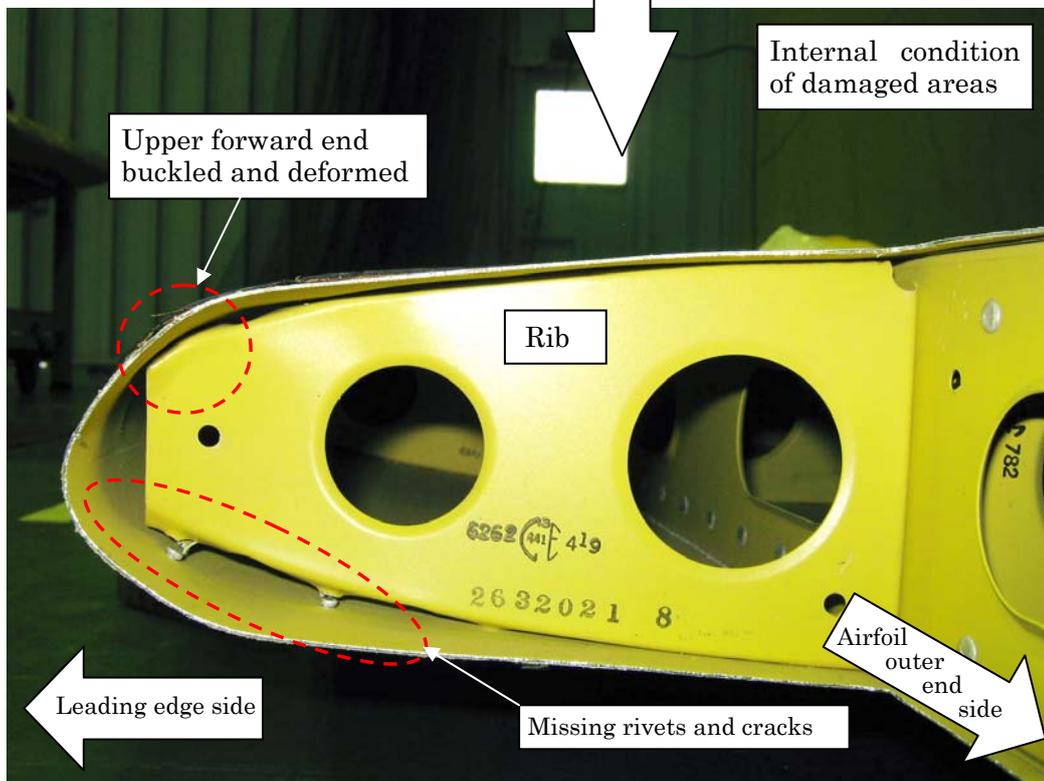
Photo 3 Damage to Horizontal Stabilizer

At the exterior inspection of the Aircraft after landing, the Captain found large dents on the leading edge of the left horizontal stabilizer as well as deformation of its top surface. The extent of the dents implied to the Captain that if Jumper A had made contact with the airframe, he would have sustained a serious injury, but the actual injury to Jumper A was identifiable only by the slightly red marks on his legs. On the day of the accident, the visibility was more than 10 km, there were scattered clouds between 5,000 and 6,000 ft, and the wind was weak up in the air. There were no problems for the flight.

Horizontal stabilizers      The damage to the leading edge of the left horizontal stabilizer consisted of a 35-cm-wide dent with a maximum depth of 10 mm and a 5-cm-wide dent with a maximum depth of 2 mm (with a distance of 50 cm between the two dents) and the rivets were missing.

The top surface of the left horizontal stabilizer was deformed (creases).
